RIPARIAN AREA MANAGEMENT

*Process for Assessing
Proper Functioning Condition*

Technical Reference 1737-9
1993; Revised 1995, 1998

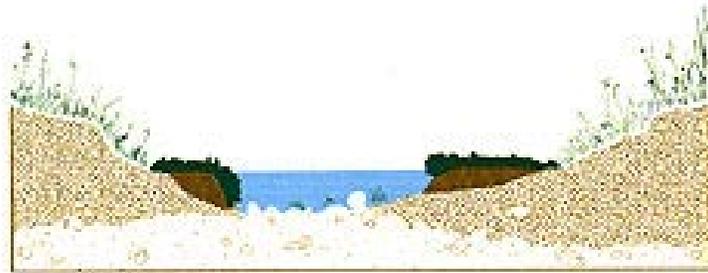
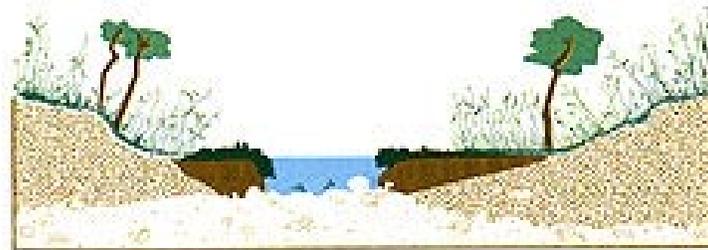
Figure 3. Stream cross sections.

Figures 2 and 3 provide an example of the relationship between PFC and vegetation community succession for one area. Assuming succession continues uninterrupted (Step 1 to Step 2 in Figure 2), the channel will evolve through some predictable changes from bare ground to PNC (although not necessarily as linearly as depicted). The riparian-wetland area will progress through phases of not functioning, functioning—at risk, and properly functioning along with plant succession. In this example, PFC occurs at the mid-seral stage (Step 3). Figure 3 shows a stream cross section of each condition (A-E) displayed in Figure 2.

A
Bare Ground

B
Early Seral

C
Mid-Seral

D
Late Seral

E
PNC or PPC

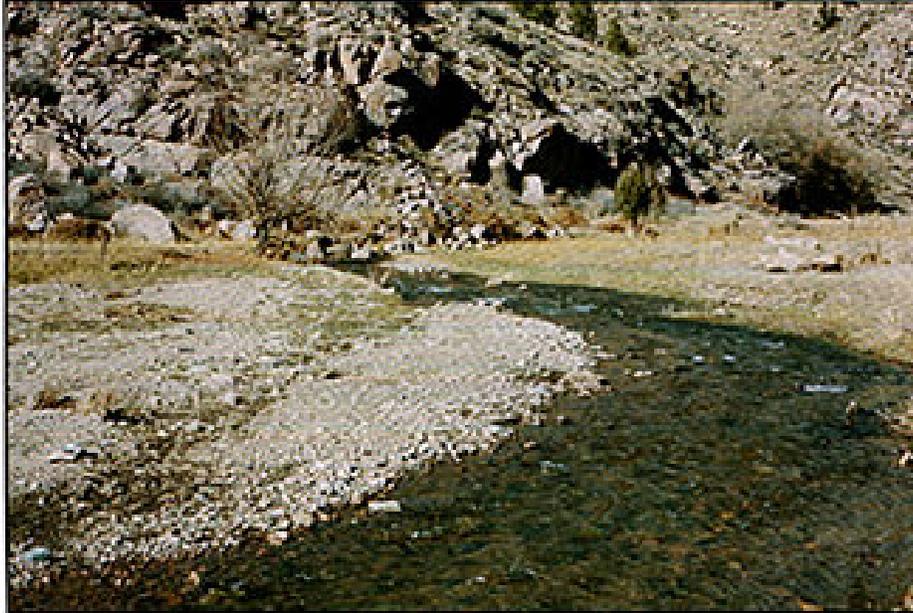
**Texas Creek—Colorado
September 1976
Nonfunctional**

Texas Creek, located in south-central Colorado on public lands administered by the Canon City District Office, would have been rated *nonfunctional* in 1976 based on the Bureau's definitions. Texas Creek is a small coldwater perennial stream that originates in the Sangre De Cristo Mountains, flowing for approximately 24 miles before it enters the Arkansas River. Inventories conducted in 1976 classified the stream as a laterally unstable area that was moderately confined, severely impacted from continuous grazing, and providing limited fish and wildlife values.

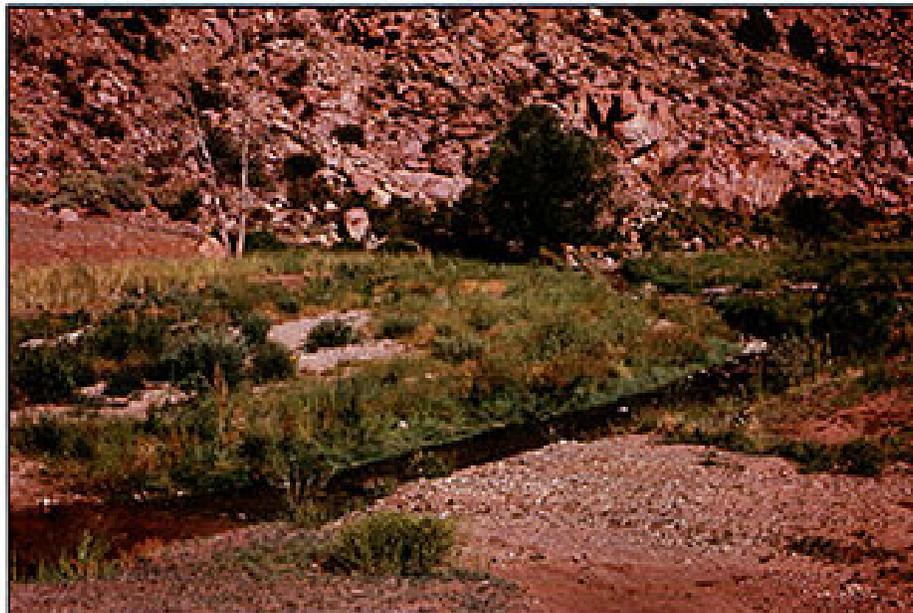
**Texas Creek—Colorado
June 1978
Functional—At Risk**

Yet, the area was still at risk because soil and vegetation attributes still made it susceptible to degradation. The area contained too much bare soil and lacked desirable species of vegetation. The dominant species present lacked root masses that stabilize streambanks against cutting action.

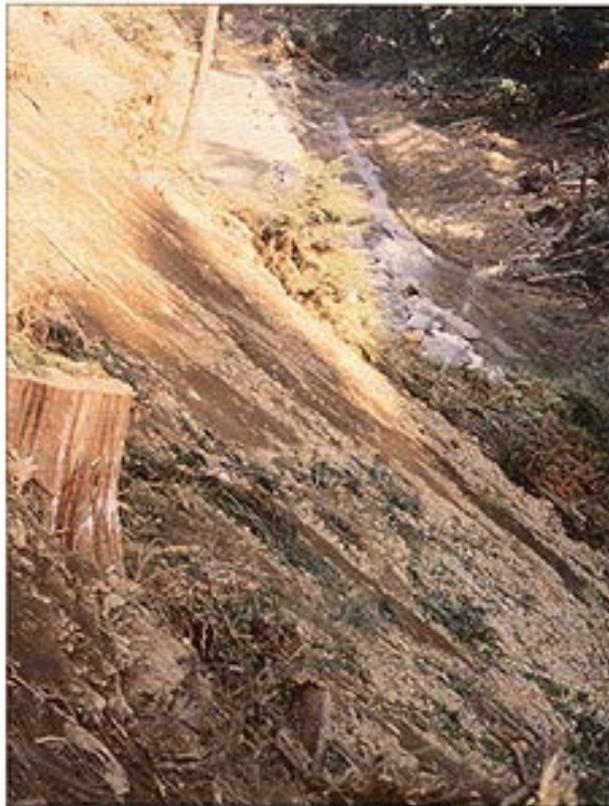
Forested Coastal Stream—Oregon Nonfunctional

The below photograph gives an example of a coastal stream, located in Oregon, that would be rated as *nonfunctional* relative to BLM's definitions for proper functioning condition. The riparian area is clearly not providing adequate vegetation, landform, or large woody debris to dissipate stream energies associated with high flows. During precipitation events, the stream channel migrates, erosion continues, sediment is not filtered, flood-water retention and ground-water recharge are limited, and water quality is altered. Wildlife values are limited, and the area is not providing diverse ponding or channel characteristics that provide habitat and water depth, duration, and temperature necessary for fish production. The area provides little biodiversity.
