*A Guide for Planning Riparian
Treatments in New Mexico*

**New Mexico Natural
Resources Conservation
Service**

September 2007

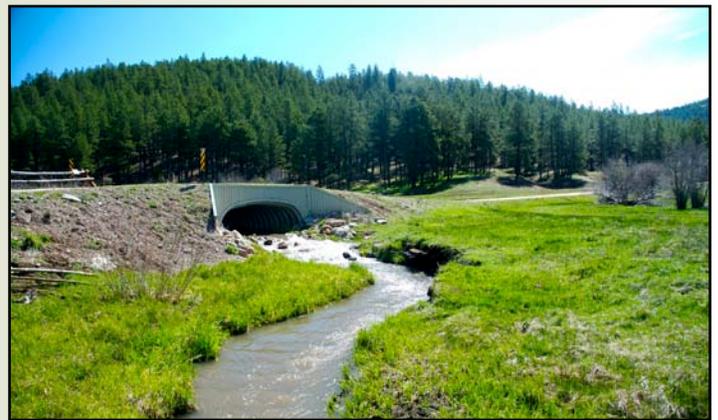
Photo 2 – Rio Guadalupe Bridge Crossing with associated armoring which reduces meandering and increases bank erosion, Sandoval County

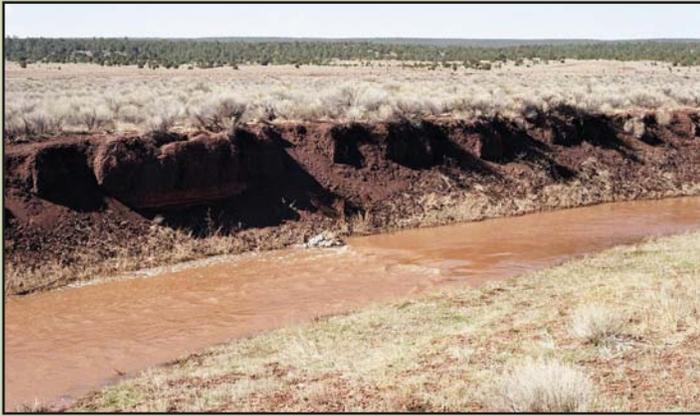
Photo 4 – Incised channel with unstable banks, Cottonwood Creek, McKinley County

Channel Condition – Channels that are stable are in balance with their landscape position. Channel form is dependent on gradient, substrate size, and watershed discharge. Depending on stream type, a healthy channel has a characteristic width depth ratio, access to its floodplain, and incisement ratio.

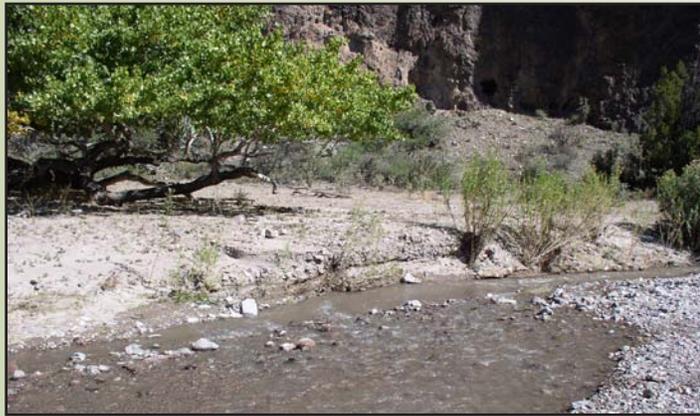
Photo 5 – Poor width to depth ratio, wide and shallow channel resulting in poor sediment transport capacity, Alamosa Creek, Sierra County

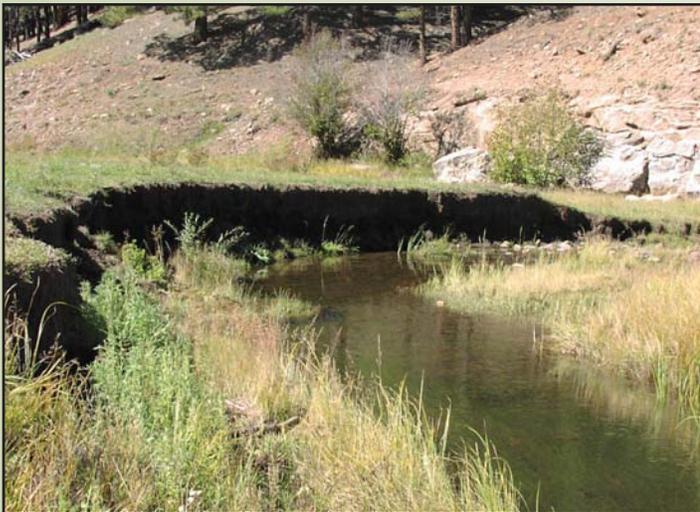
Photo 7 – Unstable bank, Rio de las Vacas, Sandoval County

Bank Stability – Stable banks assist in maintaining stream form and function in appropriate channel types and geomorphic settings.

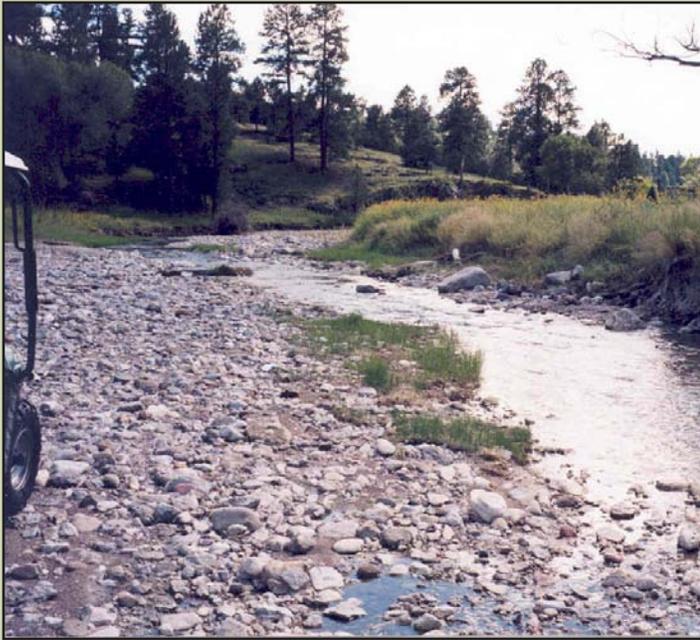
Photo 9 – Inadequate riparian zone width, Taylor Creek, Catron County

Riparian Zone Width – A healthy riparian zone will widen until it reaches the maximum extent possible. The widening can be inward (as the stream channel narrows), outward (towards the adjacent uplands), or both. The maximum extent is limited by topography, geology, soil type, and hydrologic factors.

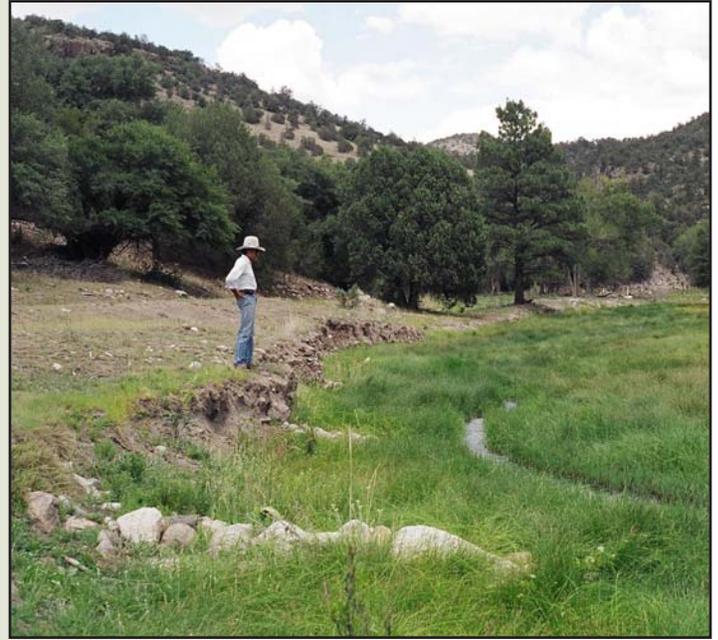
Photo 10 – Riparian area widening inward, channel narrowing, Taylor Creek, Catron County

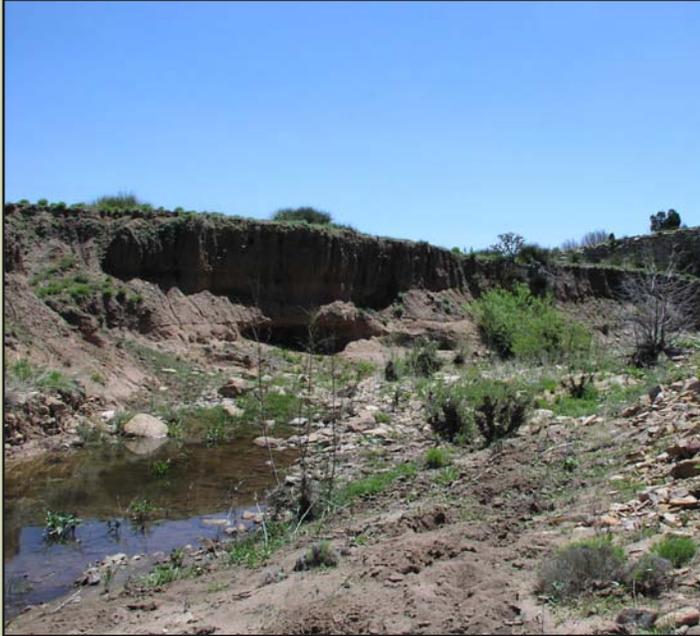
Photo 13 – Poor rooting medium due to erosion of channel and flood plain materials, Harding County

Soil Characteristics / Rooting Medium – Soil type and water holding potential are critical factors in determining the sites potential.

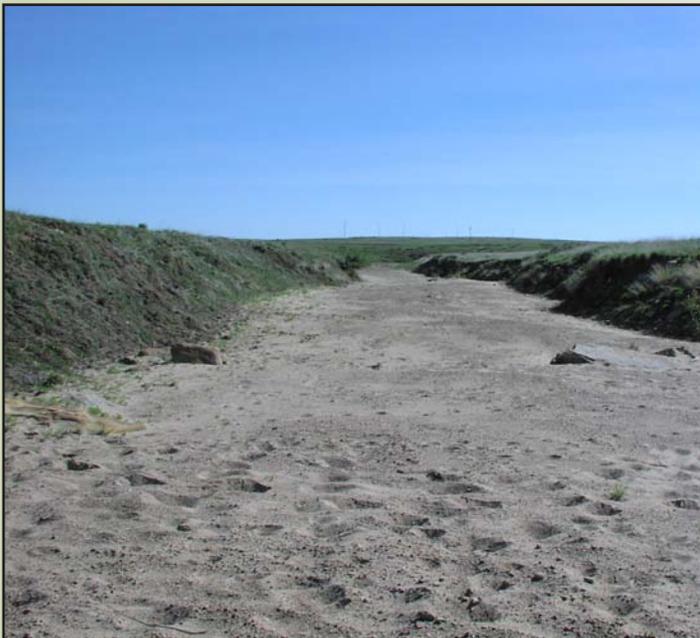
Photo 15 – Greater than 50% bare ground, Union County

Exposed or Bare Ground – Riparian vegetation acts as a ground cover to reduce erosion, insulate the soil, provide cover and habitat, and it provides a sediment filter during flow events.

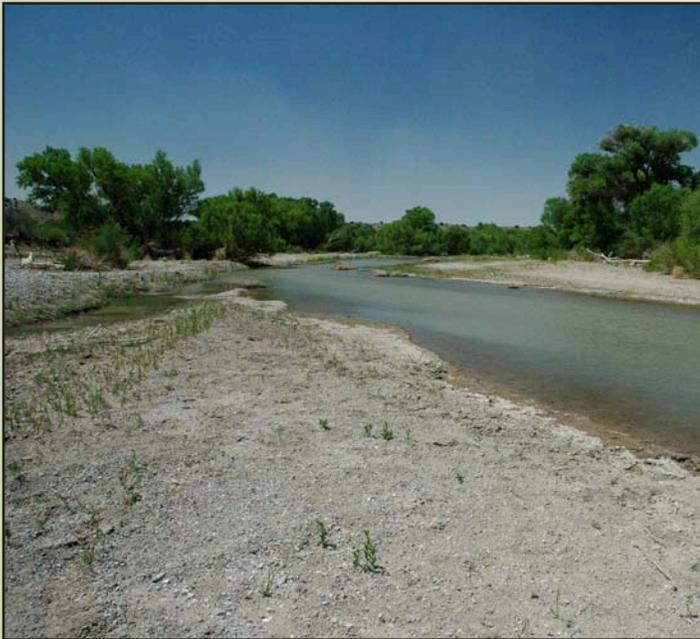
Photo 17 – Little micro-topographic variation, Gila River, Grant County

Topographic Variance or Surface Expression on Floodplain – Micro-topography increases surface roughness to dissipate energy and collect new sediment.

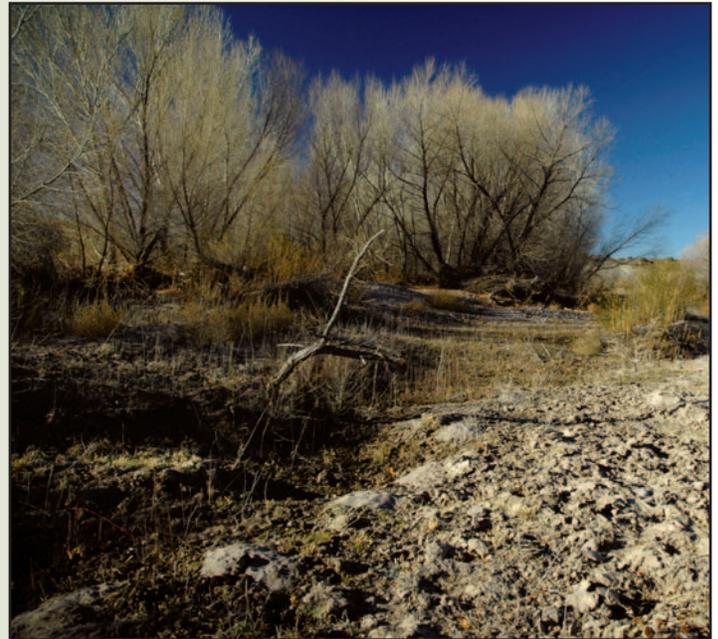
Photo 18 – Rock and large wood present, creating micro-topographic variation, Gila River, Grant County

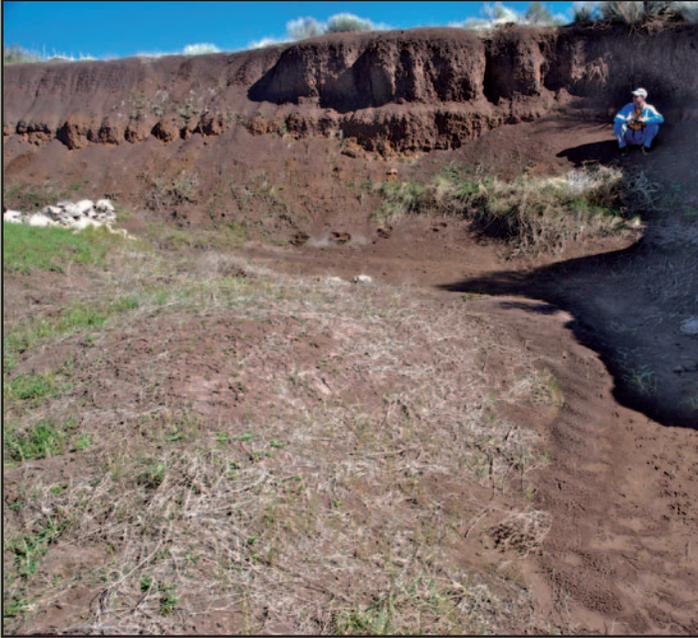
Photo 21 - Unstable point bars lead to unstable channels, Cottonwood Creek, McKinley County

Point Bar Revegetation – Point bars are indicative of a stream with a balanced channel width. New vegetation should begin to grow on newly deposited substrate.

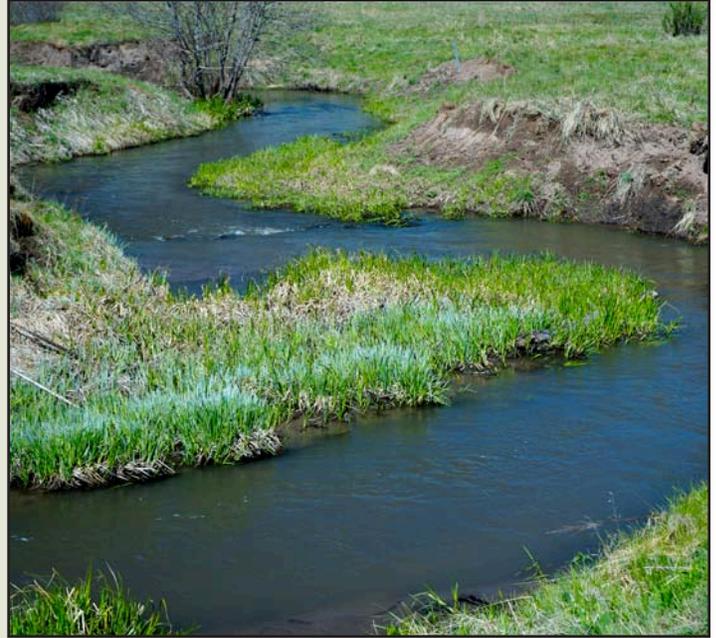
Photo 22 - Stable point bars are indicative of healthy channel width and function, Rio Guadalupe, Sandoval County

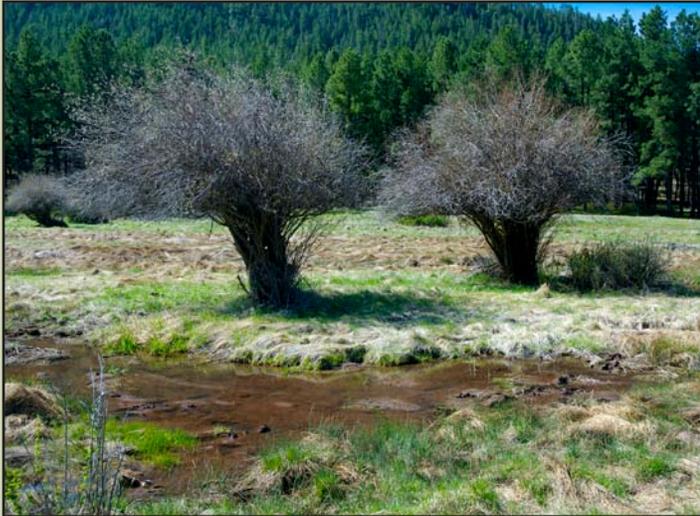
Photo 25 – Decadent willows, no seedlings or saplings, Rio Guadalupe, Sandoval County

Diverse Age Class Distribution of Shrubs – On stream types where shrubs are part of the natural community, age diversity is indicative of riparian health and stability.

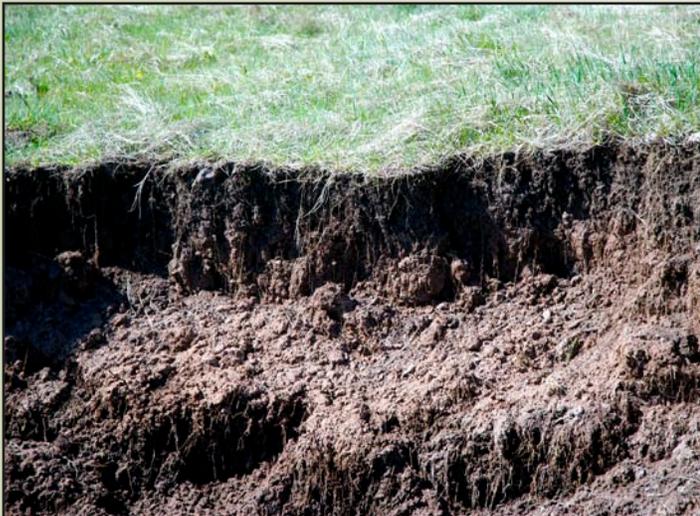
Photo 33 – Less than 25% of the bank with deep binding root mass (pasture grasses), Rio Guadalupe, Sandoval County

Percent of the Streambank with a Deep, Binding Root Mass – Riparian species with high root densities lead to greater bank stability.

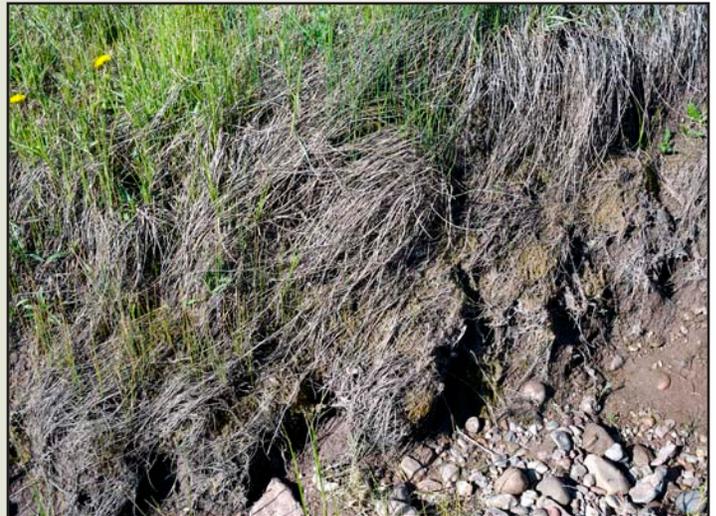
Photo 34 – Greater than 75% of the bank with a deep binding root mass (sedges), Cottonwood Creek, McKinley County

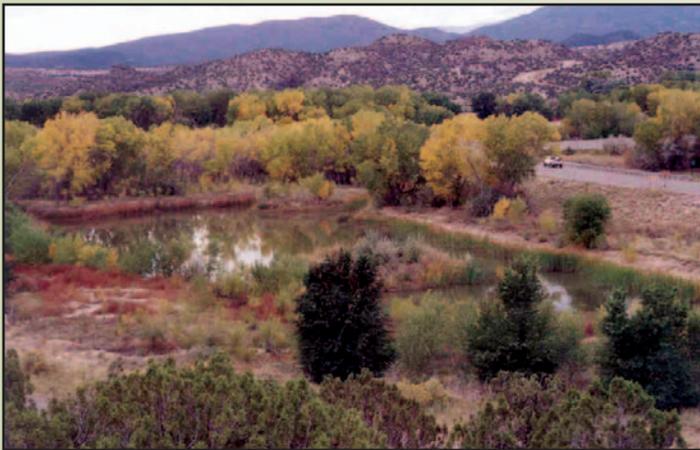
Photo 39 – The planting included: 2,000 wetland plants (bulrush, sedge, spike rush and rushes), 4,000 coyote willow, 500 cottonwood and black willow pole cuttings, and 200 longstem shrubs. Survival of the plant materials averaged about 70% after ten years. No supplemental water has been provided

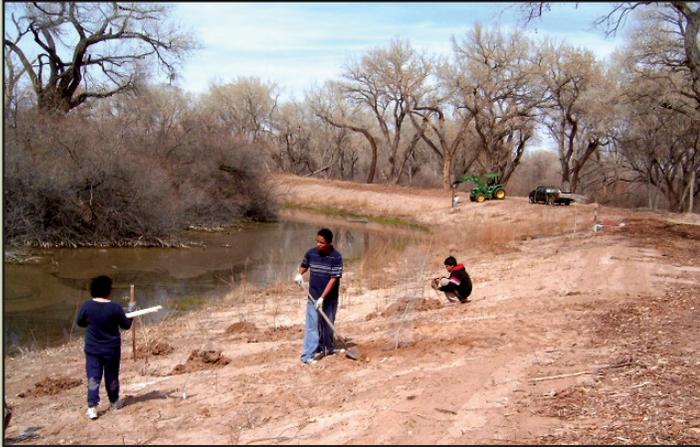
Photo 41 – 125 long-stem transplants, and 50 cottonwood and black willow poles cuttings were planted in February.

Saltcedar, Russian olive, Siberian elm were mechanically removed from a pond bank in Belen, New Mexico, where the annual precipitation is less than 10 inches. The slope of the pond was reduced to control erosion.

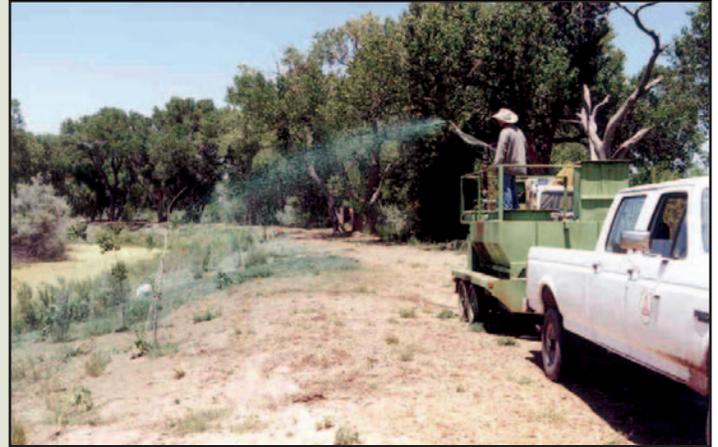
Photo 42 – In July, the site was seeded by hand broadcasting and raking. A wood fiber hydro-mulch was sprayed over the planting after seeding. Plants were temporarily covered during the hydro-mulching activity to prevent them from being coated with the sticky mulch.

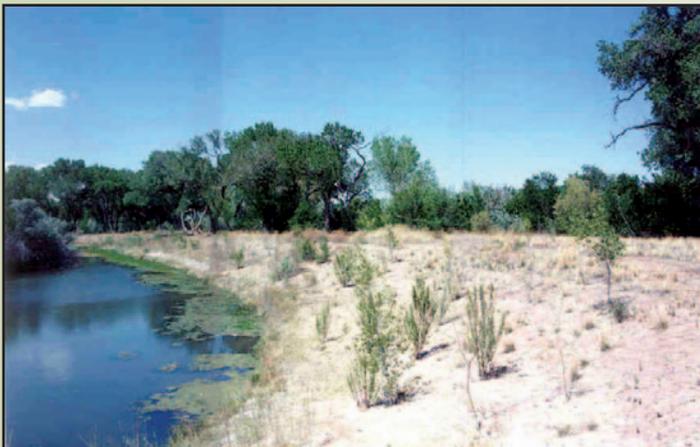
Photo 43 – By the end of the second growing season, transplants, pole cuttings, and grasses seem to be well established. The shrub and pole cuttings had a better than 80% survival with only one initial irrigation.

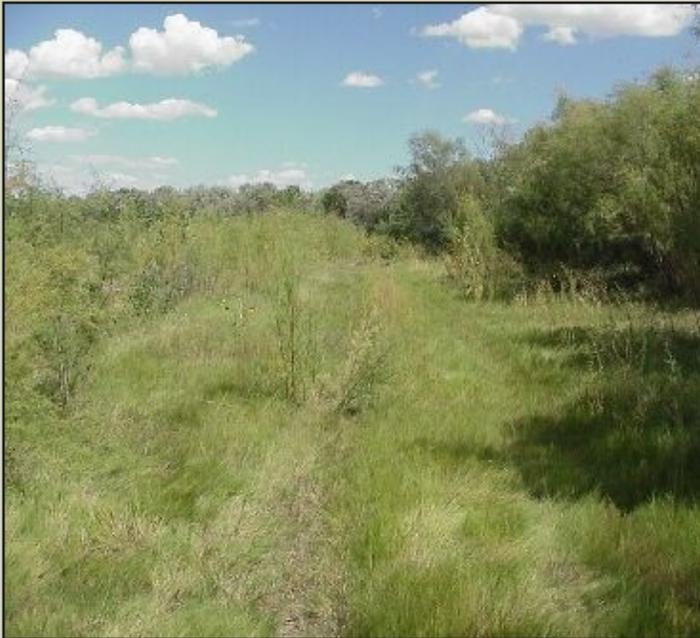
Photo 45 – Saltcedar and Russian olive were treated using the cut stump method with the chemical Triclopyr to control resprouting of the stumps on the San Juan River near Farmington, New Mexico. The annual precipitation averages less than 10 inches at this location.

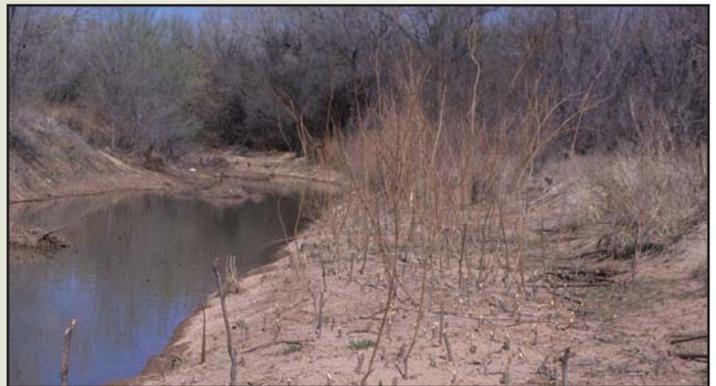
Photo 49 – Beaver predation of planted willow is common. However, because a 30 inches stem is planted, there is plenty of stem carbohydrate reserves available for re-sprouting.

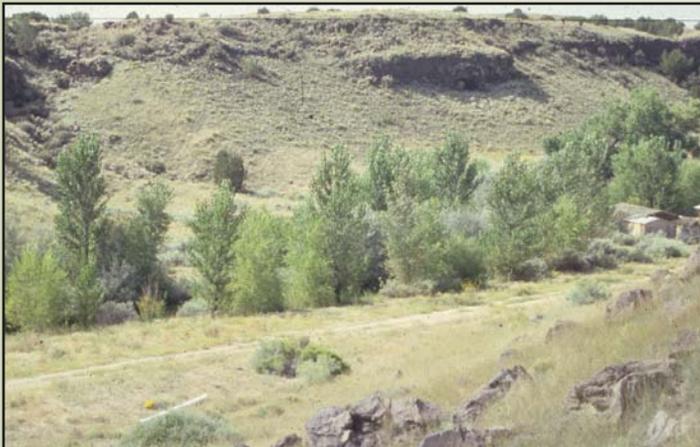
Photo 51 – A total of 350 cottonwood and black willow pole cuttings, 1,000 coyote willow whips, and 200 transplants were planted.

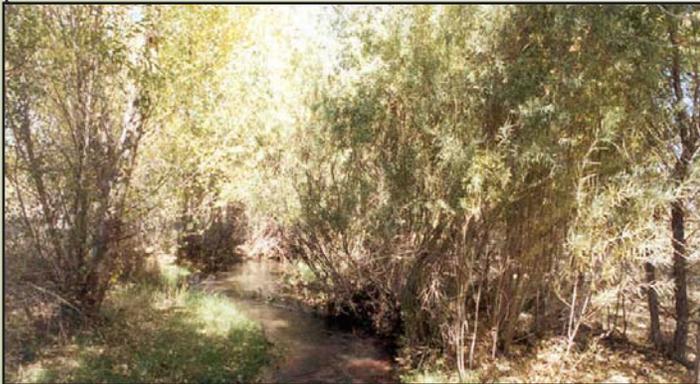
Photo 52 – By the tenth year, survival of all plants averaged about 75% and provided a closed canopy, shading the stream and enhancing fish habitat. Three supplemental irrigated treatments were provided only to the transplants: two treatments the first year and a third treatment the second year.

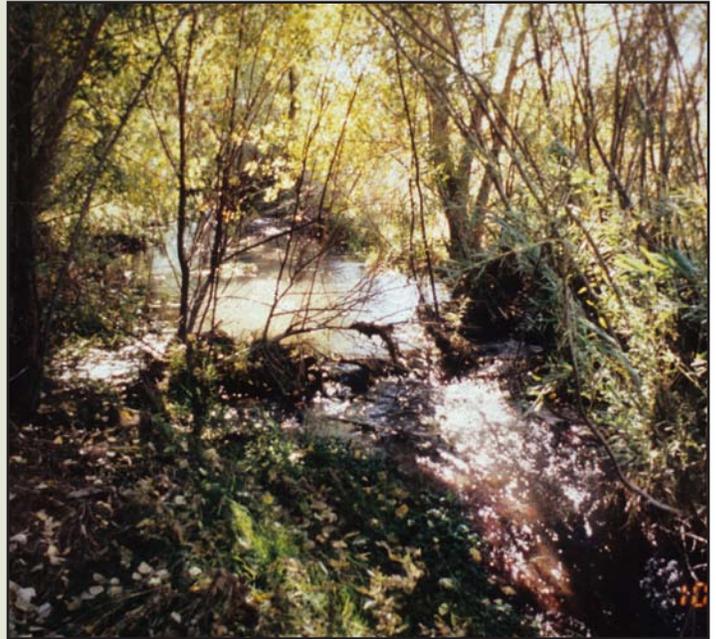
Photo 53 – Woody debris from the planting often falls in the river and may form log jams causing step pooling.

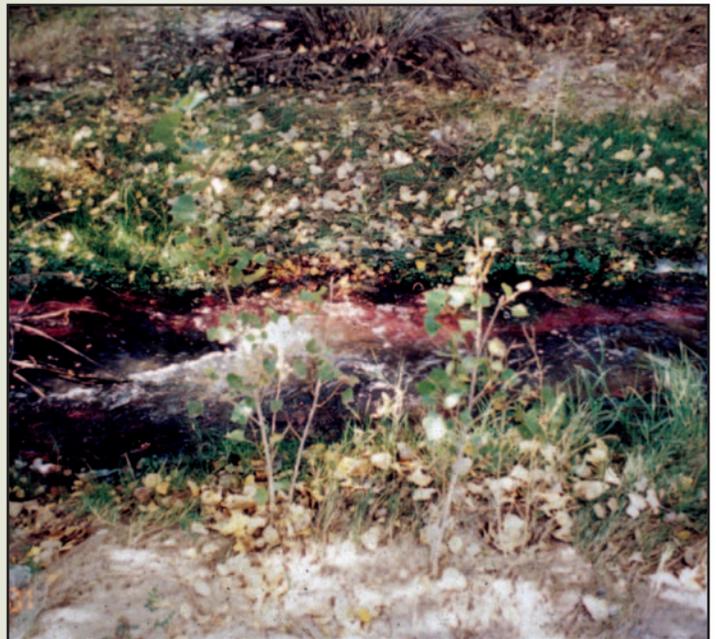
Photo 54 – Step-pooling resulted in some overbank flooding, providing the environment for natural recruitment of cottonwood seedlings.

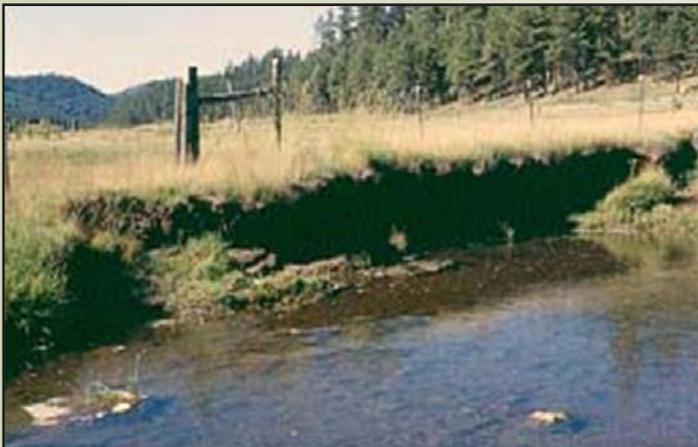
Before treatment in 1999, Rio de las Vacas, Sandoval County

Assistance was requested by the landowner to address an eroding streambank that was undermining a property line fence. The initial site investigation was conducted in August, 1997. The stream exhibited some incision which was limited by cobble to boulder armoring in the streambed. Excessive lateral erosion had occurred and was aided by the removal of riparian woody vegetation on the privately owned lands. Cutbanks can be observed throughout the valley, removing valuable topsoil from some of the pastures. The stream flow, while perennial, can fluctuate greatly depending on the amount of winter snowpack and the number and intensity of summer thunderstorm events.

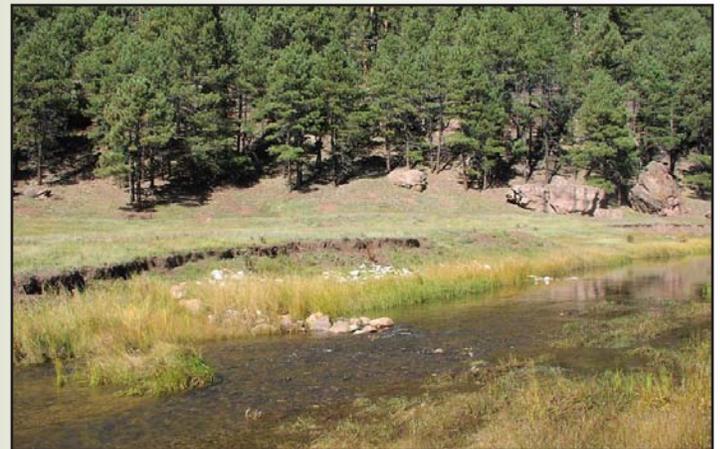
Treated site in 2006, Rio de las Vacas, Sandoval County

The project has been in place for over ten years. It has performed during spring runoff events with minimal damage. The only repairs have consisted of restacking some of the rocks from the nose of several of the barbs. These rocks had been rolled off of the barbs during high and extended flows, but overall the damage has been minimal. Woody riparian vegetation has not recovered due to continued grazing. The herbaceous species, including sedges and rushes, have increased in frequency and density. Some trampling and trails behind the barbs have continued to have detrimental effects on the treated streambanks.

This project has functioned as designed for ten years. The treated streambank has remained relatively stable although there has been minor recession as the bank reaches a stable angle of repose. The fence remains in place and has not been moved as was required before the treatment. The bank has more vegetation and more desirable riparian species than before the treatment. The stream barbs have been effective in keeping the lateral movement of the stream in check and also capturing new coarse sediment behind the barbs. The project continues to be monitored and photographed yearly.
