Cebolla Creek Wetland Restoration Monitoring:

Status Report, December, 2009. Geomorphology Monitoring

Steve Vrooman Restoration Ecology, December 9, 2009

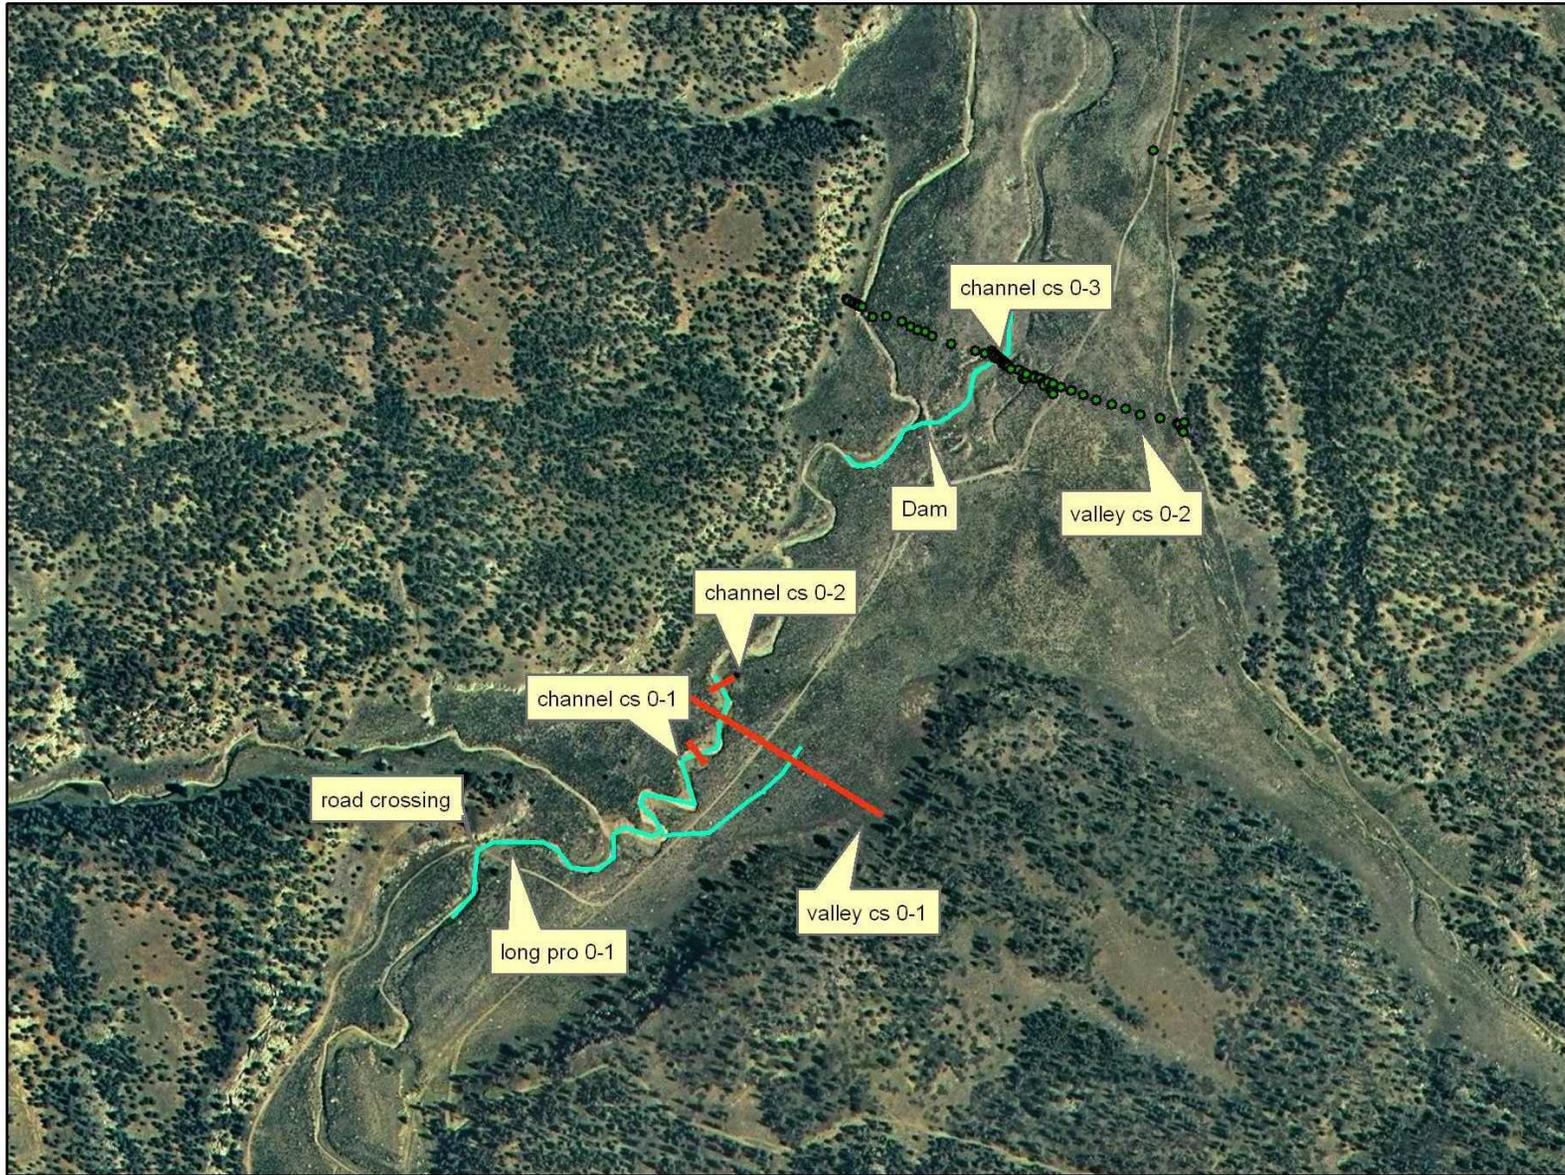
Cebolla Reach 0 geomorphology monitoring

Reach 0-1, road crossing through confluence: 2100 feet of longitudinal profile (in excel) with 600 feet of terrace elevations.

Cross sections 0-1, 0-2, Valley Cross Section 0-1.

Reach 0-2: (through dam): 1050 feet of longitudinal profile.

Valley Cross Section 0-2 (GIS), Channel Cross Section 0-3.

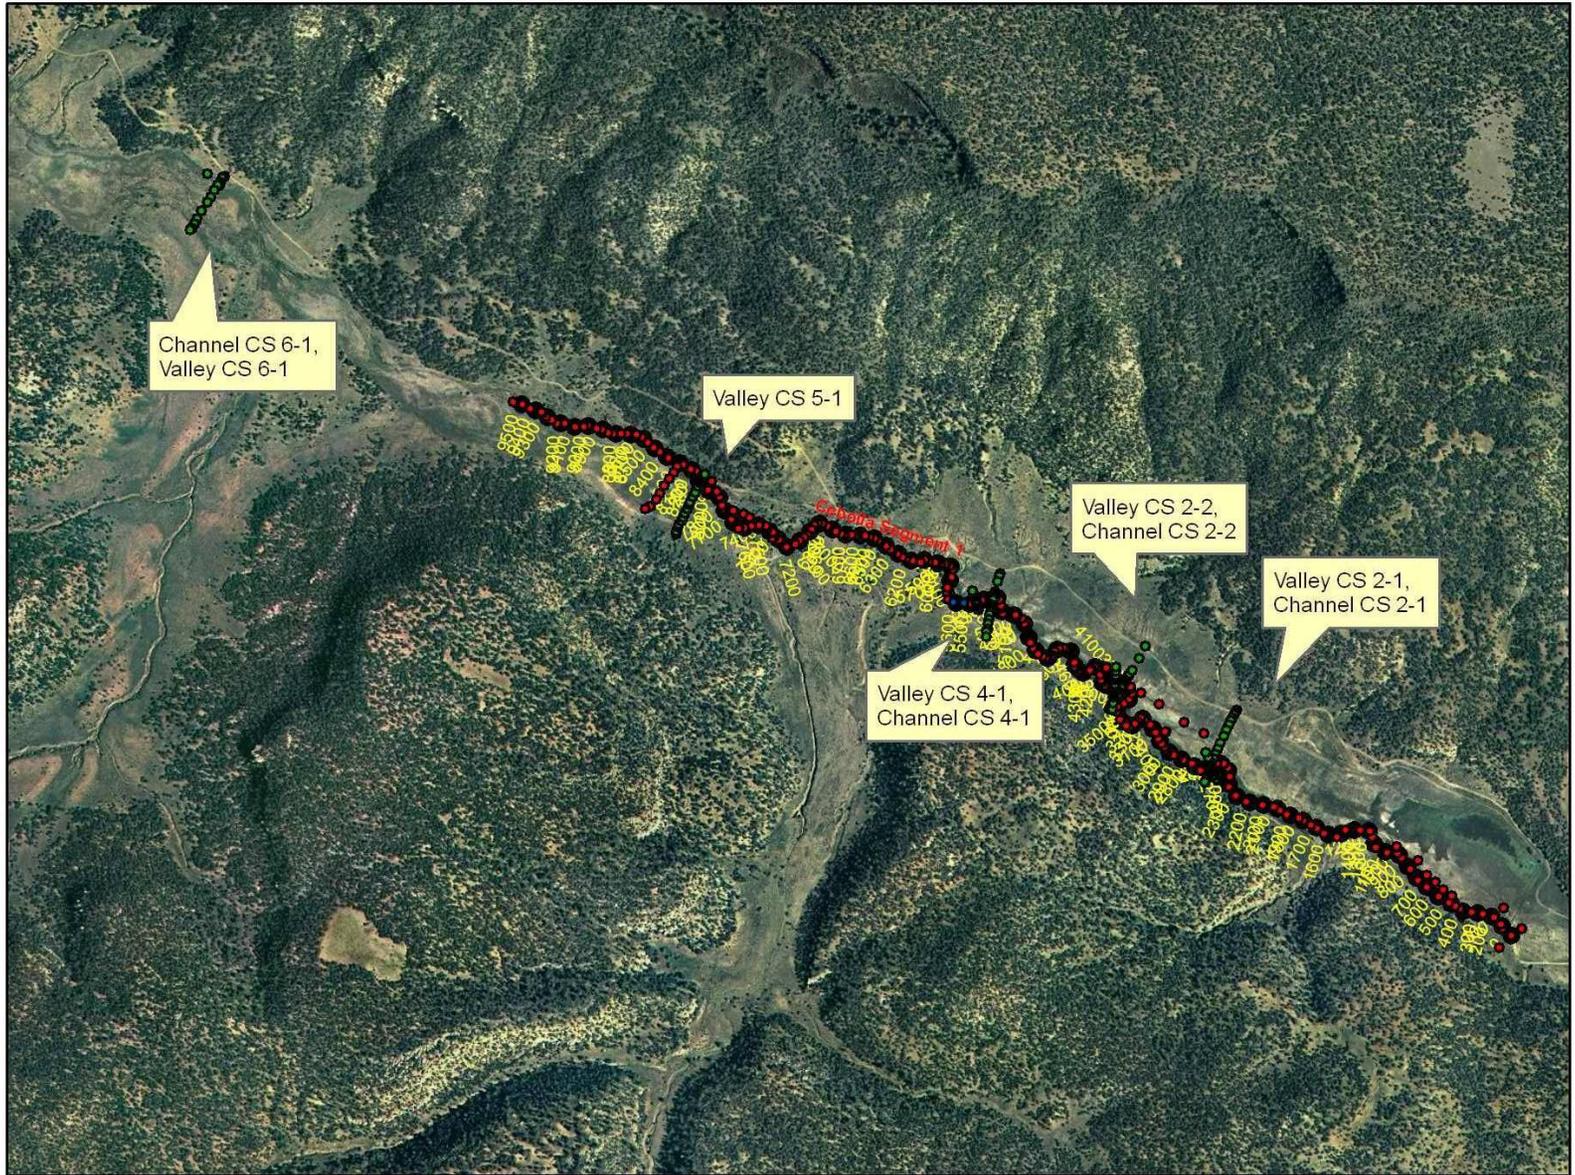
Cebolla Reach 1-6 geomorphology monitoring

Reach 1-6

Longitudinal profile: 9500 feet.

Cross Sections:

Reach 3: Valley CS 3-1,3-2. Channel CS 3-1, 3-2.

Reach 4: Valley CS 4-1, Channel CS 4-1.

Reach 5: Valley CS 5-1

Reach 6: Valley CS 6-1.

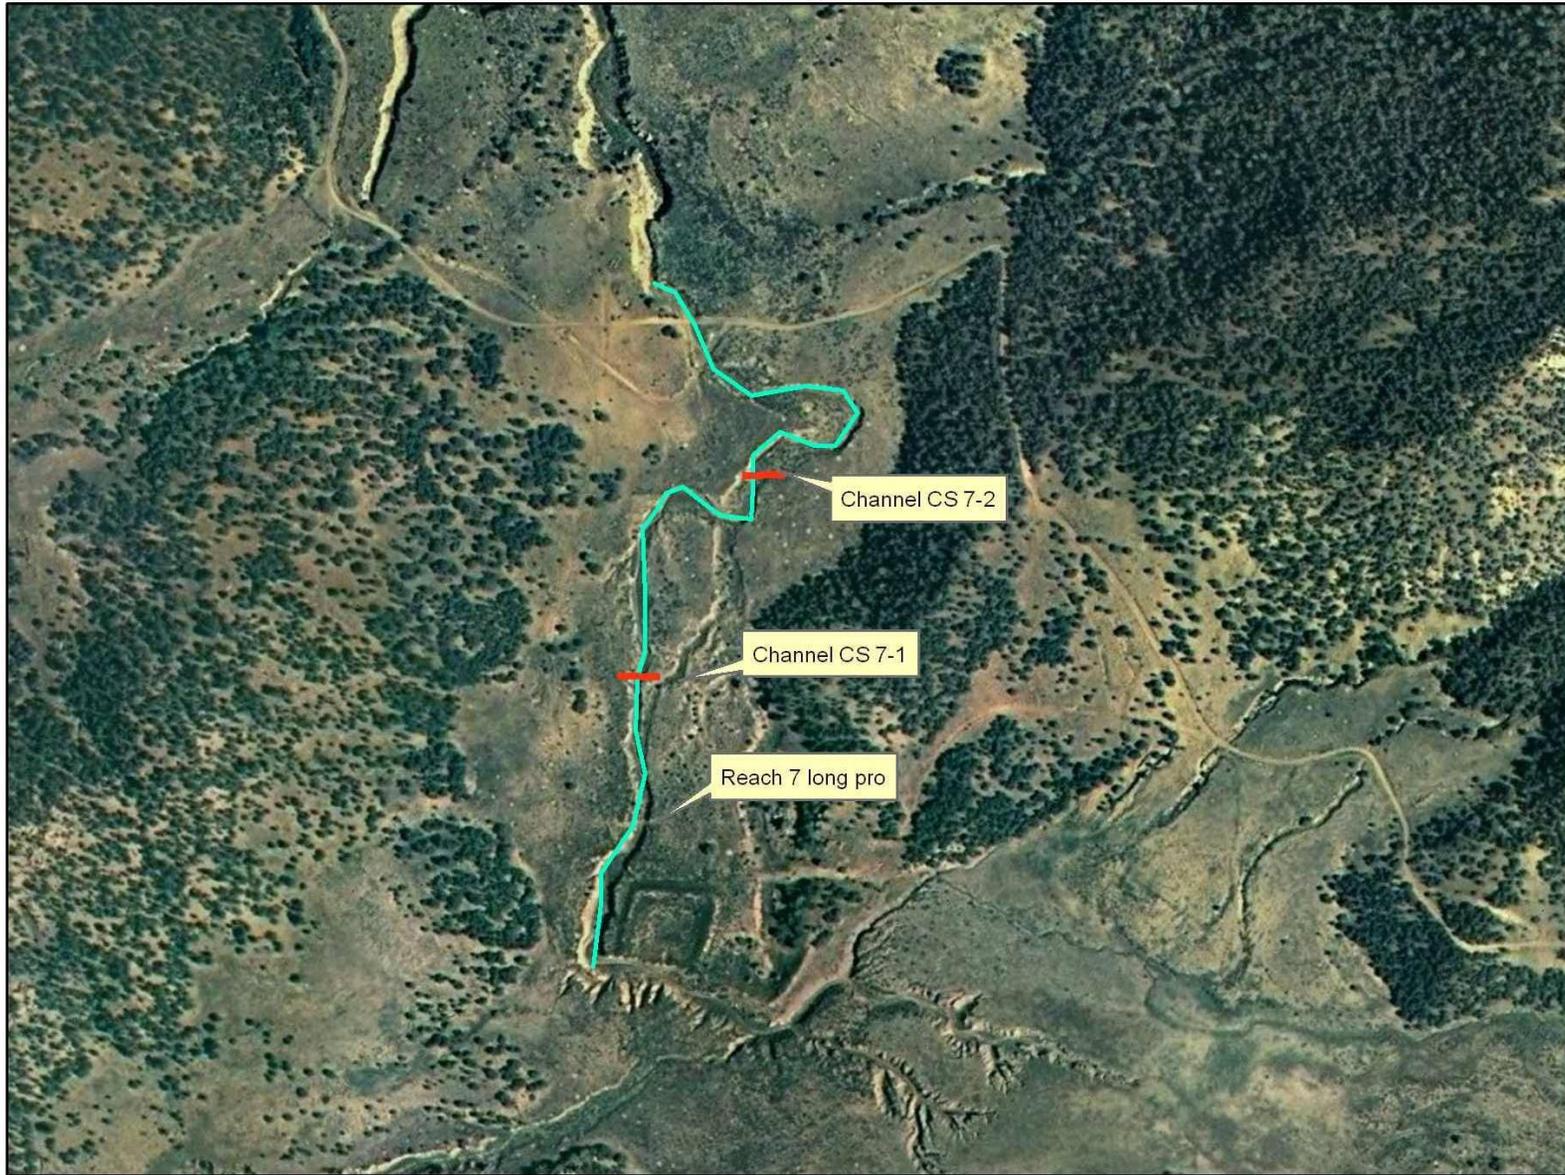
Cebolla Reach 7, geomorphology monitoring

Reach 7: 3000 feet of longitudinal profile

Cross Sections: Channel Cross Section 7-1(used for calculation of 50 year flood), and 7-2.
