**ESTANCIA BASIN WATERSHED
HEALTH AND MONITORING PROJECT:
2013 ANNUAL REPORT**

**ESTANCIA BASIN WATERSHED HEALTH, RESTORATION AND MONITORING
STEERING COMMITTEE**

SWCA ENVIRONMENTAL CONSULTANTS

March 2014

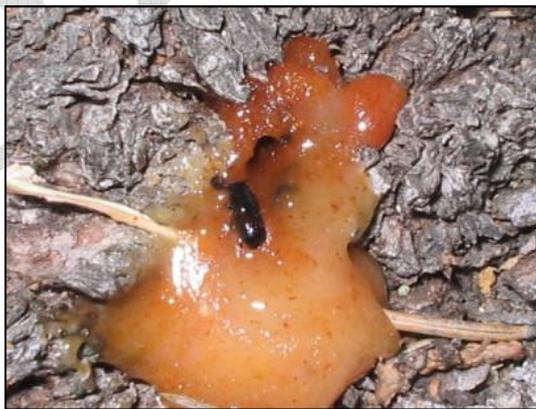
Figure 2.1. Piñon beetle (*Ips confusus*). This individual has been caught in pine sap or pitch, the usual defense against the beetle.

Much attention has been placed in recent years on the effects of thinning on bark beetle infestations throughout the western United States. For over a decade, Southwest forests and woodlands have been subjected to increased drought, insect infestation, and disease, which have resulted in a decline in forest health (Clifford et al. 2008; Shaw 2008). Mortality from drought and bark beetle infestation of ponderosa pine, piñon/juniper, and other forest and woodland species throughout the Southwest region increased dramatically between 2000 and 2003 (Zausen et al. 2005). Piñon pine was especially affected, with 774,771 hectares (ha) of piñon across New Mexico and Arizona showing evidence of bark beetle attack by 2003. Some areas experienced greater than 90% piñon mortality (Gaylord et al. 2013), while juniper mortality was significantly lower. Piñon mortality was largely a result of the piñon ips bark beetle (*Ips confusus*) (Figure 2.1), which generally attacks water-stressed or recently dead trees (Raffa et al. 2008; Rogers 1995).

The piñon ips bark beetle is always present at low numbers in piñon woodlands, attacking unhealthy trees. When persistent drought occurs and piñon pines become water stressed and the trees produce a “stress scent” (i.e., beta-pinene), this attracts the beetles. Because of water stress, the trees are not able to fight the beetles with their usual defense of resin (sap or pitch), so the beetles are able to bore into the inner bark or cambium. Therefore, piñon ips outbreaks are a symptom of drought, and the beetles are able to attach to otherwise healthy trees because of drought and water stress. During drought, the beetle populations grow rapidly into outbreak situations because so many trees are vulnerable. The *Ips* beetles slowly kill the trees by boring through the bark and laying eggs from which larvae hatch; the larvae begin feeding on the inner living bark or cambium, cutting through the cambium where tree sap flows, cutting off sap flow, and essentially girdling the trees. The beetles also carry blue stain fungus into the attacked host tree, which grows in the vascular tissue and clogs the tree’s ability to draw water and transport carbon and nutrients. The combination of larval feeding on cambium and the fungus infection generally proves fatal to the tree (Christopherson 2013), especially if the tree is already water stressed.

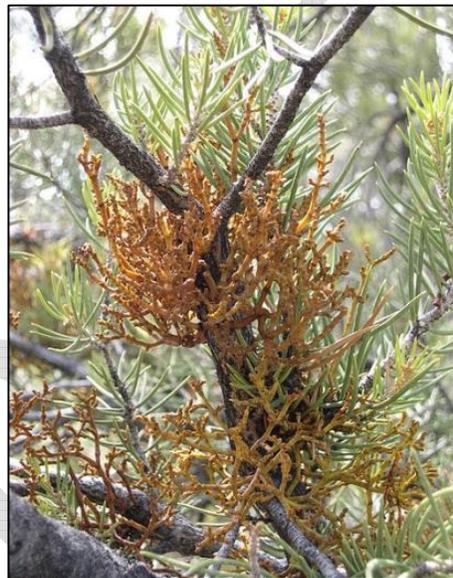
Figure 2.2. Dwarf mistletoe (*Arceuthobium divaricatum*) growing on piñon.

Piñon and juniper in the region are also infected with dwarf mistletoe (*Arceuthobium divaricatum*) (Figure 2.2) on pines and true mistletoes on juniper. They are small parasitic flowering plants that draw water and nutrients from the host tree, impacting the tree's normal growth and reproductive processes. Increased mortality is associated with severe mistletoe infestations (Mathiasen et al. 2002), but even in minor cases, dwarf mistletoe and true mistletoe are thought to increase the host tree's susceptibility to other damaging agents such as insect and disease.

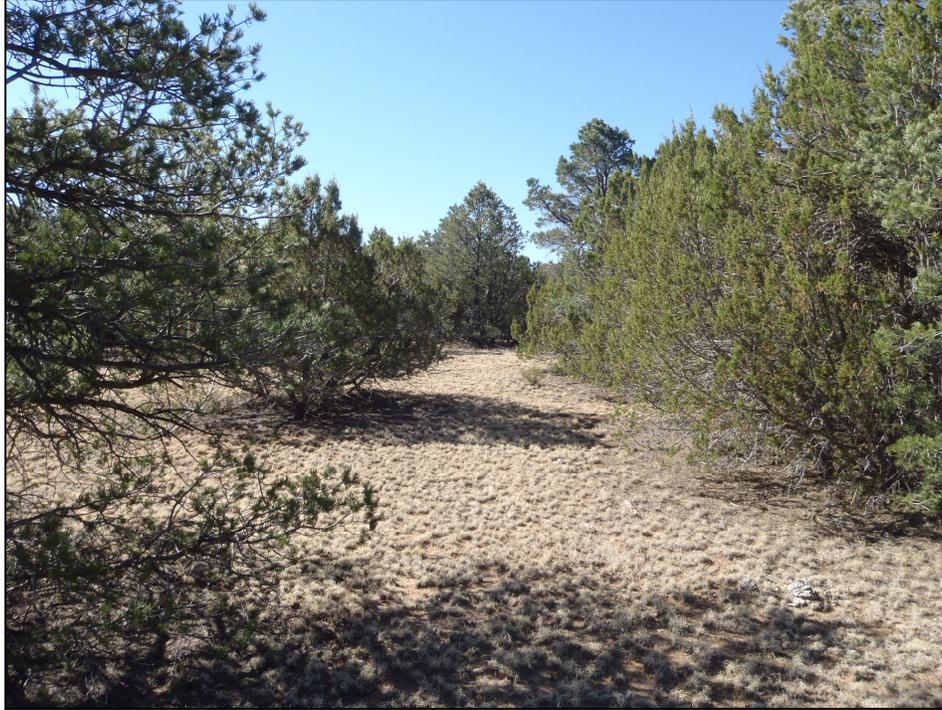
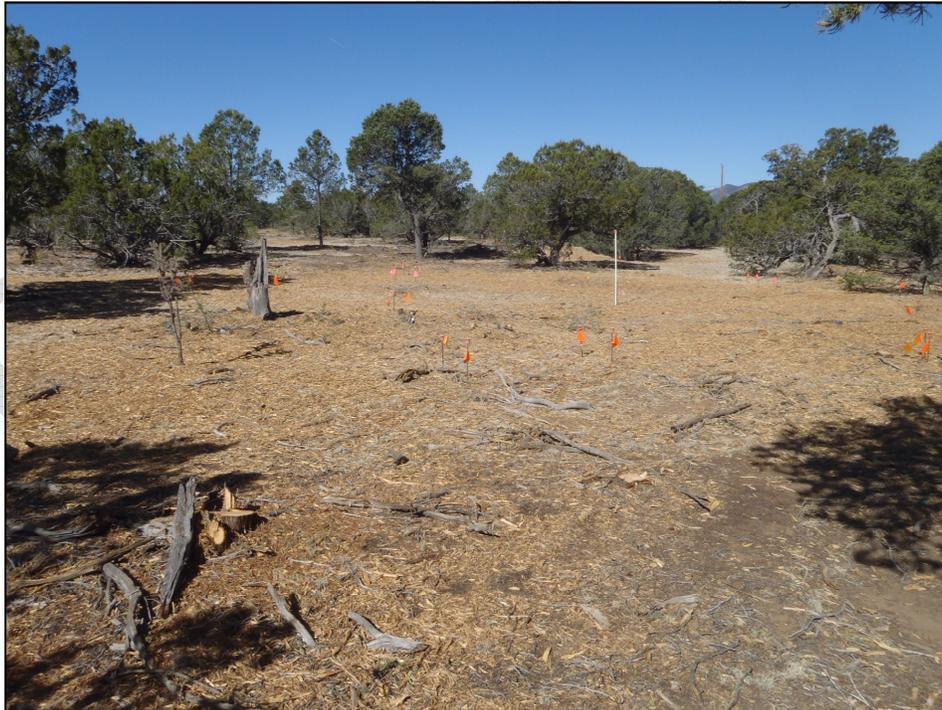
a. Non-thinned control plot (plot C).

b. Thinned treatment plot (plot T).

Figure 2.3. Kelly piñon/juniper site thinning treatment plot after excess trees were removed in late 2010.

Tree thinning treatments were conducted as planned and were inspected by New Mexico State Forestry to ensure that all protocols were followed and that the thinning was conducted to the standards developed by the agency for the region for both ponderosa pine and piñon/juniper woodland. In addition to reducing the density of trees on treatment monitoring plots, the thinning process also required that small branches from cut trees be chipped on-site and spread on the ground surface. Large-diameter wood was removed from the sites for firewood. Figure 2.3 through Figure 2.6 show views of both the non-treated control plots and adjacent treatment plots where trees were thinned from each of the four monitoring sites. Plots were photographed in late fall 2010 and early spring 2011, following tree thinning treatments. Note the open structure of the tree stands and wood chips spread over the ground surfaces of the thinned plots.

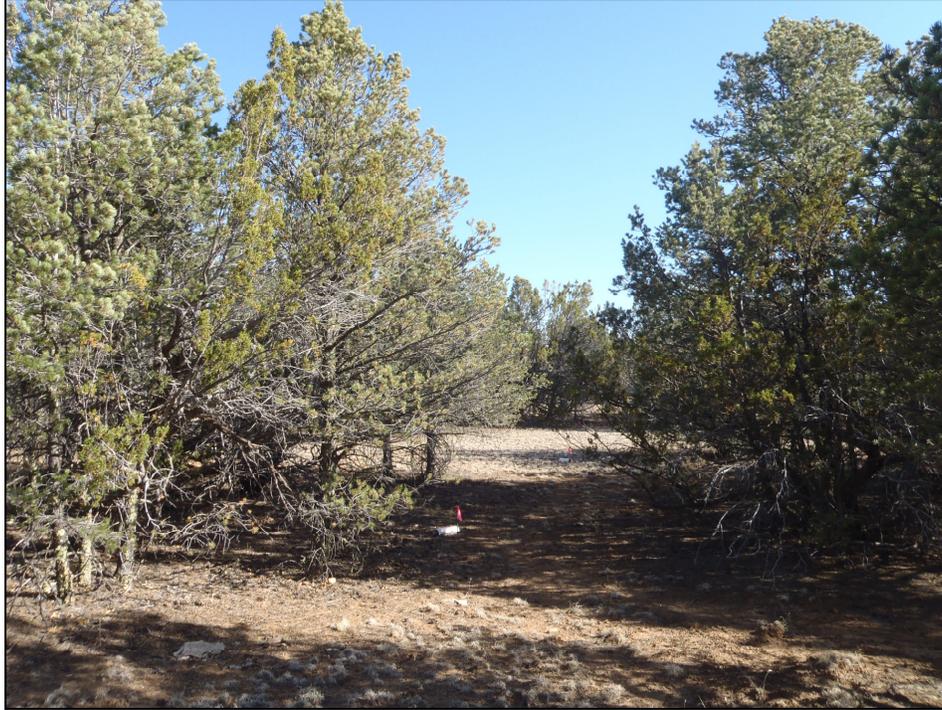
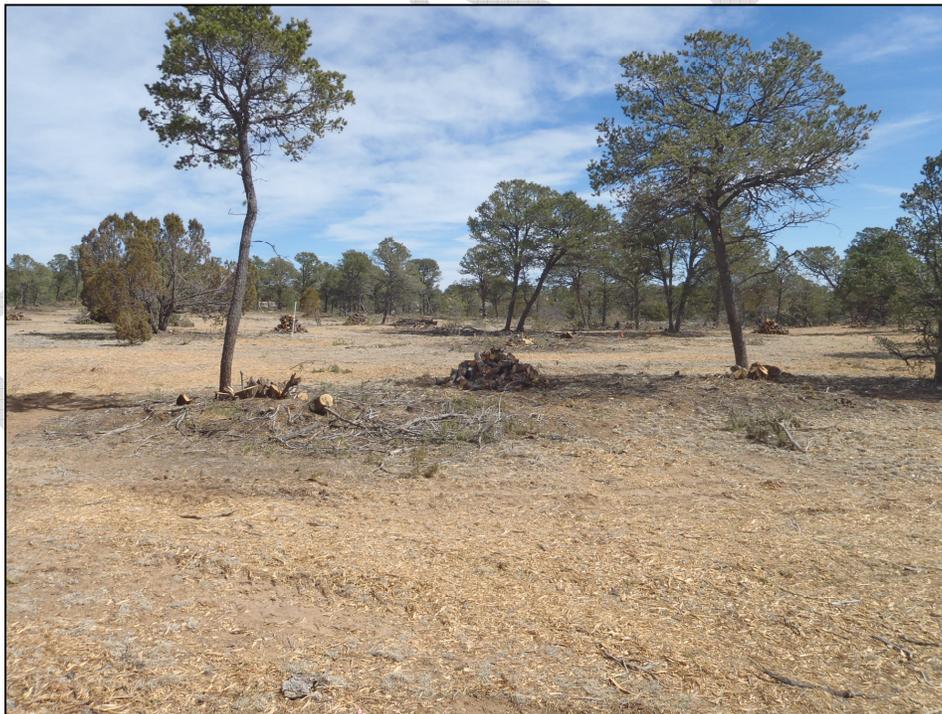
a. Non-thinned control plot (plot C).

b. Thinned treatment plot (plot T).

Figure 2.4. The Vigil piñon/juniper site following tree thinning treatments in late 2010. Note the open stand and wood chips. Stacked wood was removed shortly after the photograph was taken.

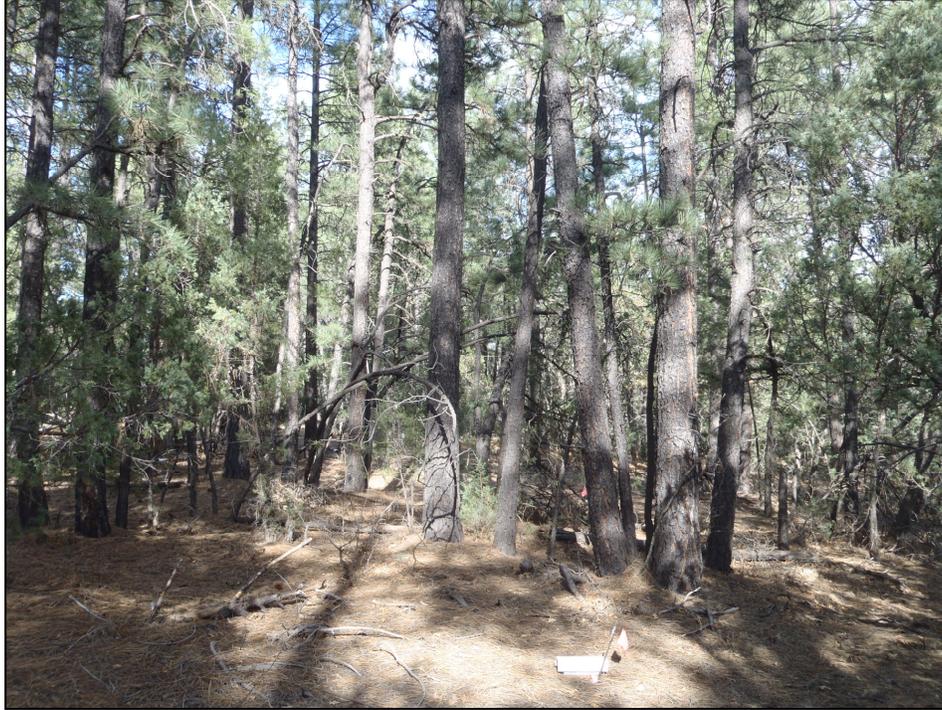
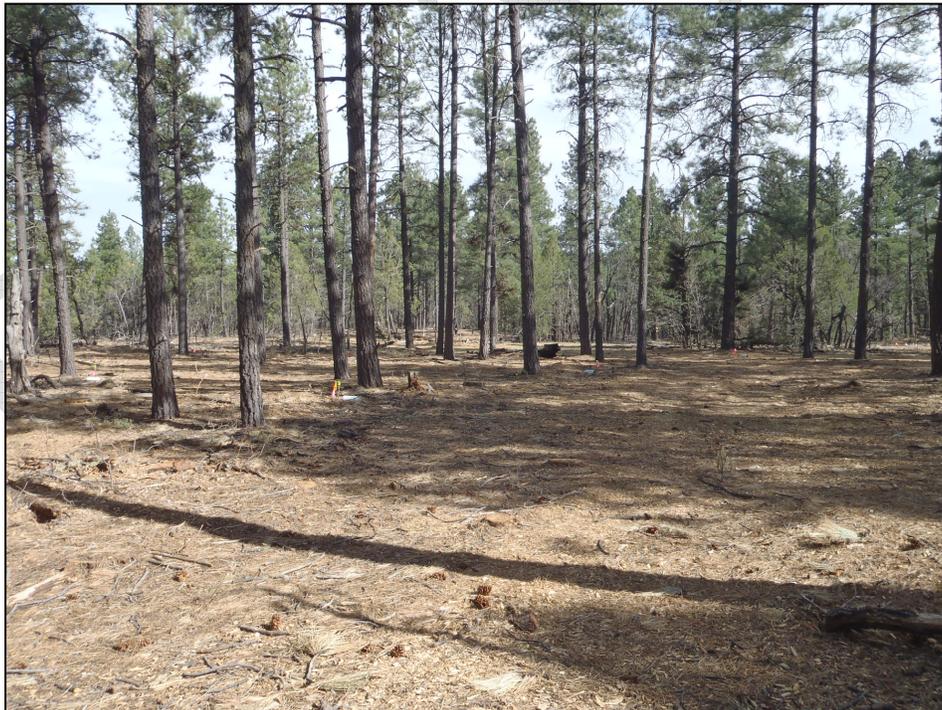
a. Non-thinned control plot (plot C).

b. Thinned treatment plot (plot T).

Figure 2.5. The Chilili ponderosa pine site following tree thinning.

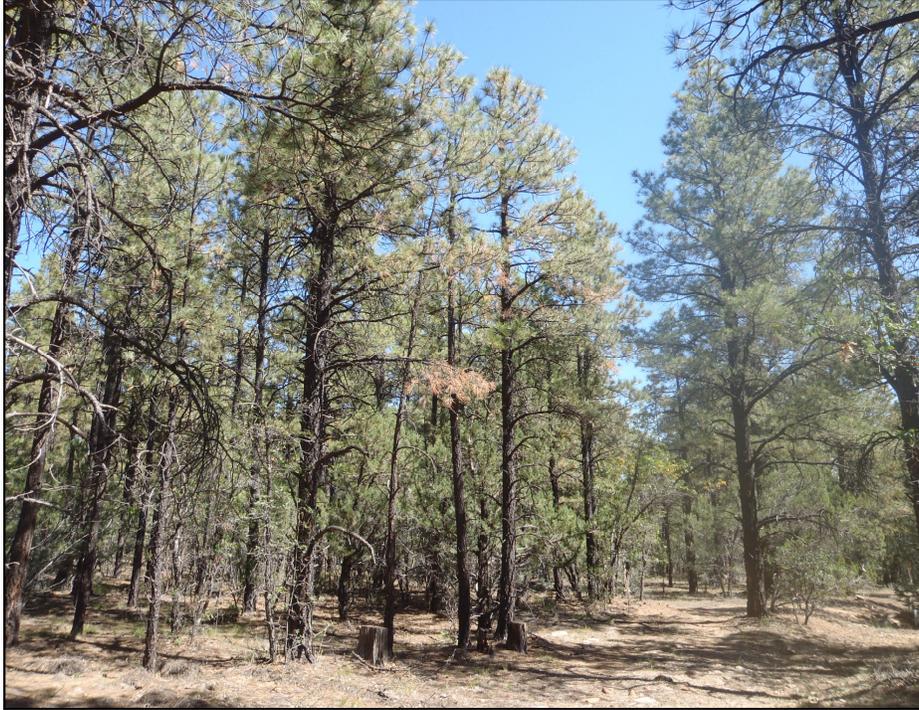
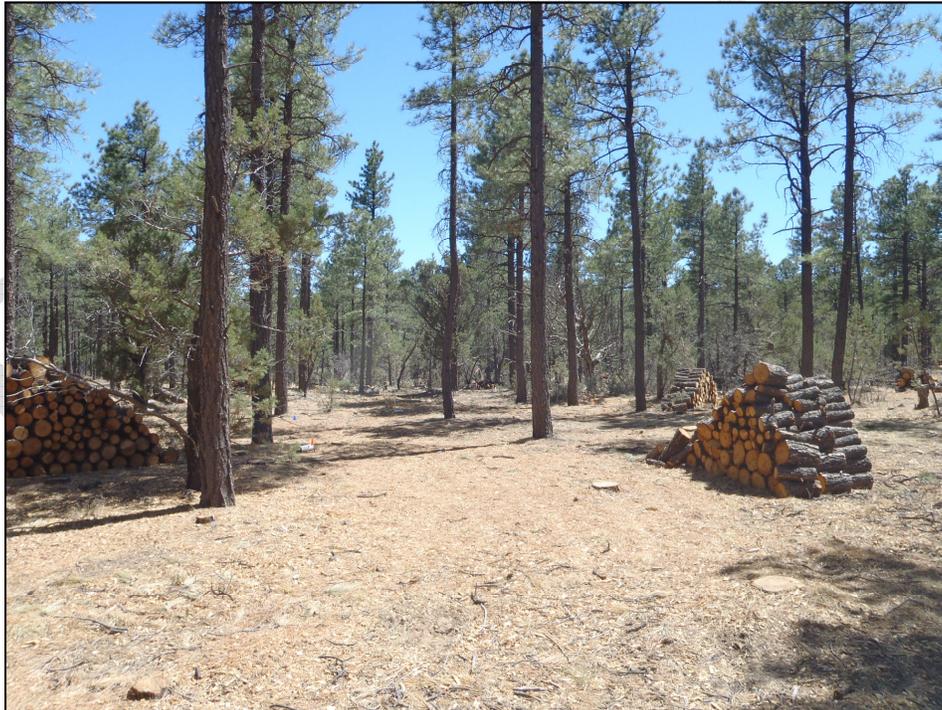
a. Non-thinned control plot (plot C).

b. Thinned treatment plot (plot T).

Figure 2.6. The Wester ponderosa pine site in early spring 2011 following tree thinning. The stacked wood was removed in early summer 2011.

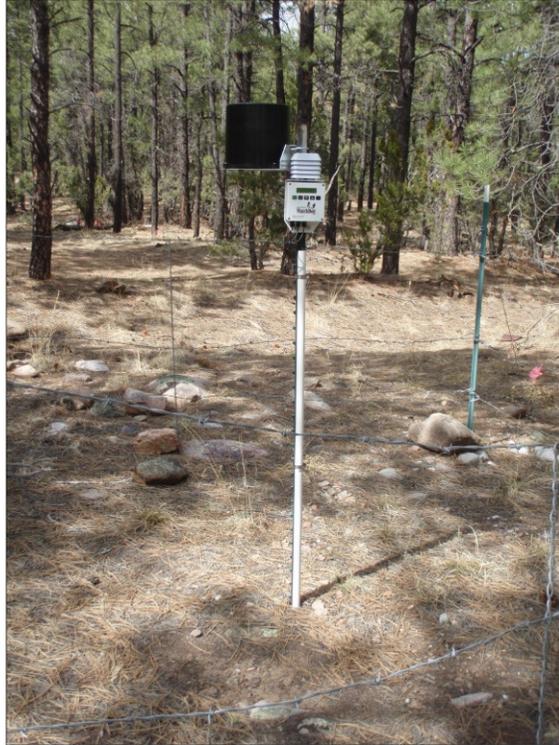
Figure 2.7. WatchDog mini weather station at the Wester ponderosa pine site.

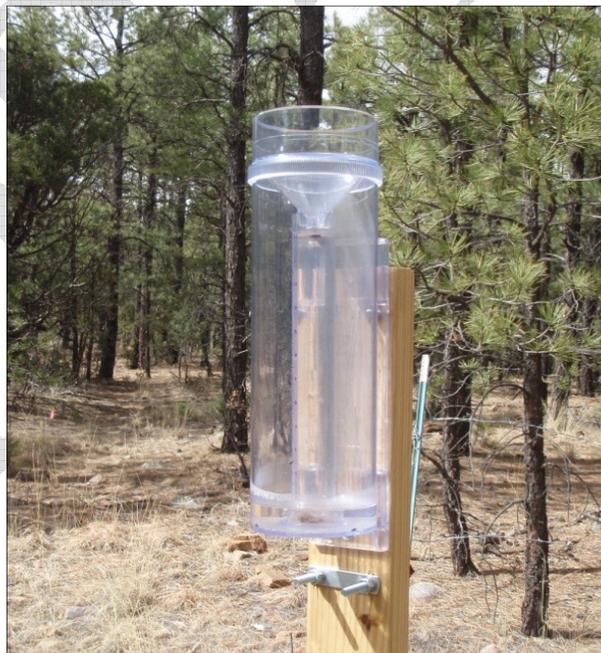
Figure 2.8. Graduated rain gauges are used for backup in the case of failure of one of the WatchDog weather stations.

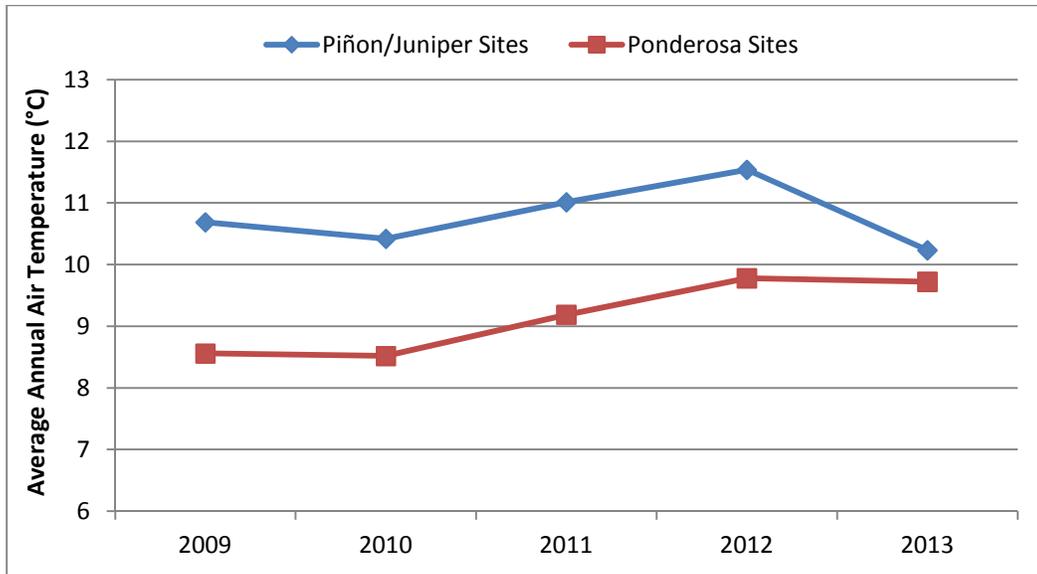
Figure 2.13. Annual average ambient temperature values at the piñon/juniper and ponderosa pine sites, 2009–2013.

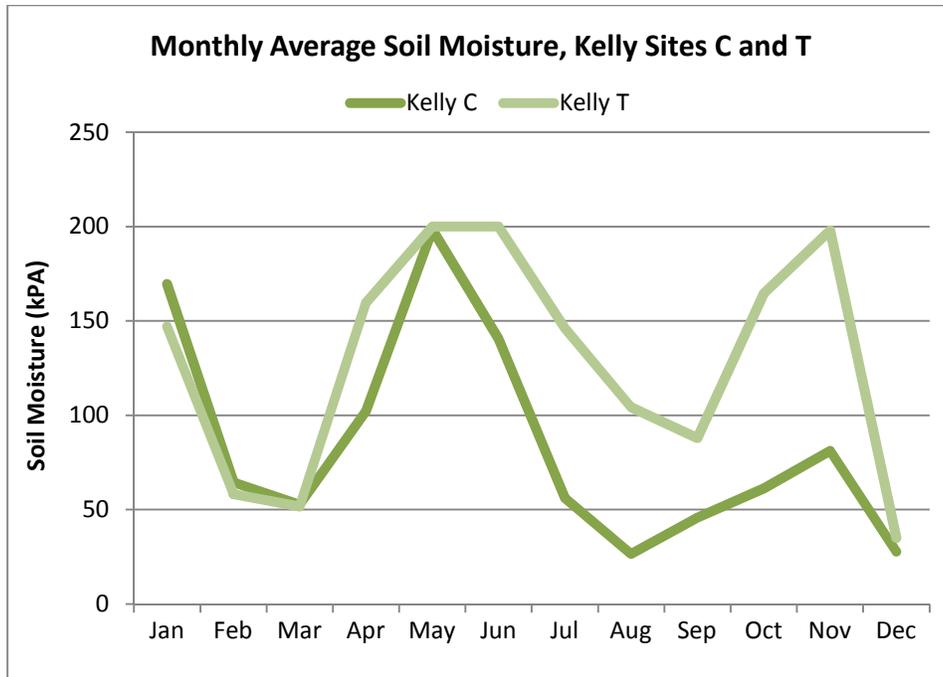
Figure 2.14. Monthly average soil moisture tensions (–10 cm) from the two paired Kelly piñon/juniper study plots in 2013.

An example of monthly averages of hourly –10 cm soil moisture readings are presented for the paired study plots at the Kelly piñon/juniper site (Figure 2.14). Soil moisture was measured with Watermark soil moisture probes that measure soil water tension in kilopascal (kPa) values that are directly equivalent to California Bearing Ratio (cbr) values for soil water saturation. Results for paired plots were generally similar. More detailed information on the trends in soil moisture can be found in Section 2.5.1 below on soil TDR measurements.

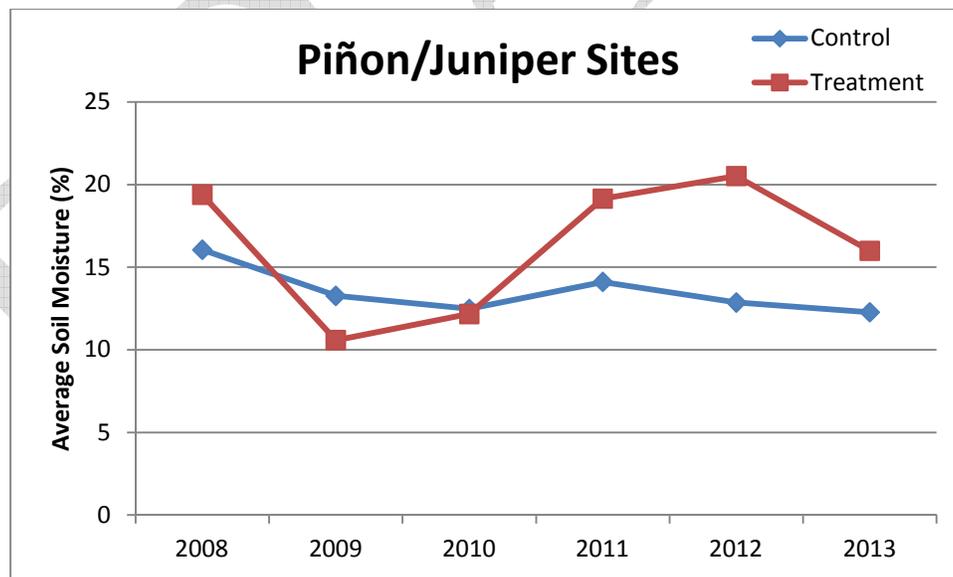
Figure 2.17. Annual average soil moisture percentage for the piñon/juniper sites, 2008–2013; moisture readings were averaged annually from the monthly readings.

Average percent soil volumetric water content on the piñon/juniper and ponderosa plots from 2008 through 2013 is displayed below in Figure 2.17 and Figure 2.18. These results show that the piñon/juniper and ponderosa sites are acting in similar fashion prior to the thinning treatments completed in 2011, but after 2012 the piñon/juniper sites showed a decrease in average soil moisture on both control and treatment plots while the ponderosa sites show an increase in average soil moisture on control and treatment plots. Average annual soil moisture between the paired plots is presented below for 2008–2013 from all forest thinning plots (Figure 2.19–Figure 2.22). These figures indicate that the treated sites retain on average more soil moisture throughout the year, especially after storm events and during times of drought. These figures also show the difference in soil moisture between the treatment and control is more pronounced on the piñon/juniper plots than the ponderosa pine plots. This finding can likely be contributed to the decrease in canopy cover and the increase in ground cover in the form of wood chips. This pattern has been evident for both 2012 and 2013 monitoring periods, whether these findings continue to persist into the future remains to be seen.

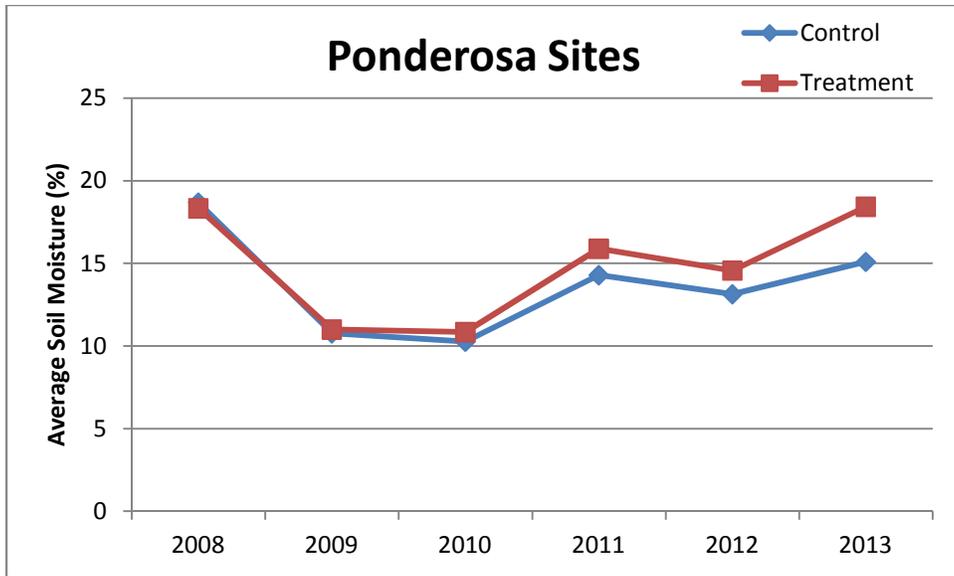
Figure 2.18. Annual average soil moisture percentage for the ponderosa sites, 2008-2013; moisture readings were averaged annually from the monthly readings.

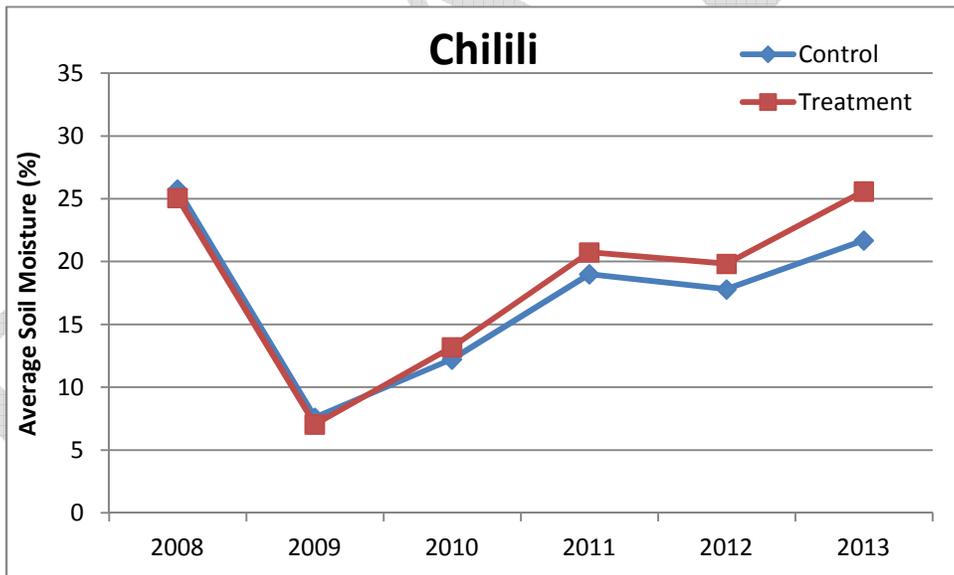
Figure 2.19. Average annual soil moisture readings taken at the Chilili site, 2008–2013.

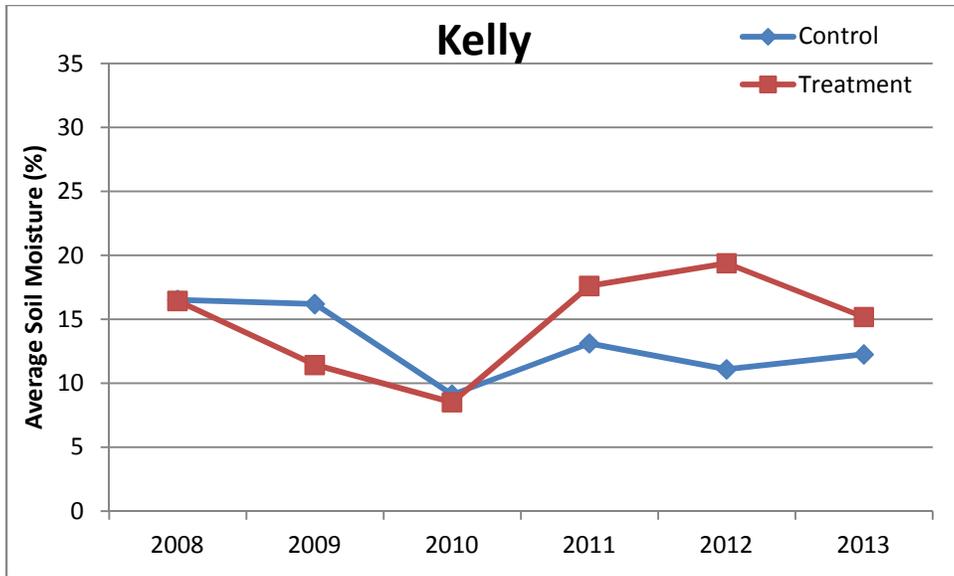
Figure 2.20. Average annual soil moisture readings taken at the Kelly site, 2008–2013.

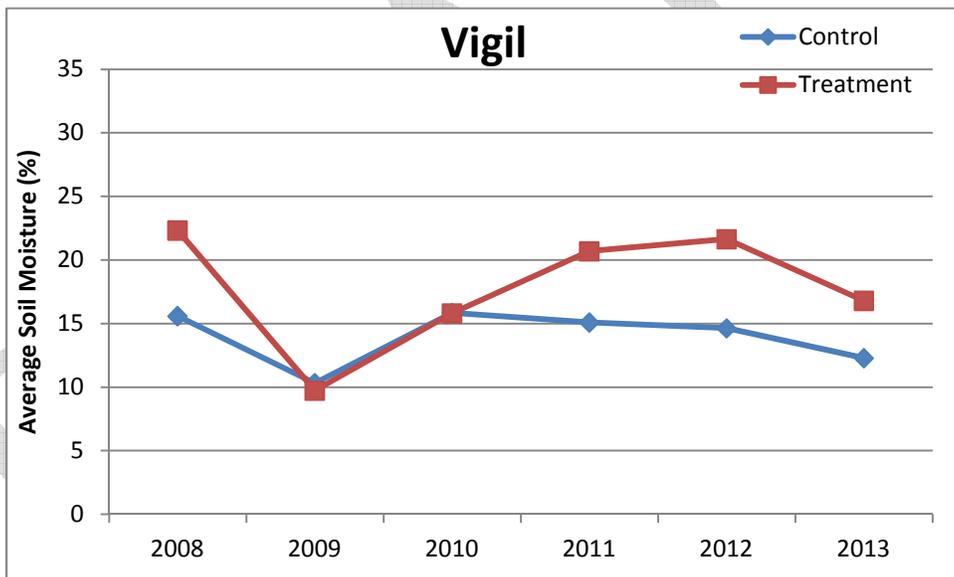
Figure 2.21. Average annual soil moisture readings taken at the Vigil site, 2008–2013.

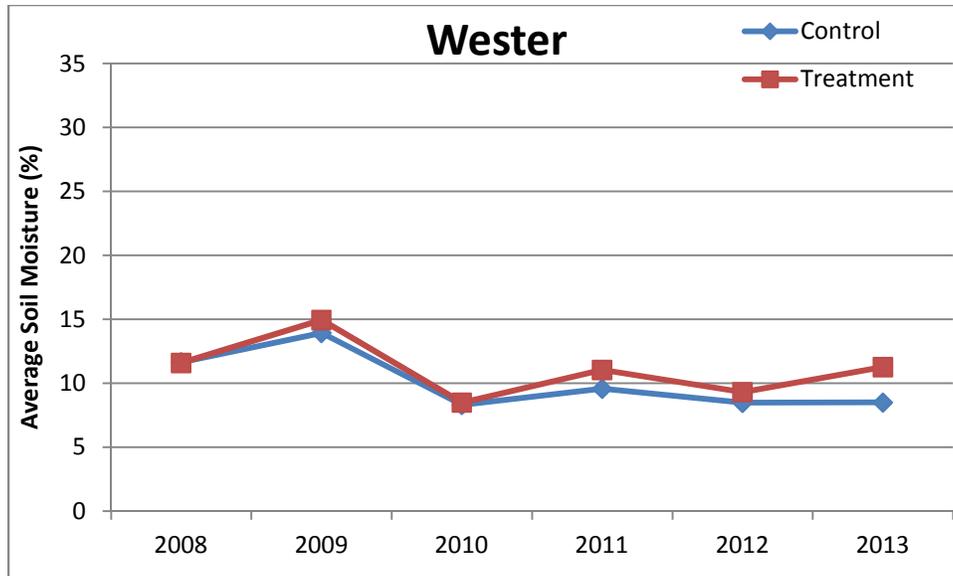
Figure 2.22. Average annual soil moisture readings taken at the Wester site, 2008–2013.

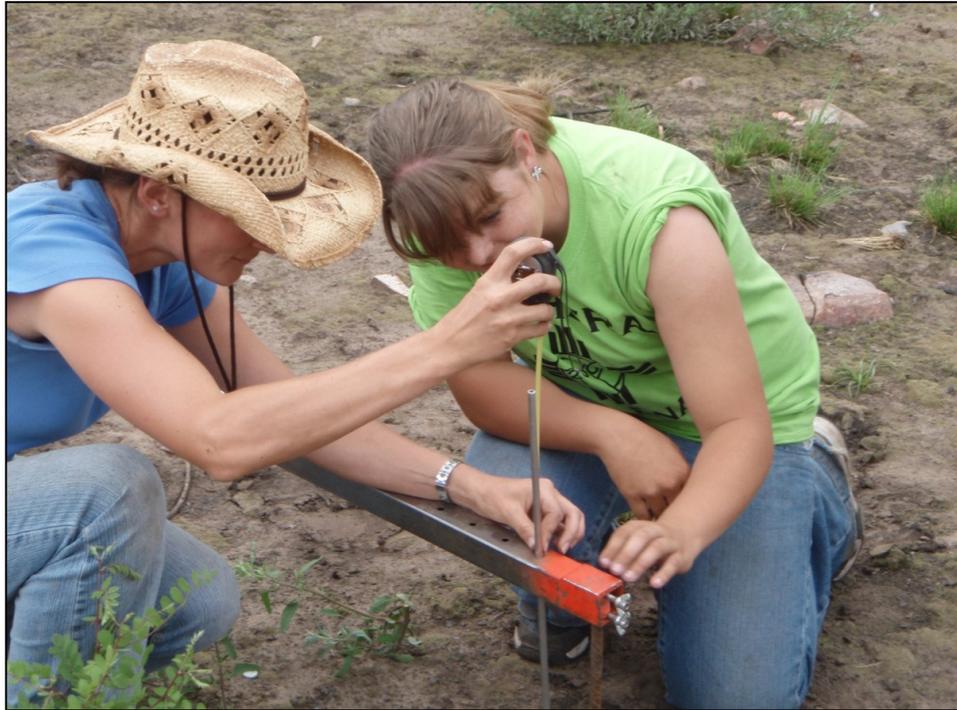
Figure 2.23. Measurement of soil surface topography using a soil movement bridge helps understand the yearly variability associated with soil topography.

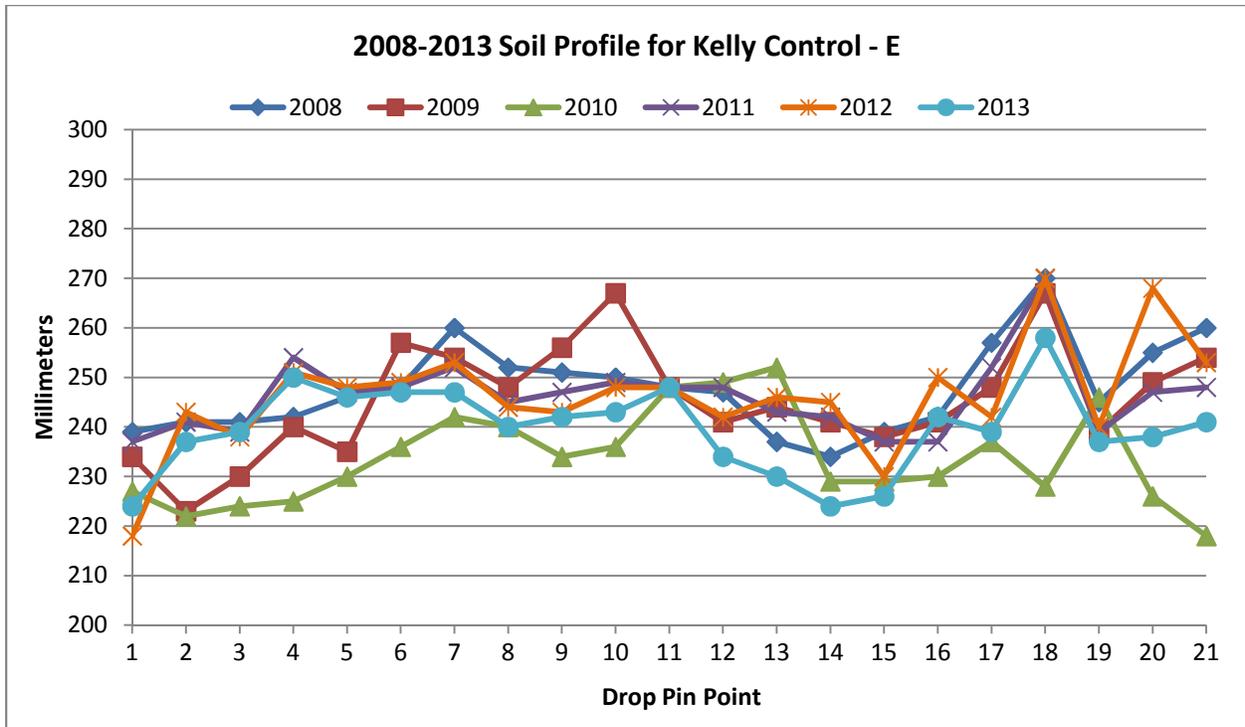
Figure 2.24. Soil surface profile from the soil movement bridge located at the Kelly piñon/juniper control site over 2008–2013, showing variation in the soil surface profile over a five-year period. Each point 1–21 on the x axis represents one measurement point from the soil surface to the level bridge above the surface. Point 11 is the set point (head of a spike) for calibration.

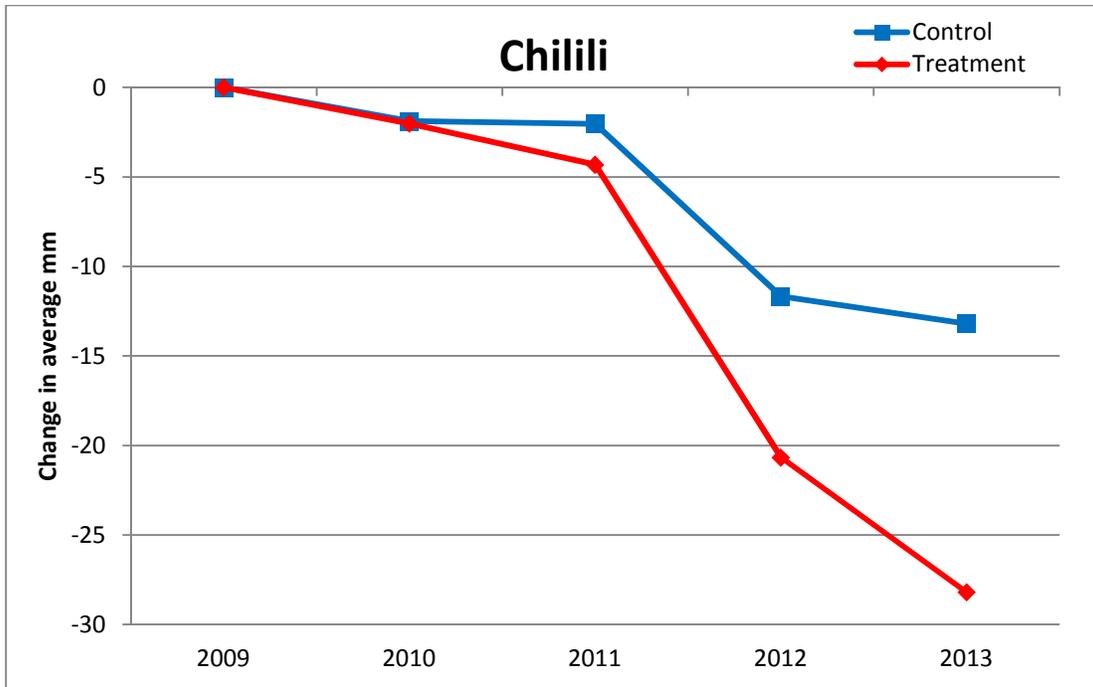
Figure 2.25. Average soil surface profiles for the Chilili sites, averaged from three soil movement bridges located on each of the paired study plots over the three-year period, 2009–2013.

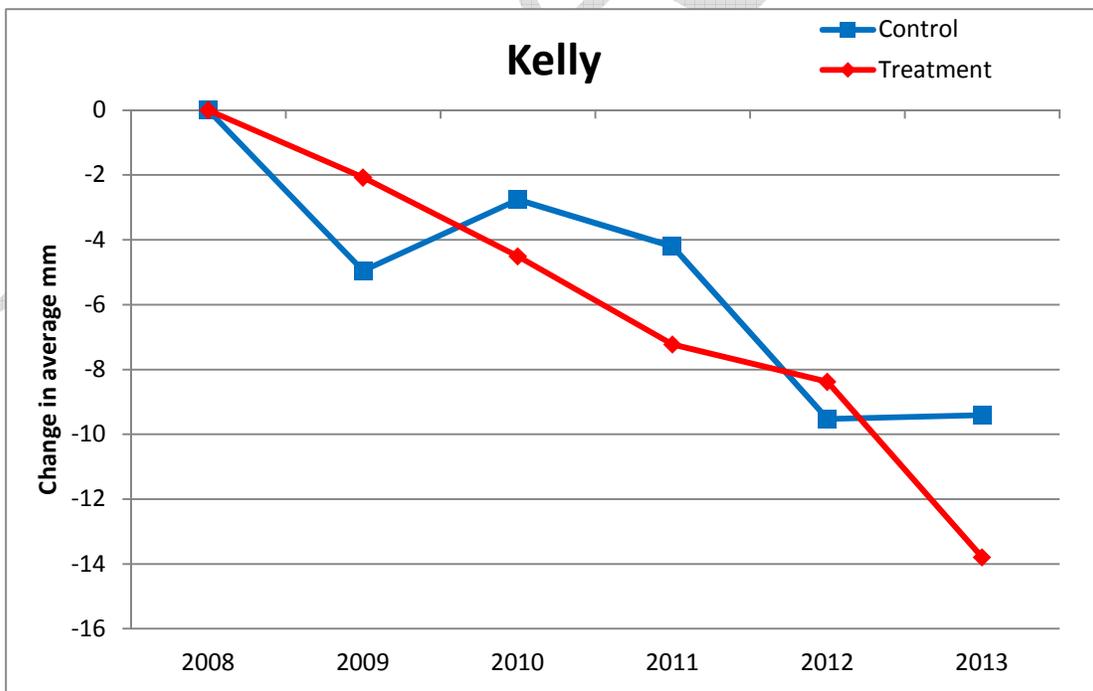
Figure 2.26. Average soil surface profiles for the Kelly sites, averaged from three soil movement bridges located on each of the paired study plots over the five-year period, 2008–2013.

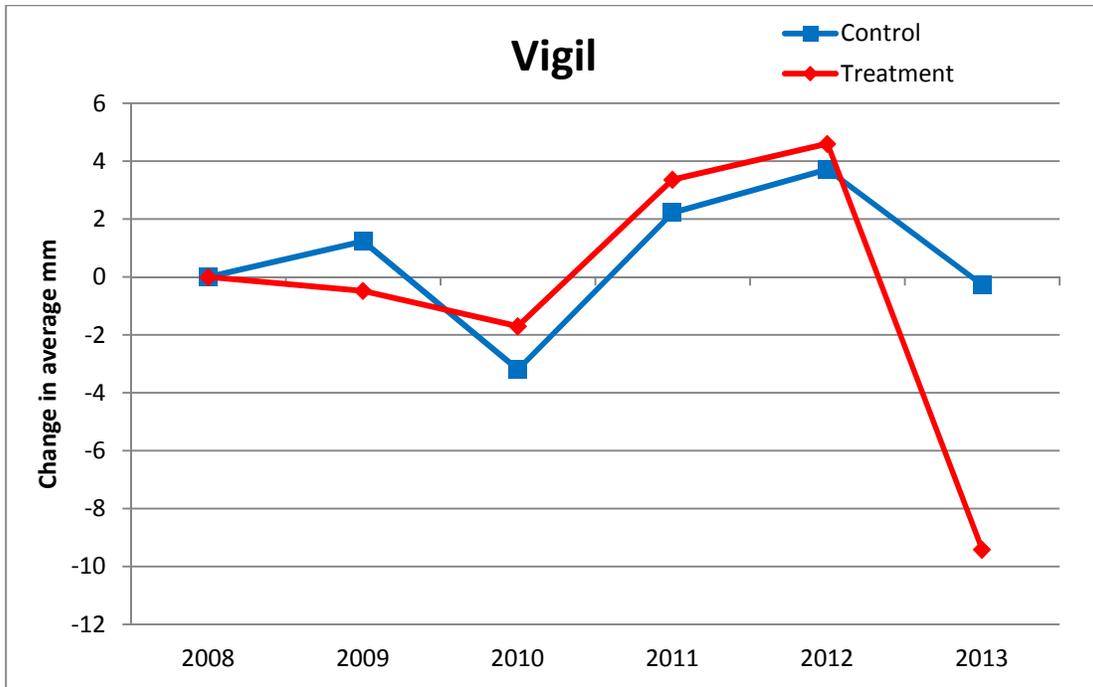
Figure 2.27. Average soil surface profiles for the Vigil sites, averaged from three soil movement bridges located on each of the paired study plots over the five-year period, 2008–2013.

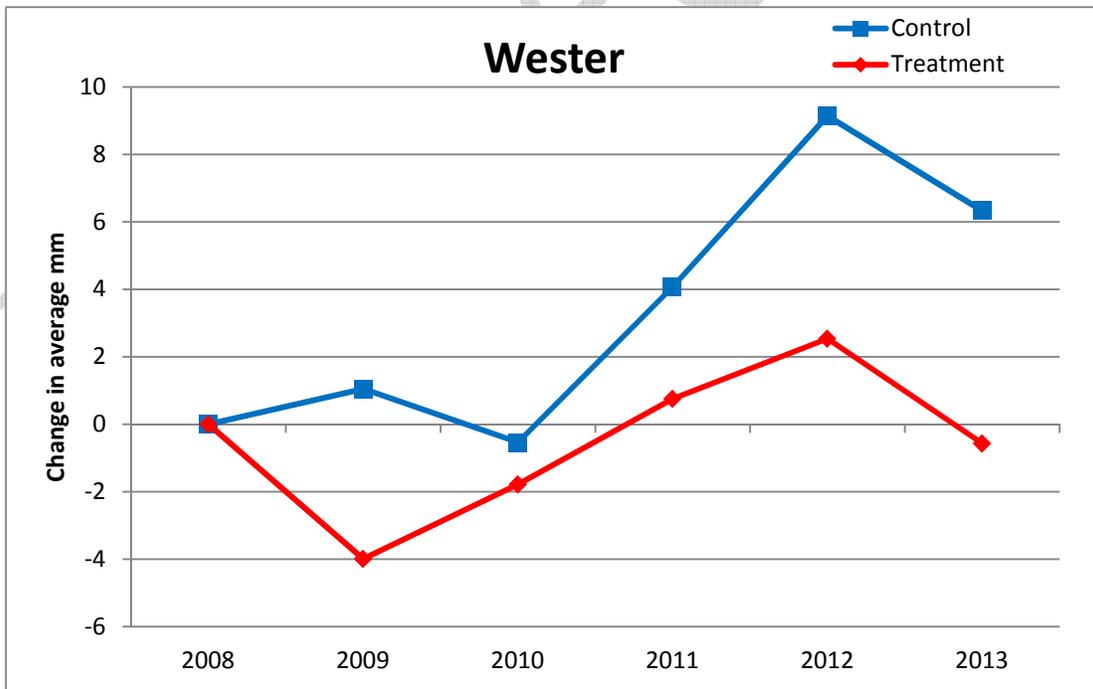
Figure 2.28. Average soil surface profiles for the Wester sites, averaged from three soil movement bridges located on each of the paired study plots over the five-year period, 2008–2013.

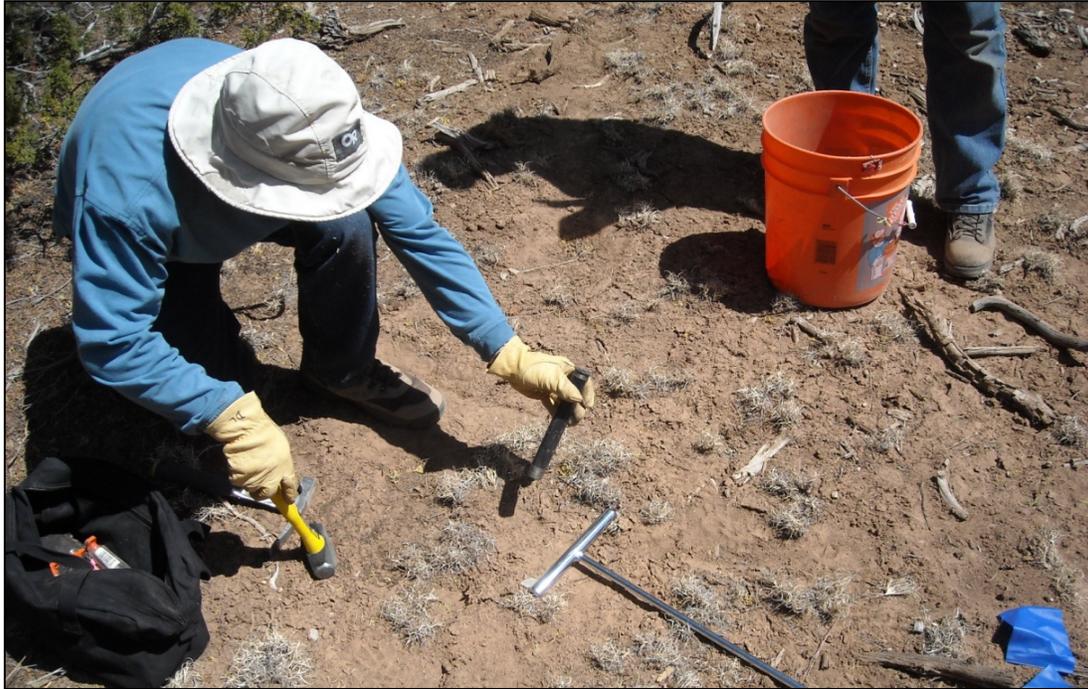
Figure 2.29. Soil cores were taken using an impact corer, shown above, for chemical analysis.

Baseline measurements of soil chemistry were obtained in 2008, 2009, and 2010 before thinning treatments at the Kelly, Vigil, and Wester sites; Chilili was not included until the 2009 sampling because this plot had yet to be established. The purpose of taking these measurements was to quantify changes to soil chemistry potentially caused by thinning activities. The methods used in 2008, however, were slightly different than those used in 2009 and 2010 and can be a reason for any large differences seen between years. The soil samples were obtained using a 4-cm-diameter (1.6-inch-diameter), 20-cm-deep (8-inch-deep) impact soil corer at the four corners of the three established vegetation plots (Figure 2.29). In 2008 the 12 subsamples were placed in labeled separate bags in order to attempt in-house analysis with Cardy soil kits. The variability associated with these kits, however, proved to be too great for reliable results, so the subsamples were combined into one bag for each site and sent to the New Mexico State University Soils and Water Testing (SWAT) laboratory for further analysis. In 2009, 2010, 2011, 2012, and 2013, the 12 subsamples were combined into the same bag at the time of sampling. These pooled samples were considered to be representative of the study areas. The 2009, 2010, and 2011 samples were sent to the SWAT laboratory for analysis. The New Mexico State University SWAT laboratory closed in early 2012, so the 2012 and 2013 samples were sent to the Soil, Water, and Plant Testing Laboratory at Colorado State University (CSU). These methods followed the USFS Forest Inventory and Analysis Guide procedures (USFS 2005).

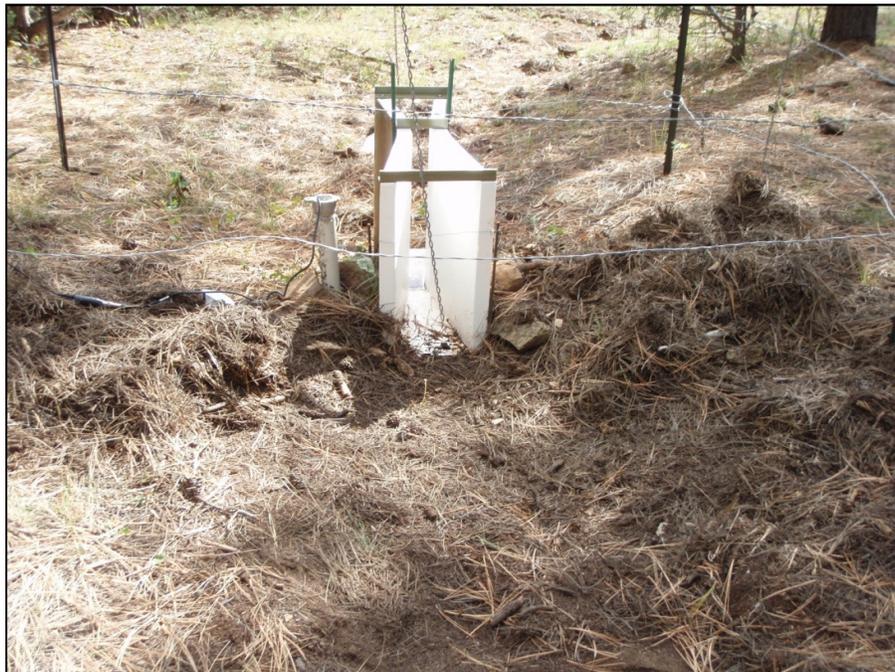
Figure 2.38. Parshall flume located at the thinned Chilili site.

Monitoring flumes (Parshall flumes) complete with pressure transducers were installed at all four study sites to study the impacts of tree thinning to surface flow (Figure 2.38). For more detailed information on the methodology, site location, and relevant background information, please refer to the 2008 Monitoring Plan (SWCA 2008).

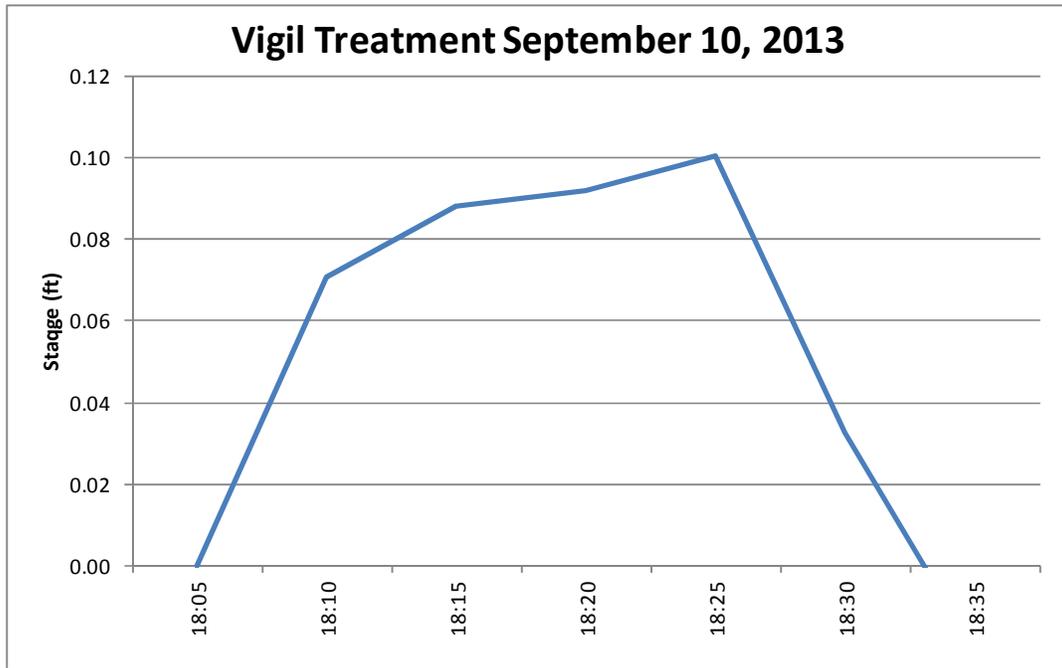
Figure 2.39. Hydrograph showing plot from the Vigil treatment during a storm flow event on September 10, 2013.

Runoff Parameters	Study Site
	Vigil Treated
Flow start	18:05
Flow stop	18:30
Peak stage (feet)	0.10
Peak flow (cubic feet/second)	0.03
Flow duration (minutes)	25
Total volume of flow (cubic feet)	28.8
Watershed area (acres)	0.68
Volume of flow per acre (cubic feet/acre)	42.35
Total rainfall (inches)	0.9
Total volumetric rainfall (cubic feet)	3,135
Rainfall/Runoff ratio	0.01

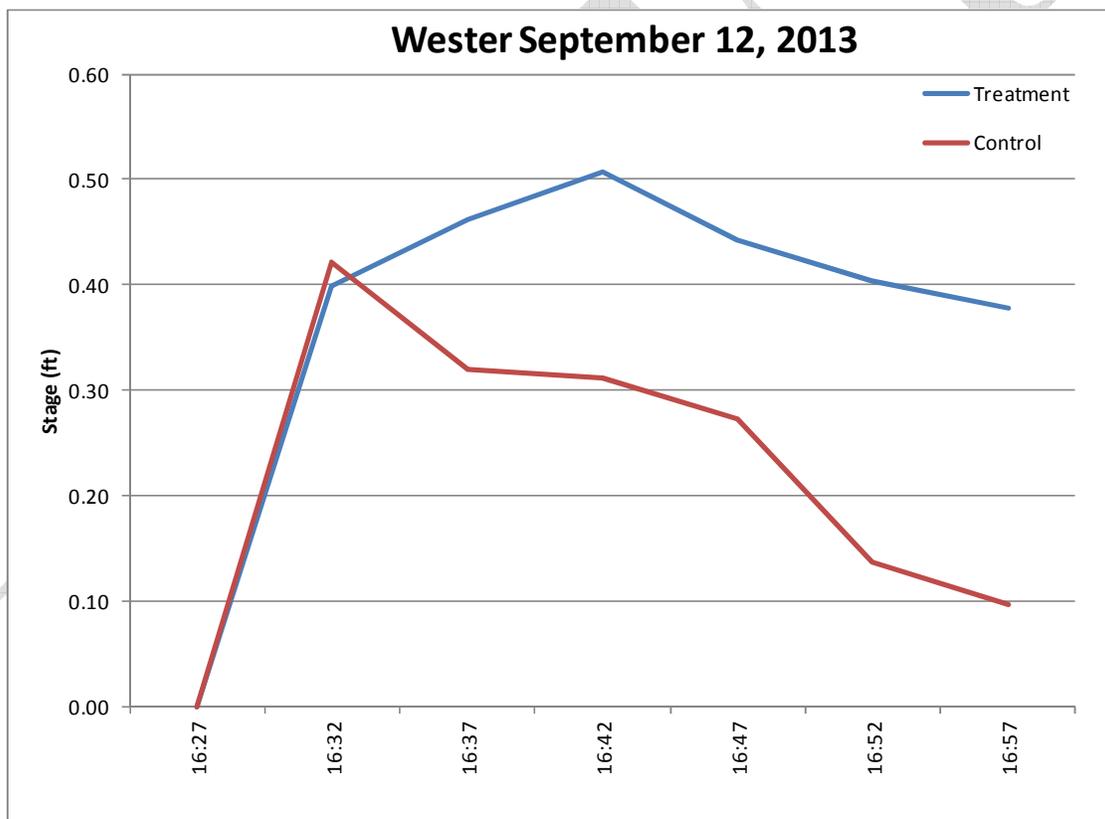
Figure 2.40. Hydrograph showing the storm flow at the treatment and control Wester site that occurred on September 12, 2013

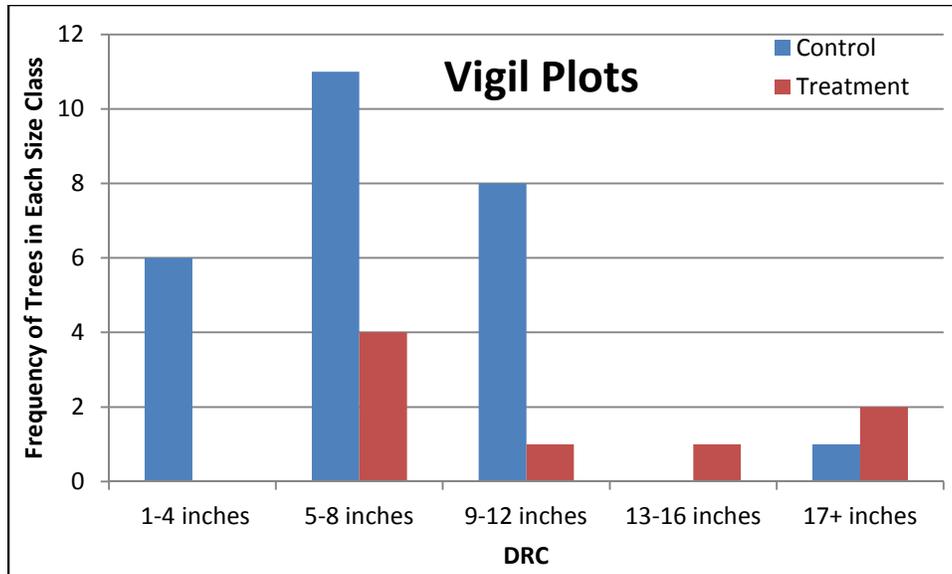
Figure 2.44. Size classes of piñon/juniper trees measured at DRC on the Vigil control and treatment plots.

Figure 2.41 through Figure 2.44 illustrate the difference in size class distribution between control and treatment plots for each site. At both ponderosa pine sites (Chilili and Wester), the control plots have a greater number of trees distributed in the lower size classes (1–7 inches, and to a lesser extent 8–11 inches), compared to the treatment plots where trees are more uniformly distributed across size classes and the number of smaller-diameter trees (1–4 inches) is reduced. For the piñon/juniper control plots on both sites (Kelly and Vigil), the greatest numbers of trees fall in size classes 5–8 and 9–12 inches DRC, respectively, and there are relatively fewer large-diameter trees. Both piñon/juniper treatment plots had no trees less than 4 inches DRC, and the remaining trees were more evenly distributed across size classes than the control plots.
