**ESTANCIA BASIN WATERSHED
HEALTH AND MONITORING PROJECT:
2013 ANNUAL REPORT**

**ESTANCIA BASIN WATERSHED HEALTH, RESTORATION AND MONITORING
STEERING COMMITTEE**

SWCA ENVIRONMENTAL CONSULTANTS

March 2014

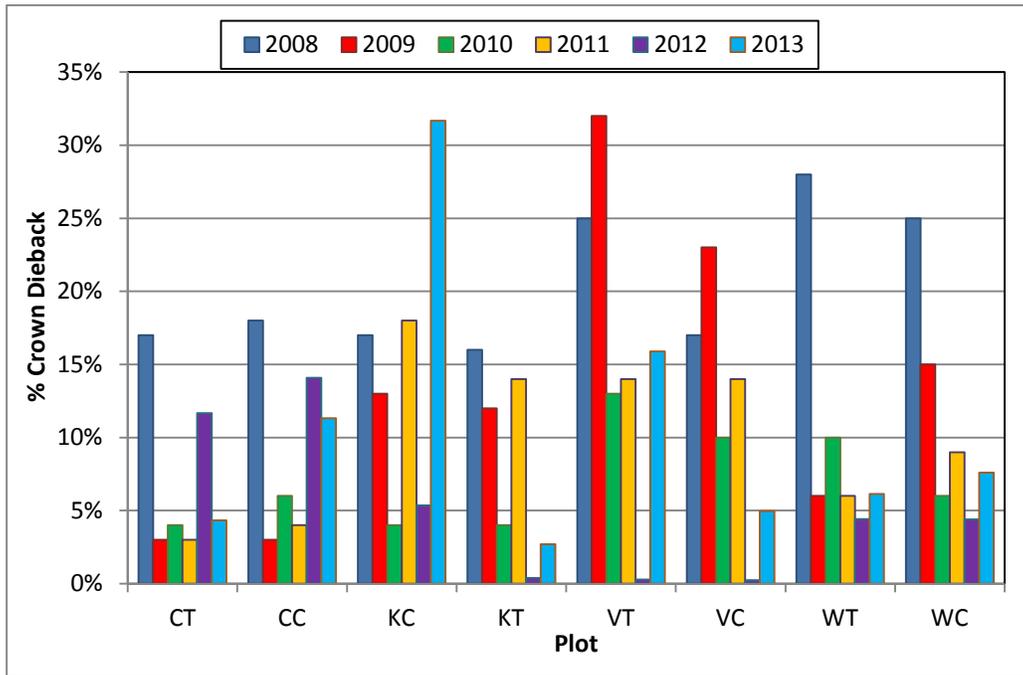
Figure 2.45. Average percent crown dieback of tree canopies for each thinning plot, 2008–2013.

be particularly prevalent at the Kelly control site. We believe that dieback levels are within the normal range of variability for all six years.

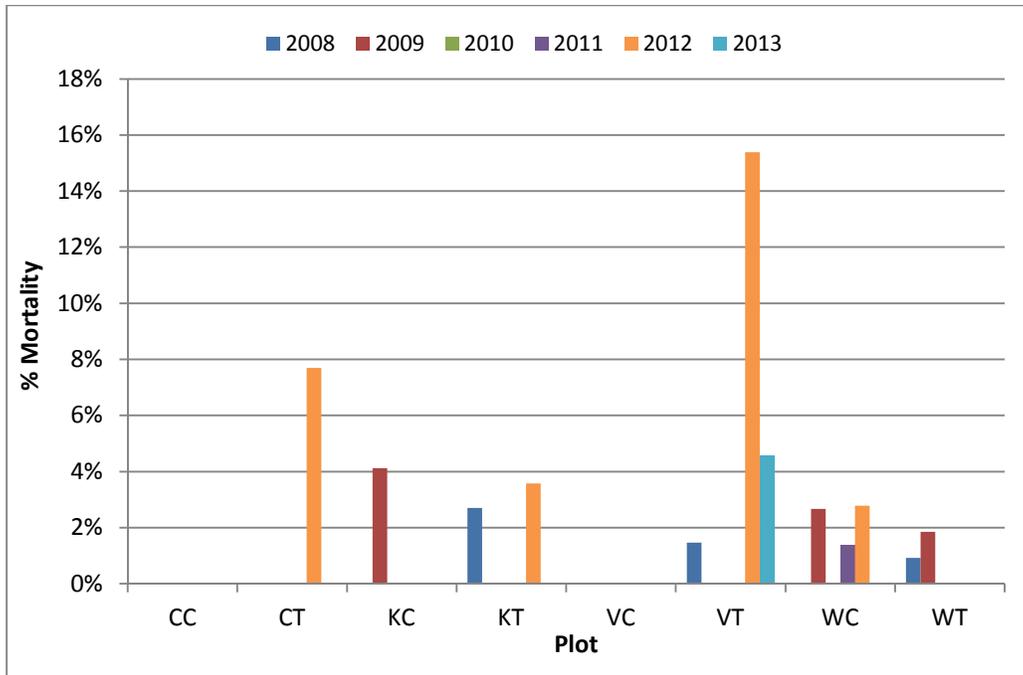
Figure 2.46. Percent tree mortality recorded across all thinning plots from 2008–2013. Percent mortality is recorded in relation to tree status in 2008.

The 2012 season saw the highest mortality (not attributed to tree cutting) of all six years, with most mortality recorded on previously thinned plots (with the exception of Wester). The Vigil treatment was the only plot to experience mortality in 2013; 100% of this mortality was of piñon pine and was attributed to bark beetle infestation. Conversely, the Vigil control plot showed no tree mortality in any of the six years. The Vigil treatment plot has experienced the greatest percent mortality of all plots; similarly, this plot also exhibited higher crown dieback than other plots in previous years, suggesting that the trees on that plot were experiencing environmental stress possibly leading to the high mortality in 2012 and 2013. The Chilili and Kelly treatment plots also suffered tree mortality of a little less than 10% in 2012. The Wester control plot was the only control plot that exhibited mortality in 2012. This plot had suffered tree mortality in 2009, 2011, and 2012, which is likely a result of competitive stress and/or beetle damage. A number of trees at the Wester site suffered broken/dead tops and showed signs of drought stress. As demonstrated in Figure 2.45, a number of plots experienced crown dieback in 2013 that may result in increased mortality in subsequent years. Tree mortality will continue to be monitored every fall.

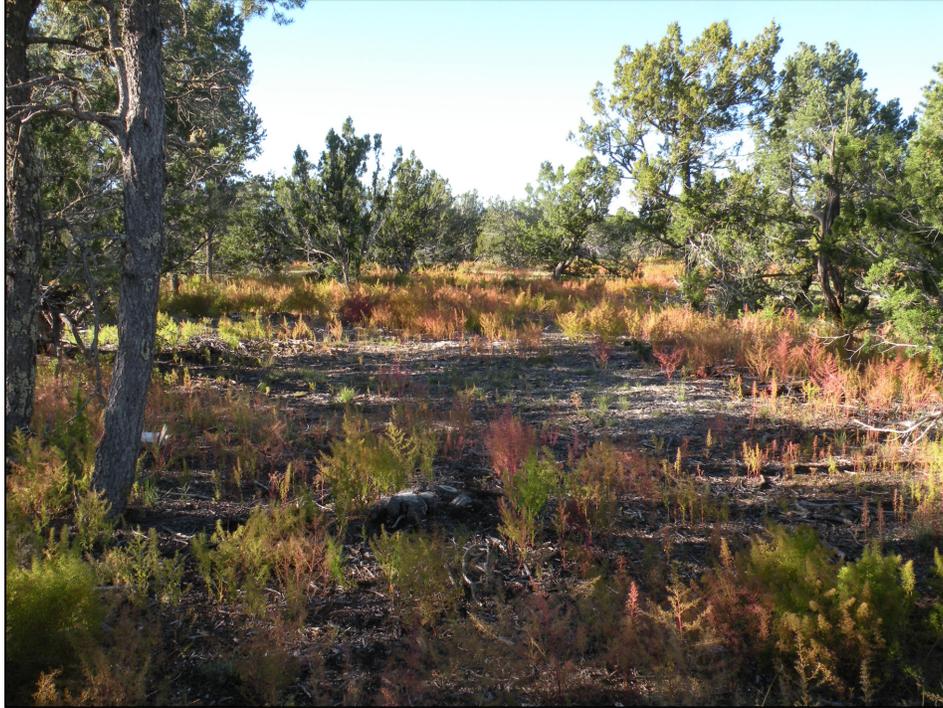
Figure 2.48. Forbs growing on disturbed soils and wood chips at the Kelly site treatment plot, October 2013. The visible dominant species is native annual forb *Chenopodium graveolens*.

Total herbaceous vegetation canopy cover was significantly greater on all treated plots at all sites except for Chilili in 2013 (Figure 2.47 a–d; Table 2.9). Total herbaceous canopy cover was not significantly different between control and treatment plots at any site in 2010 prior to tree thinning treatments, but total herbaceous cover was significantly greater on treated plots at all sites except Chilili from 2011 through 2013 following thinning treatments. The amount of herbaceous vegetation cover on treatment plots has tended to increase even more relative to control plots through 2013 (Figure 2.47 a–d). Forb canopy cover was significantly higher on the treated plots at both of the piñon/juniper sites in 2013, but not at either of the ponderosa pine sites (Figure 2.47, f–h). Forb cover at both the Kelly and Vigil sites was considerably higher in 2013 than it was before thinning treatments in 2010 and after treatments in 2011 and 2012. Forb cover on control plots remained relatively constant over the three-year period at the Vigil site, but also increased on the control plot at the Kelly site in 2013. The majority of forb species were summer annual plants that grew on disturbed soils and wood chips. All of the dominant species were native; no exotic invasive forb species were found. An example of the forb growth at the Vigil treatment plot in 2013 is provided in Figure 2.48.

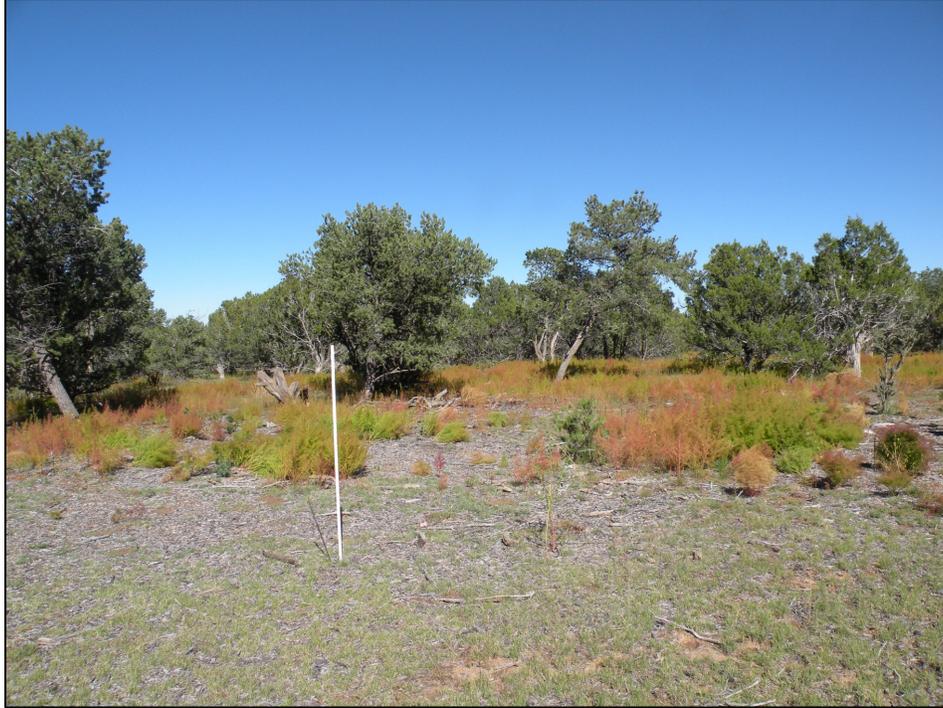
Figure 2.49. Perennial blue grama growing through wood chips (foreground) at the Kelly piñon/juniper site treatment plot in 2013. Note that the blue grama had been grazed down by livestock.

Grass cover was significantly higher only on the treated plot at the Vigil piñon/juniper site and at the Wester ponderosa pine site in 2013 (Table 2.9; Figure 2.47, i–l). Grass cover increased steadily on the treated plot at the Vigil site from 2010 to 2013, but remained similar on the control plot. Grass cover was significantly higher on the treated plot at the Wester ponderosa pine site even before thinning treatments in 2010. However, in 2013 grass cover on the treatment plot continued to increase over 2012, while it declined on the control plot from 2012, indicating a positive response to the thinning treatment. Dominant grasses at the two piñon/juniper sites that responded positively to tree thinning were perennial species such as blue grama (*Bouteloua gracilis*) and James' galleta (*Pleuraphis jamesii*). Those grasses grew through the wood chips from existing individual plants that were in place prior to thinning treatments, unlike annual forbs that colonized the disturbed soils and wood chips. Blue grama growing through wood chips at the Vigil site is shown in Figure 2.49.

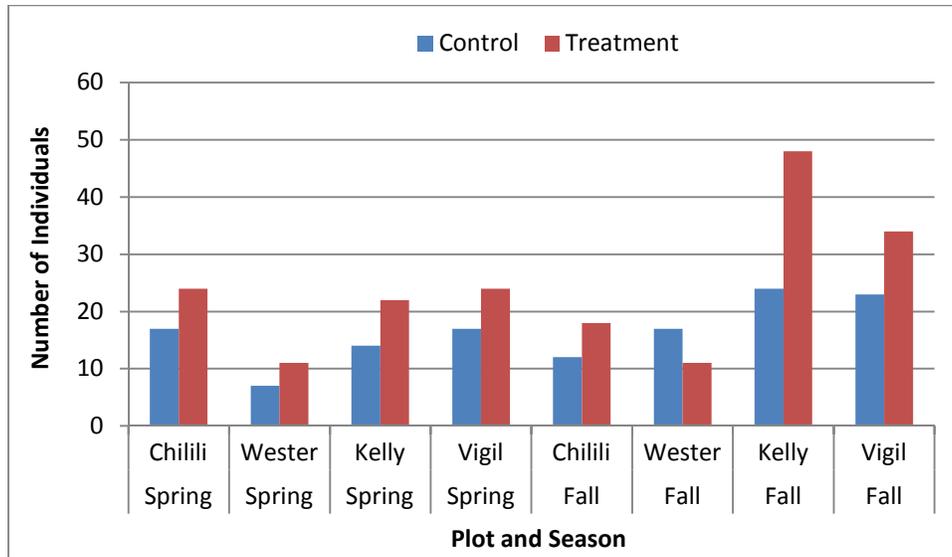
Figure 2.51. Numbers of individual birds recorded from thinning treatment and control plots across the four study sites in both spring and fall 2013.

Counts of individual birds in 2013 revealed that more birds were found on all treated plots than on control plots in both the spring and fall, except for at the Wester site during the fall (Figure 2.51). Numbers of bird species were also always higher (or equal at Wester in the fall) on treated plots than control plots in both spring and fall, especially at the two piñon/juniper sites (Figure 2.52).

Figure 2.53 presents the species and numbers of individuals of those species summarized in Figure 2.51 and Figure 2.52. Examination of Figure 2.53 shows that in most cases, different species of birds dominate the spring and fall bird communities. Such findings should be expected, given that some of the species that breed at those sites in the spring migrate south in the fall and are replaced by species and individuals that migrated to the sites from locations farther north and/or higher in elevation.

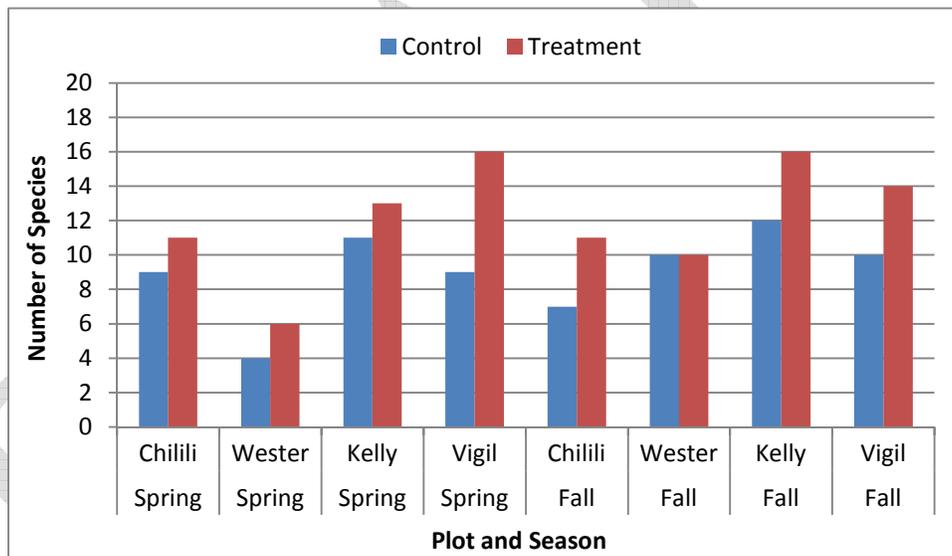
Figure 2.52. Numbers of bird species recorded from thinning treatment and control plots across the four study sites in both spring and fall 2013.

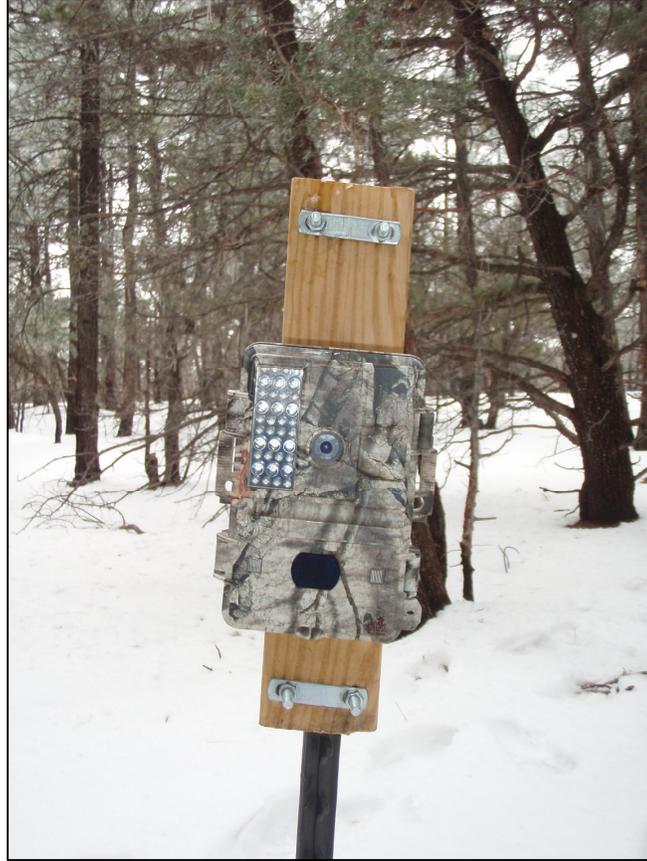
Figure 2.60. Automatic wildlife camera.

Wildlife cameras (Figure 2.60) were established on the forest thinning paired control and treatment monitoring plots in February 2012 to evaluate how medium and large wildlife species are using the control versus treated study plots. The cameras were all Leaf River IR5 infrared cameras that had a detection sensor up to 21 m (70 feet). One camera was placed on each of the eight control and treatment study plots among the four sites, Chilili, Kelly, Vigil, and Wester. The wildlife cameras were erected near the center of each wildlife monitoring plot, approximately 1.2 m (4 feet) from the ground and oriented toward open areas free of trees up to 20 m (66 feet) away from each camera. The cameras operate during day and night using a movement sensor infrared flash. Camera photograph cards were offloaded each month.

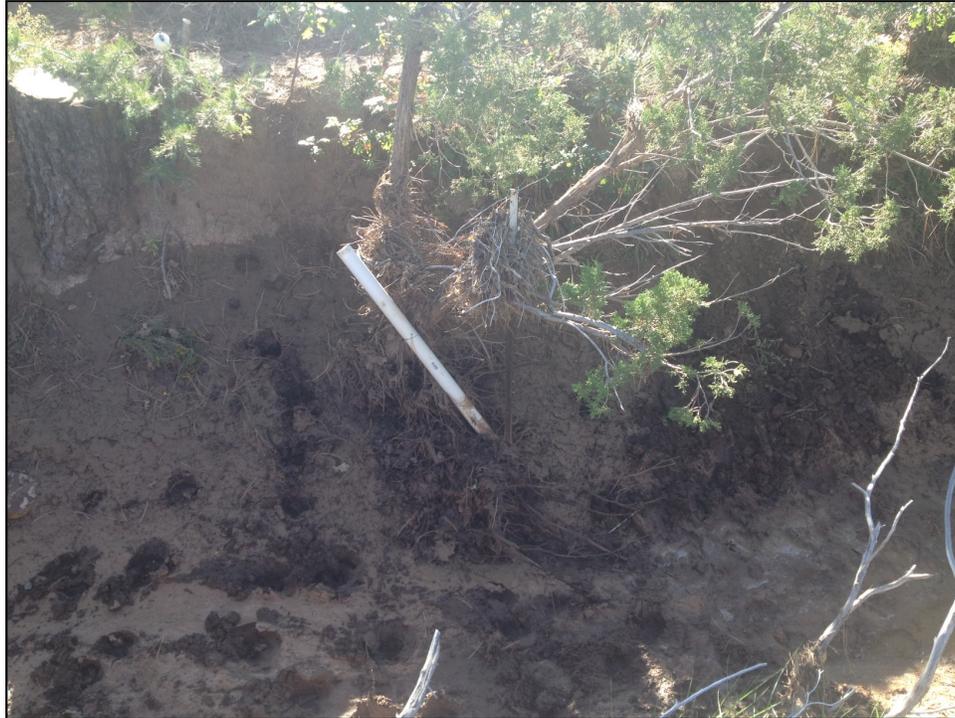
Figure 3.2. The Vigil piezometer in the fall of 2013 after a storm event compromised the gauge.

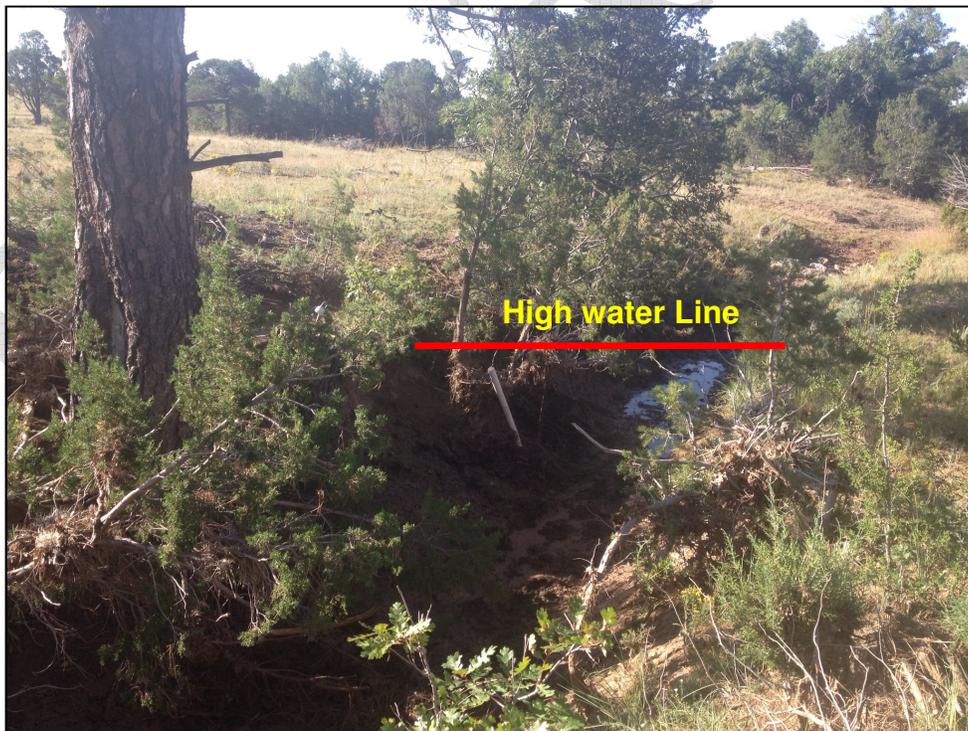
Figure 3.3. View of the Vigil piezometer facing downstream showing the high water mark (1.5 meters) as a red line above the piezometer.

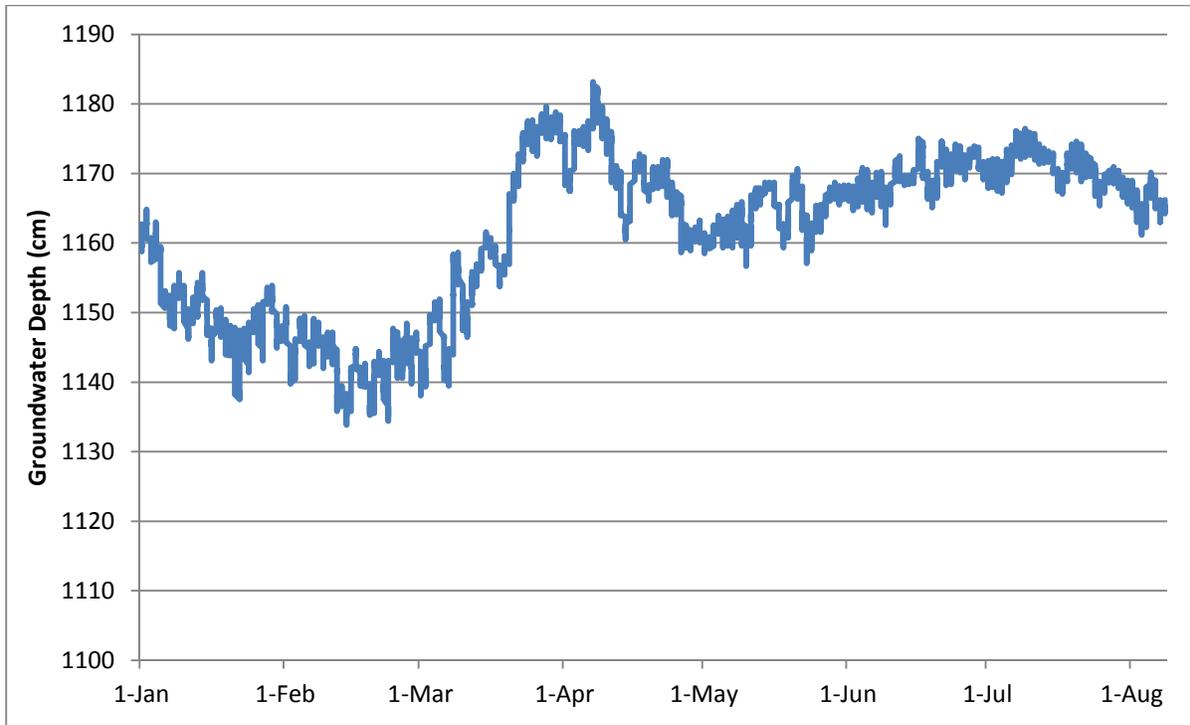
Figure 3.4. Well data from the Chilili site showing a declining water level until the snowmelt which generates a small rise in groundwater depth.

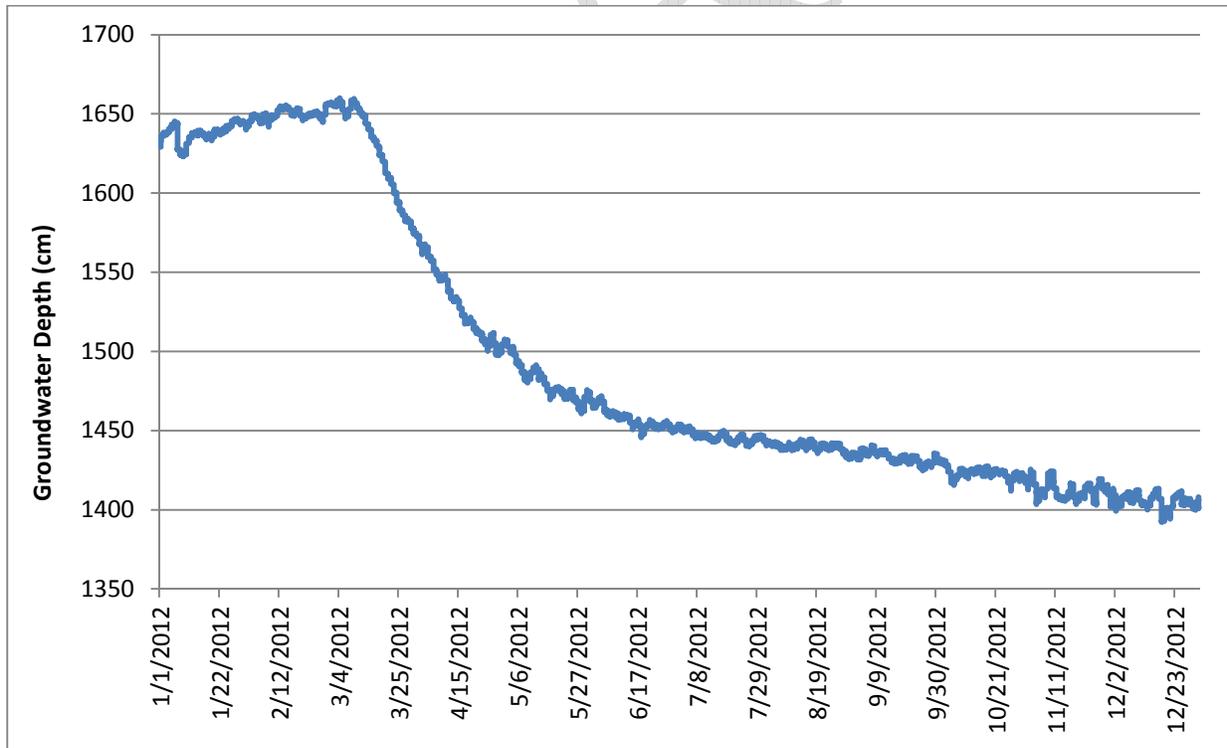
Figure 3.5. Well data from the Punta de Agua site showing steady rise of the groundwater over the summer months.

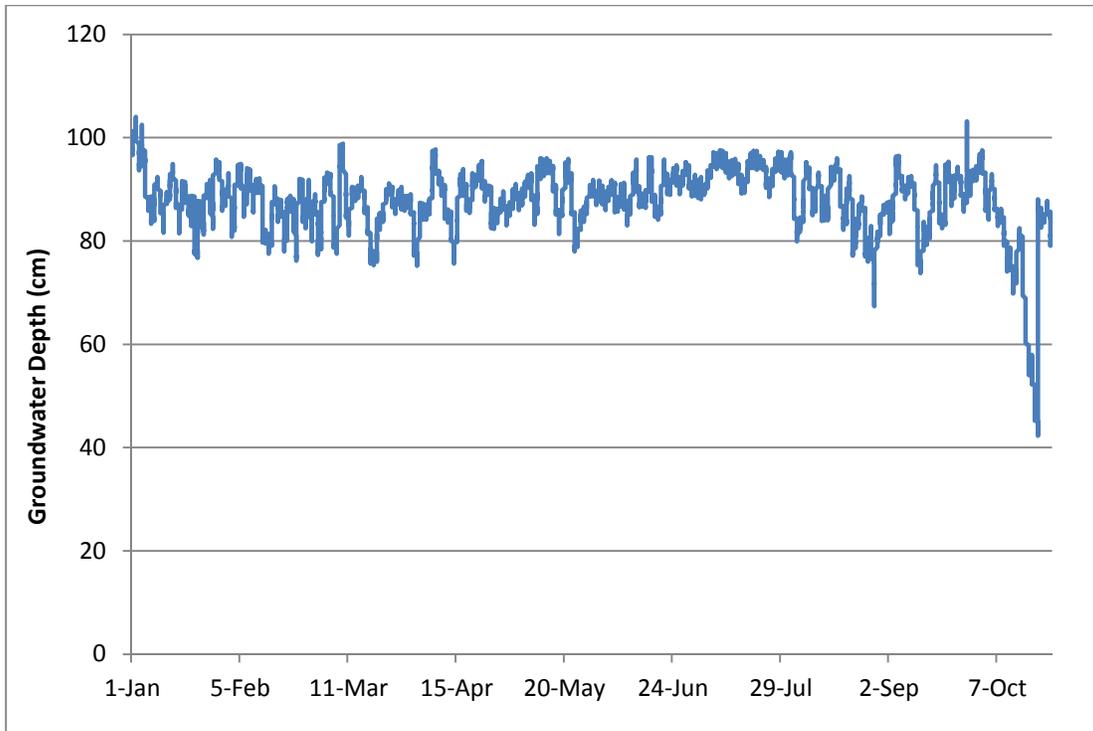
Figure 3.6. Well data from the Manzano site showing the well being dry for most of the year.

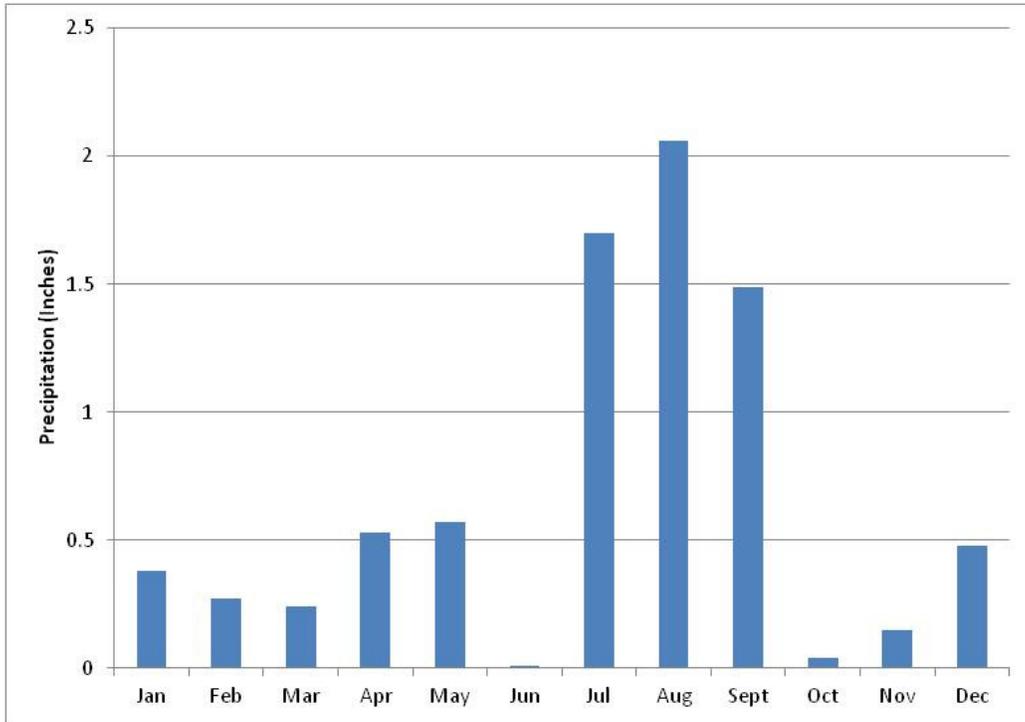
Figure 4.2. Graph showing monthly total rainfall over the course of 2013.

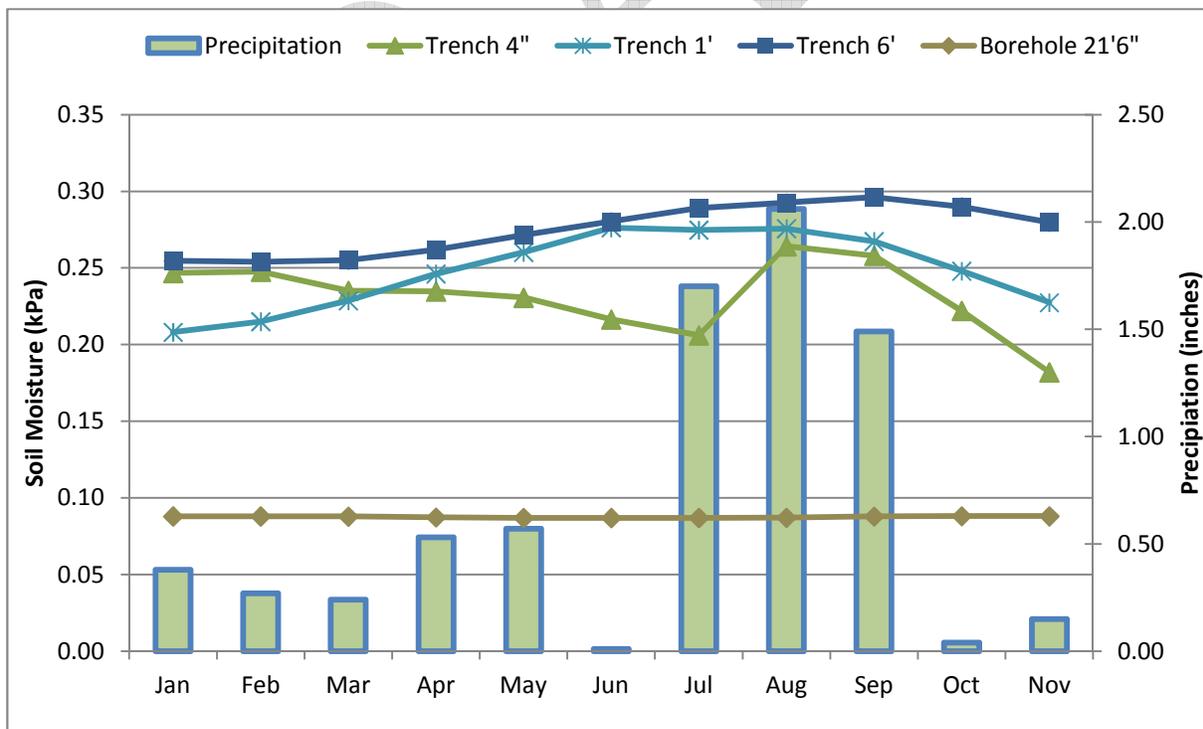
Figure 4.3. Tree site monthly average soil moisture and total precipitation for 2013.

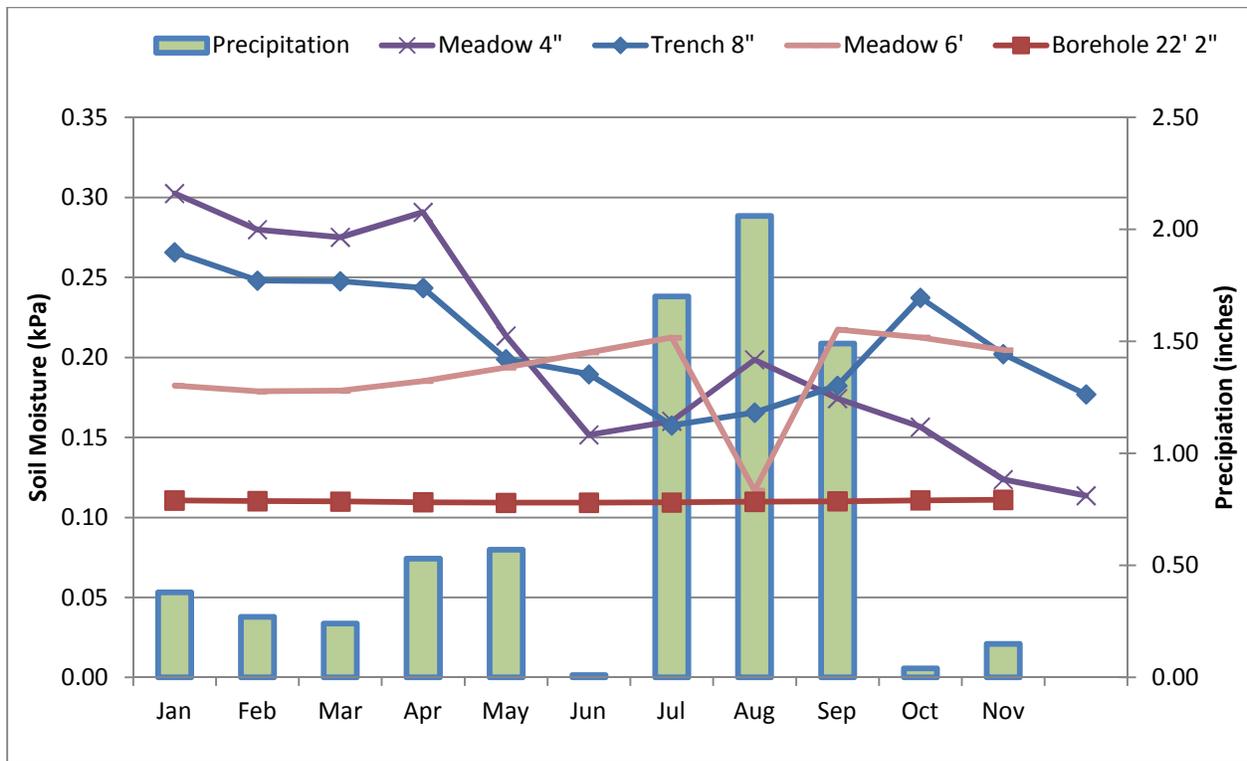
Figure 4.4. Meadow site average monthly soil moisture and total precipitation for 2013.

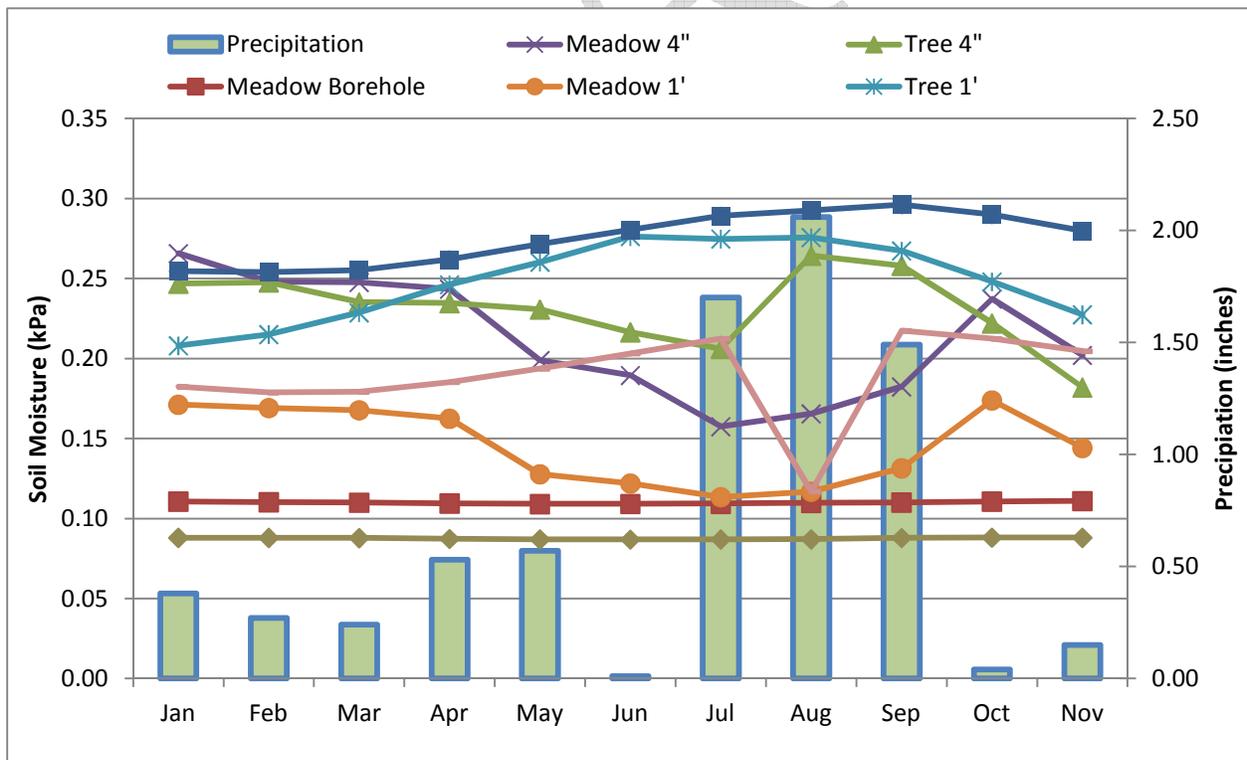
Figure 4.5. Tree and Meadow site average monthly soil moisture and total precipitation for 2013.

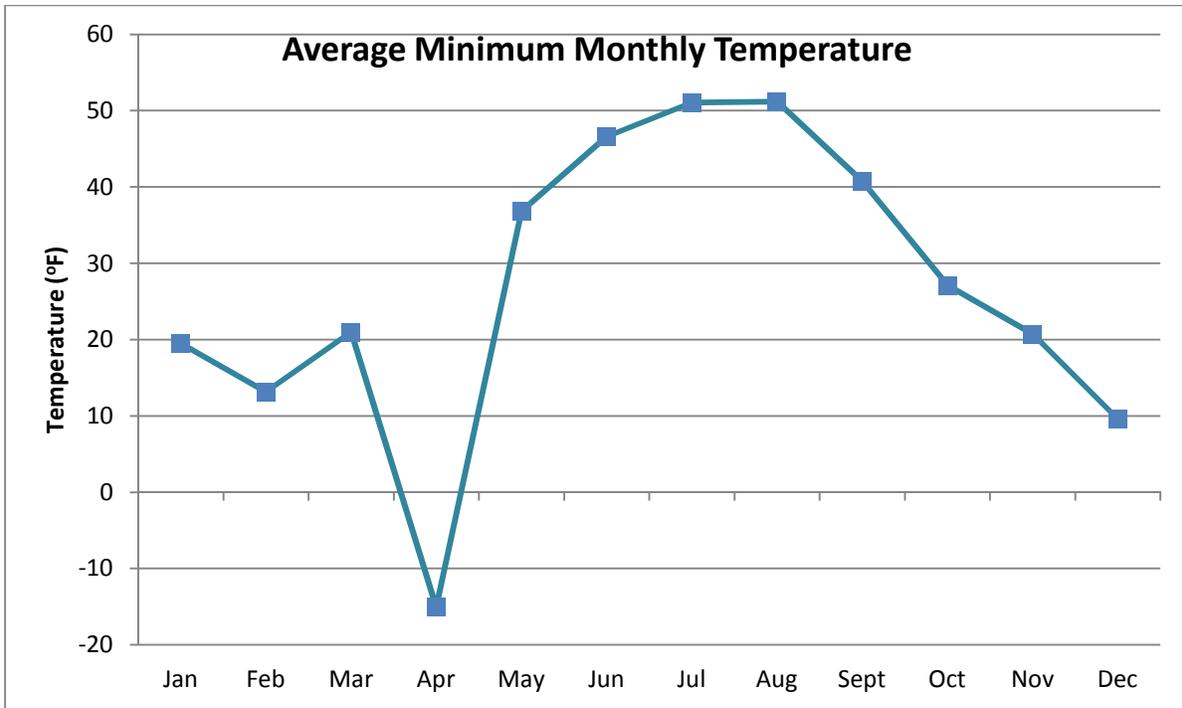
Figure 4.6. Minimum monthly temperature experienced at the SMWS during 2013.

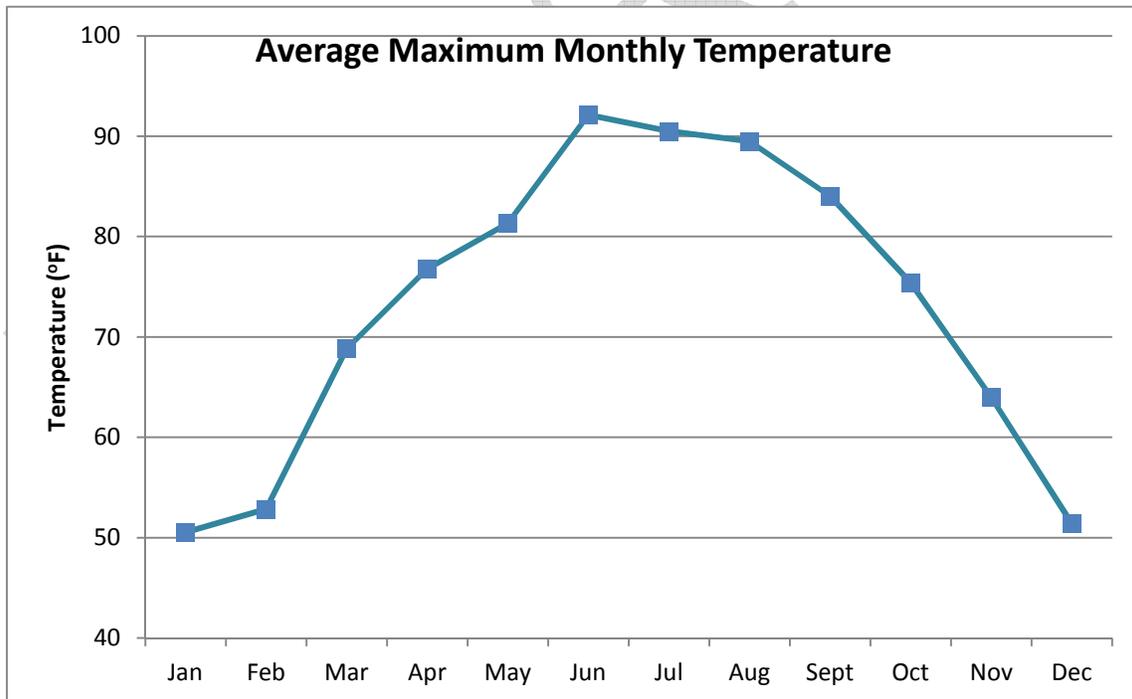
Figure 4.7. Maximum monthly temperature experienced at the SMWS during 2013.

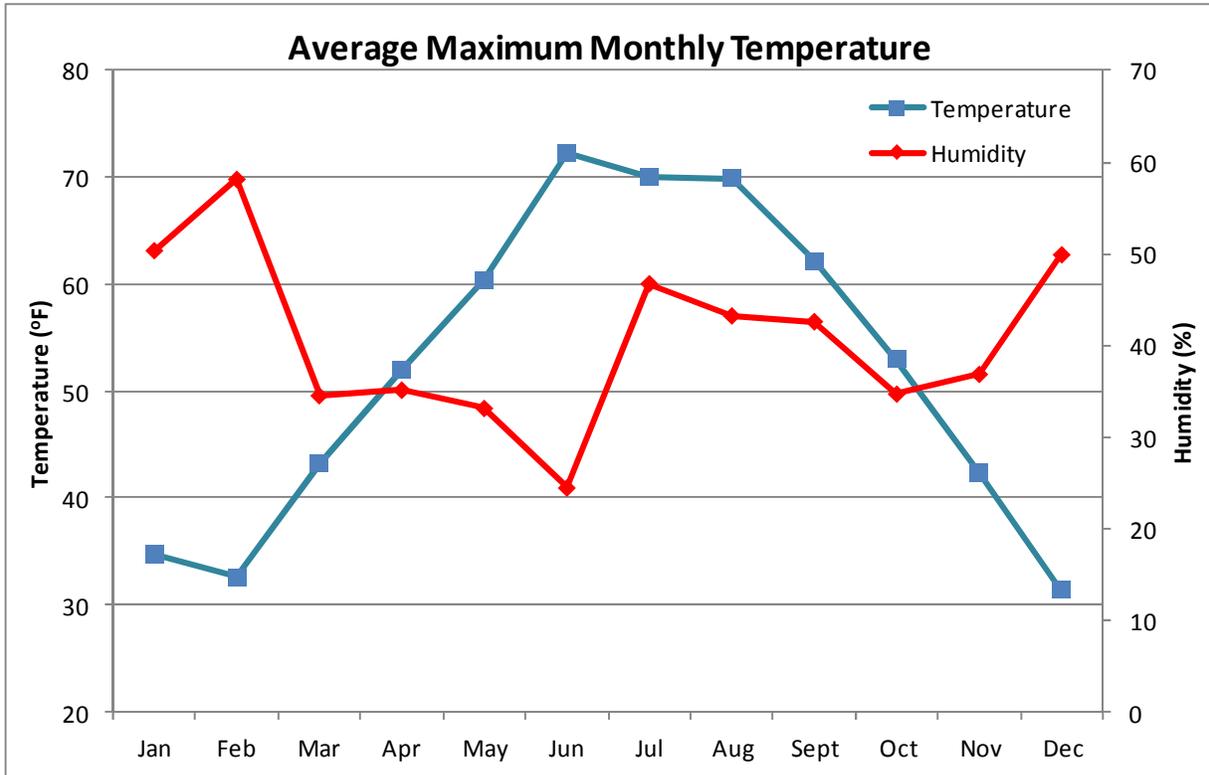
Figure 4.8. Daily average temperature and relative humidity over the course of 2013.

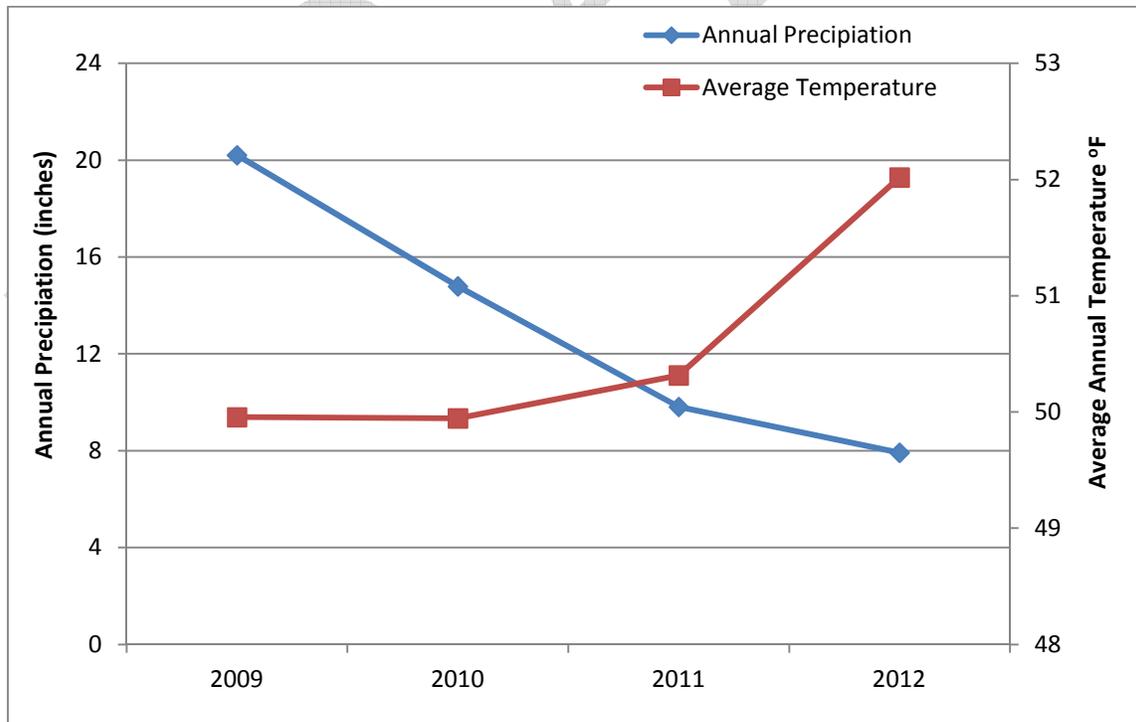
Figure 4.9. Annual precipitation and average annual ambient temperature at the SMWS 2009–2013.

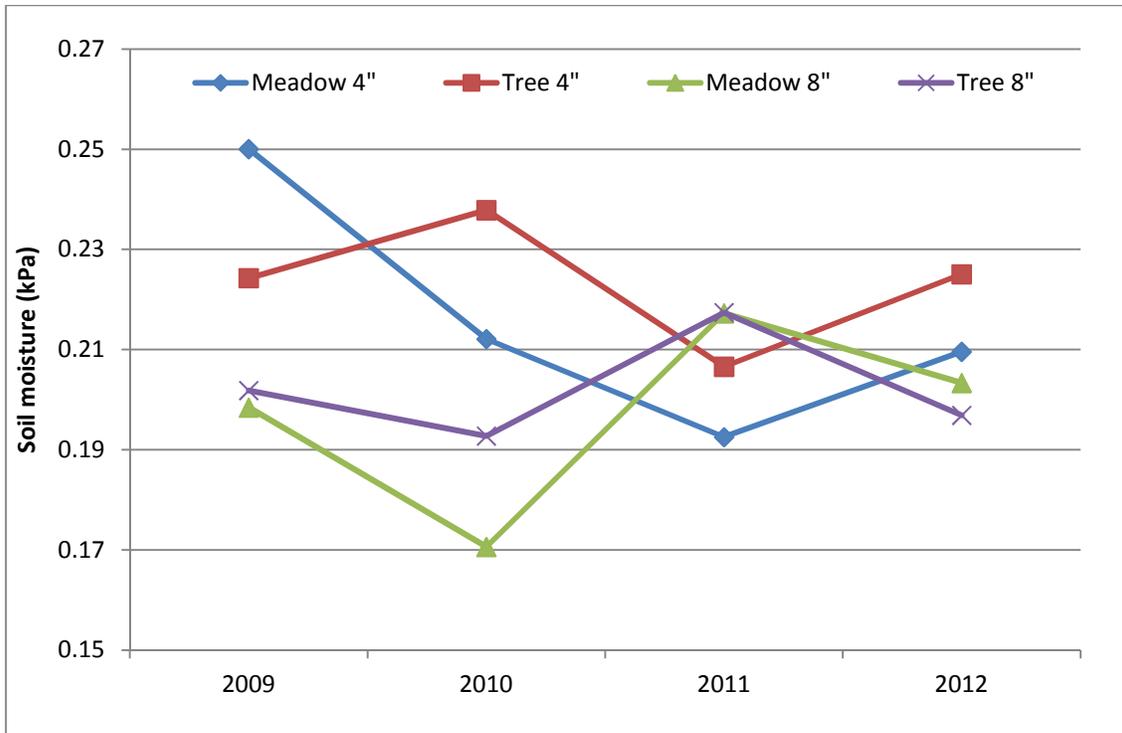
Figure 4.10. Average annual soil moisture from the two shallow depths at the tree and meadow sites with no difference seen between the 4- and 8-inch depths.

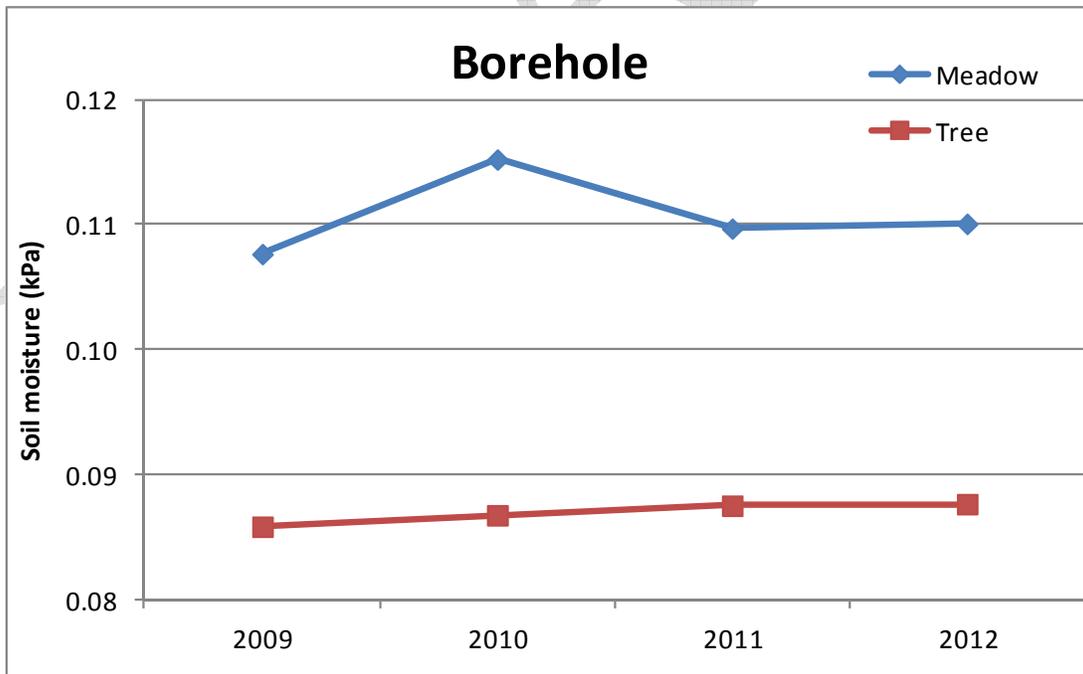
Figure 4.11. Average annual soil moisture from the two deep bore-hole depths (21 feet 6 inches) at the Tree and Meadow sites show no significant time differences throughout the 4 years of monitoring.
