**ESTANCIA BASIN WATERSHED HEALTH AND MONITORING PROJECT:  
2009 ANNUAL REPORT**

**ESTANCIA BASIN WATERSHED HEALTH, RESTORATION AND MONITORING  
STEERING COMMITTEE**

**SWCA<sup>®</sup> ENVIRONMENTAL CONSULTANTS**

March 2010

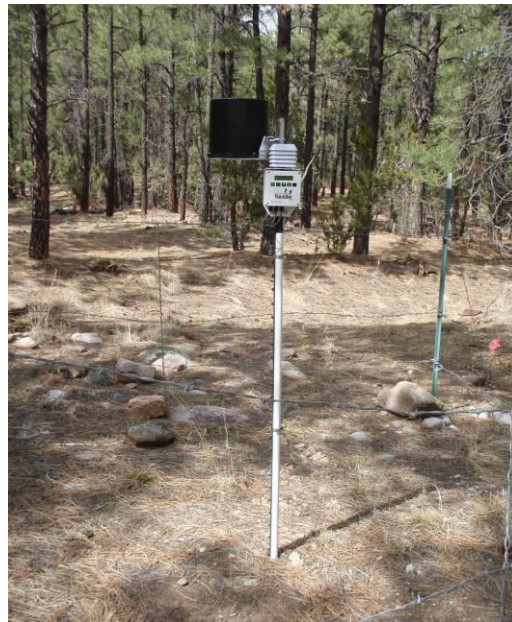
**Figure 2.1. WatchDog weather station at the Westponderosa pine site.**

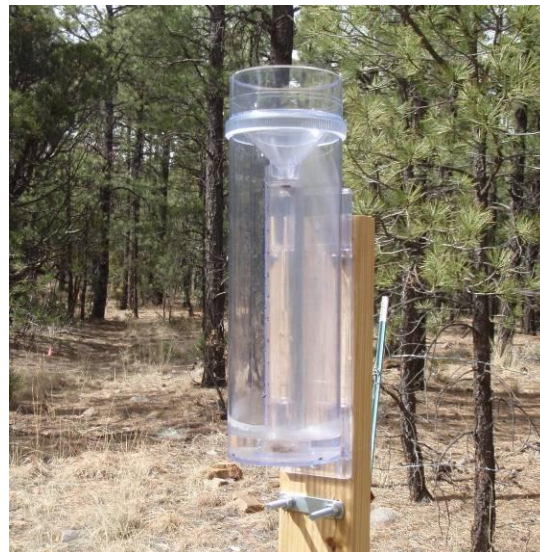
**Figure 2.2. Graduated rain gauges are used for backup in the case of failure from one of the WatchDog weather stations.**

checked monthly when Time Domain Reflectometer (TDR) soil moisture and temperature readings are taken (with a Field Scout TDR 200 unit) and mineral oil is added to these gauges to prevent evaporation of water collected. The WatchDog stations are set to record ambient temperature, soil moisture 10 cm (4 inches) below the soil surface (-10 cm), and soil temperature -10 cm, all at one-hour increments. Soil moisture and temperature data from each WatchDog station provide baseline comparisons for the Field Scout TDR 200 soil water content and soil temperature data that are sampled monthly at each study plot. All data from the stations are off-loaded approximately every three months and entered into a database. Summaries for precipitation, ambient temperature, soil moisture, and soil temperature from 2009 on the Westponderosa site and the Kelly piñon/juniper woodland site are presented as examples below.

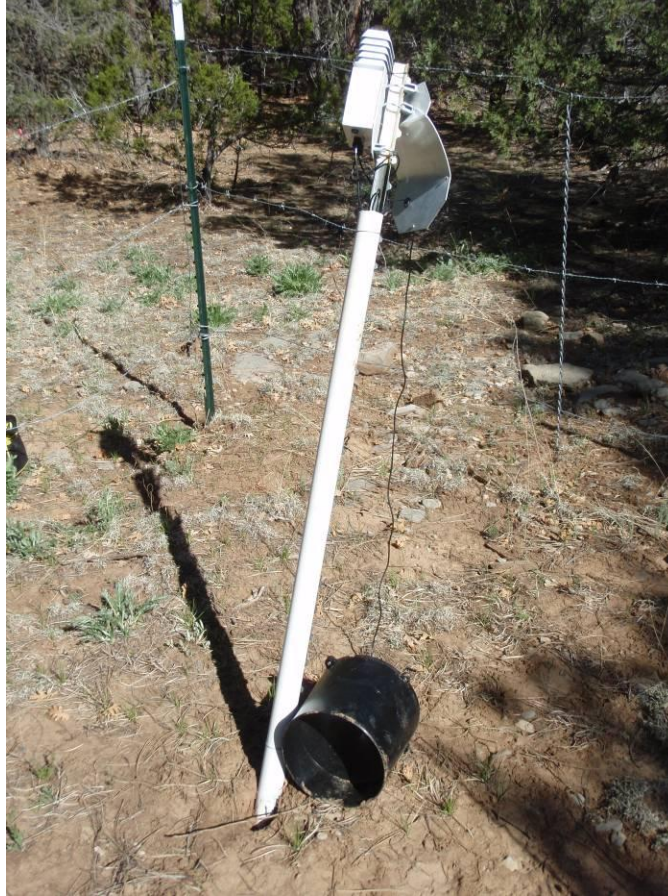
**Figure 2.5. Photo taken in April 2009 showing initial bear damage caused to the WatchDog station.**

Precipitation was not recorded at the Chilili ponderosa sites on either WatchDog weather station from sometime in December 2008 until November 4, 2009. However, the graduate cylinders that serve as a backups to the WatchDog stations recorded the precipitation events during this period, but only on a monthly basis (not daily), which makes it difficult to analyze flow events. The likely cause of this malfunction was due to black bear (*Ursus americanus*) damage, which occurred throughout 2009. The bear activity resulted in one of the WatchDog rain buckets being removed from the station and subsequently needing replacement (Figure 2.5). Bear activity also managed to unplug the other rain bucket from the unit, causing no precipitation to be recorded. This precipitation bucket, however, was functional once plugged back into the unit.

In order to prevent future damage from bear activity at this site, an electric fence was built around one of the stations during summer 2009 with a “dummy” fence set up around the other (Figure 2.6). Unfortunately, the dummy fence failed to keep a bear out of the station, and sometime in the fall the rain gauge was once again disturbed (Figure 2.7). To further protect the rain gauges, the dummy fence will be equipped with a charging unit in spring 2010 once purchased and should prevent any further damage to the WatchDog stations.

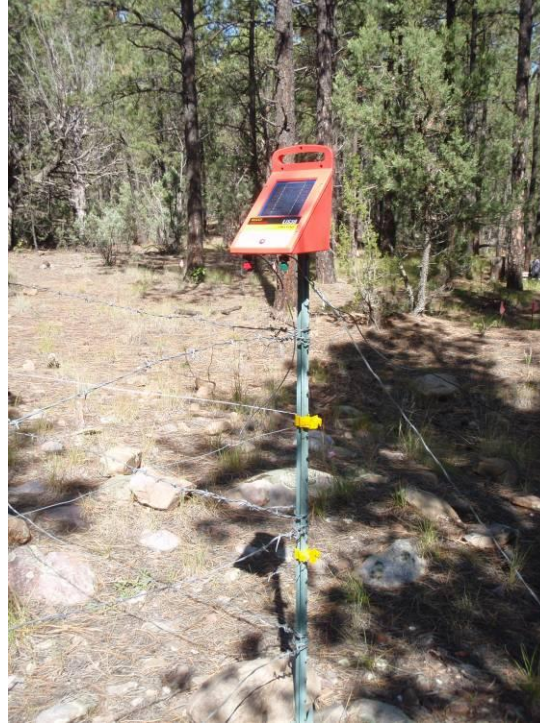
**Figure 2.6.** Charging station for the electric fence constructed around the WatchDog station at the Chilili ponderosa pine study site in 2009 to combat the bear problems.

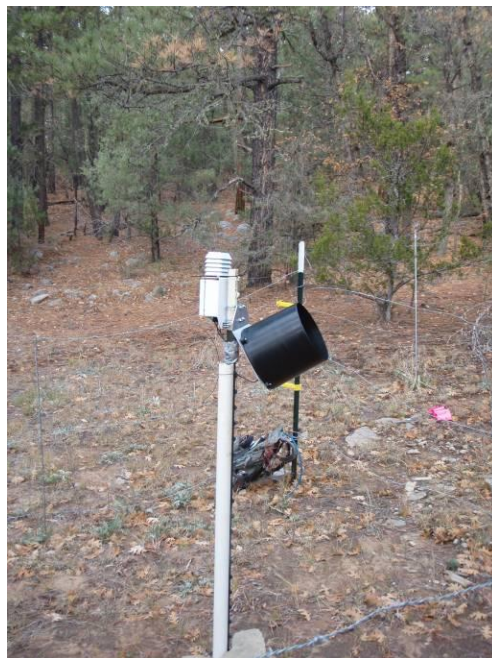
**Figure 2.7.** Photo taken October 27, 2009, at the Chilili ponderosa pine site showing bear damage to the precipitation bucket causing precipitation not to be recorded.

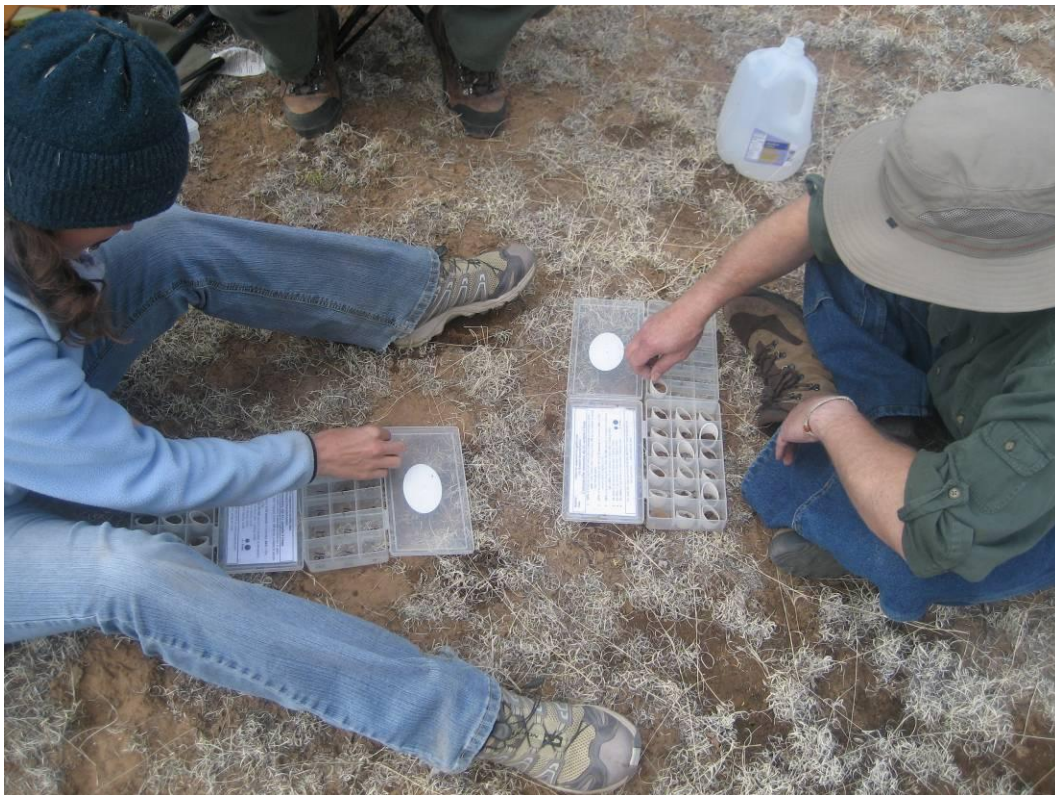
**Figure 2.18. Soil stability test in use on the study sites.**

Soil surface stability was measured and scored in May 2009 using the Soil Stability Test Kits developed by the USDA Agricultural Resource Service (Herrick et al. 2005) (Figure 2.18). Further details of the measurement methods and a review of the literature can be found in the 2008 Monitoring Plan (SWCA 2008). Figure 2.19 provides average soil surface stability scores for each of the eight subplots representing each of the vegetation and soils sampling plots from the four sites (Chilili, Kelly, Vigil, and Wester). Scores are partitioned by subplot and overstory vegetation canopy type. Figure 2.20 provides average soil subsurface (1 cm below the soil surface, or -1 cm) stability scores for each of the eight subplots.

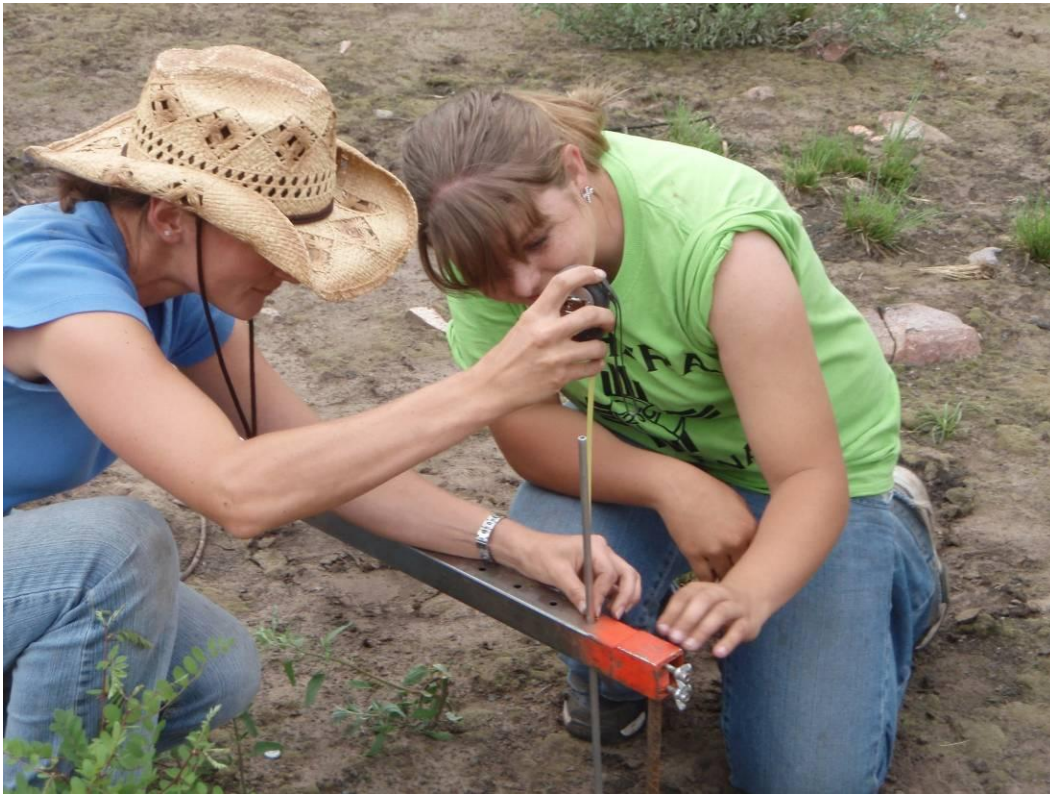
**Figure 2.21. Measurement of soil surface topography using a soil movement bridge helps understand the yearly variability associated with soil topography.**

Soil movement was monitored using soil movement bridges (called soil erosion bridges in the 2008 report) (Figure 2.21) modeled after White and Loftin (2000). Permanent bridge support posts were installed at consistent, systematically determined, and unbiased locations at one of each of the vegetation and soil subplots for a total of three bridges at each paired plot at all four sites. Please refer to the 2008 Annual Report for detailed monitoring protocols and literature associated with soil movement (SWCA 2009). Figure 2.22 shows the micro-soil topography profile from the Wester ponderosa pine site for both 2008 and 2009. The graph clearly shows the yearly variability associated with soil movement on a plot. The processes of soil erosion and soil deposition can clearly be seen when plotting data from 2008 and 2009. After thinning treatments are completed, post-treatment data will be available to compare with pre-treatment data. These comparisons will allow us to assess the changes in soil movement potentially caused by restoration treatments. Over a series of years, this study will document losses and/or gains to the soil surface profiles at each bridge site and will provide average values for each of the eight plots in this study (Chilili, Kelly, Vigil, and Wester).

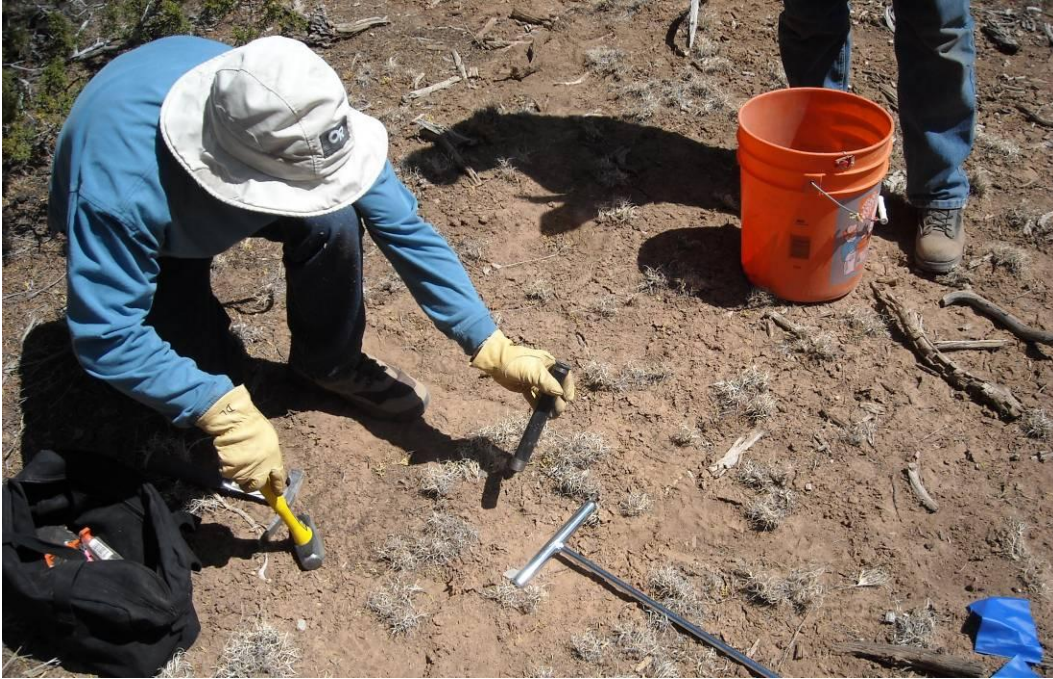
**Figure 2.23. Soil cores were taken using an impact corer, shown above, for chemical analysis.**

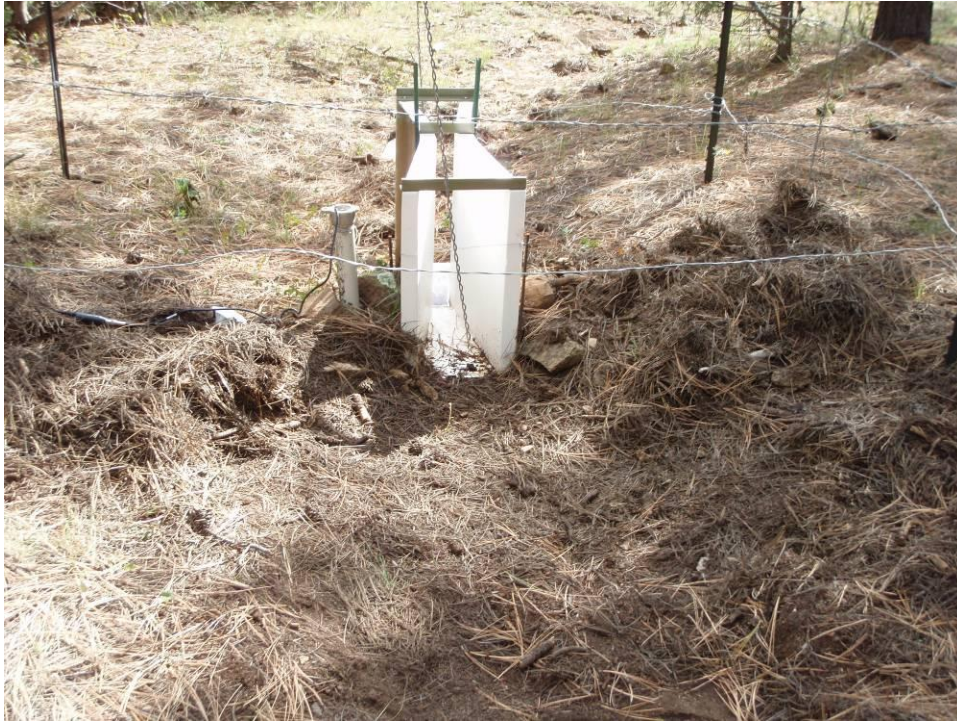
**Figure 2.29. Parshall flume located at Chilili site plot 1.**

Monitoring flumes (Parshall flumes) complete with pressure transducers were installed at study sites in order to study impacts of tree thinning to surface flow. For study this, flumes were installed at all four monitoring sites (Figure 2.28). For more detailed information on the methodology, site location, and relevant background information, please refer to the 2008 Monitoring Plan (SWCA 2008). Since the Chilili watershed information was not included in the 2008 report, both figures of the flumes (Figure 2.29 and Figure 2.30) and watershed map (Figure 2.31) are included. A complete table (Table 2.1) of all the subwatershed acreages is included with data that were not presented in the 2008 Annual Report.

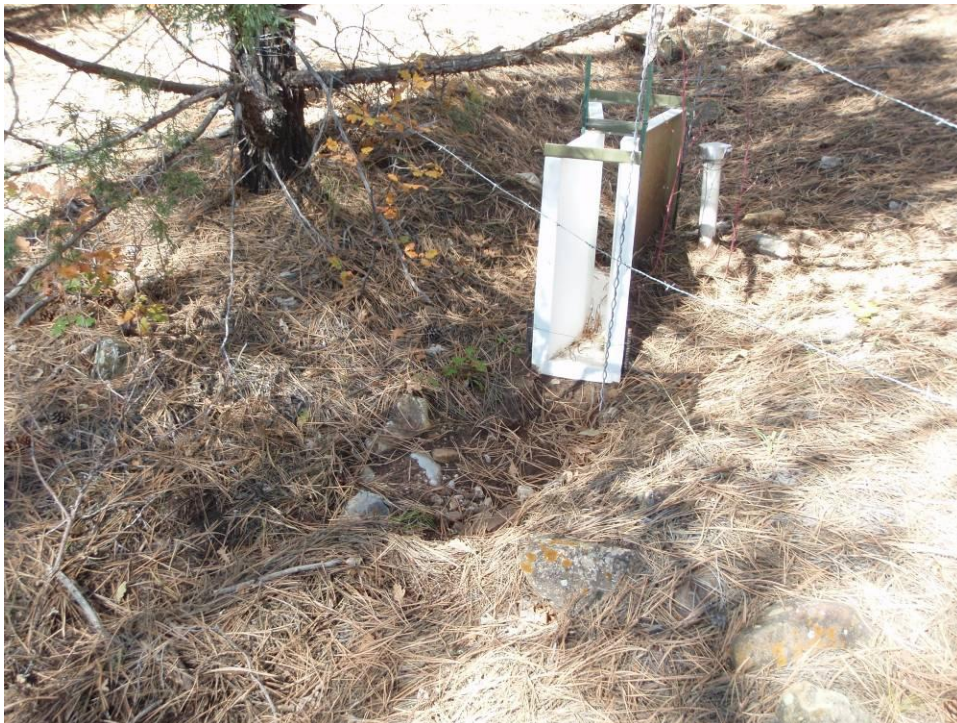
**Figure 2.30. Parshall flume located at Chilili site plot 2.**

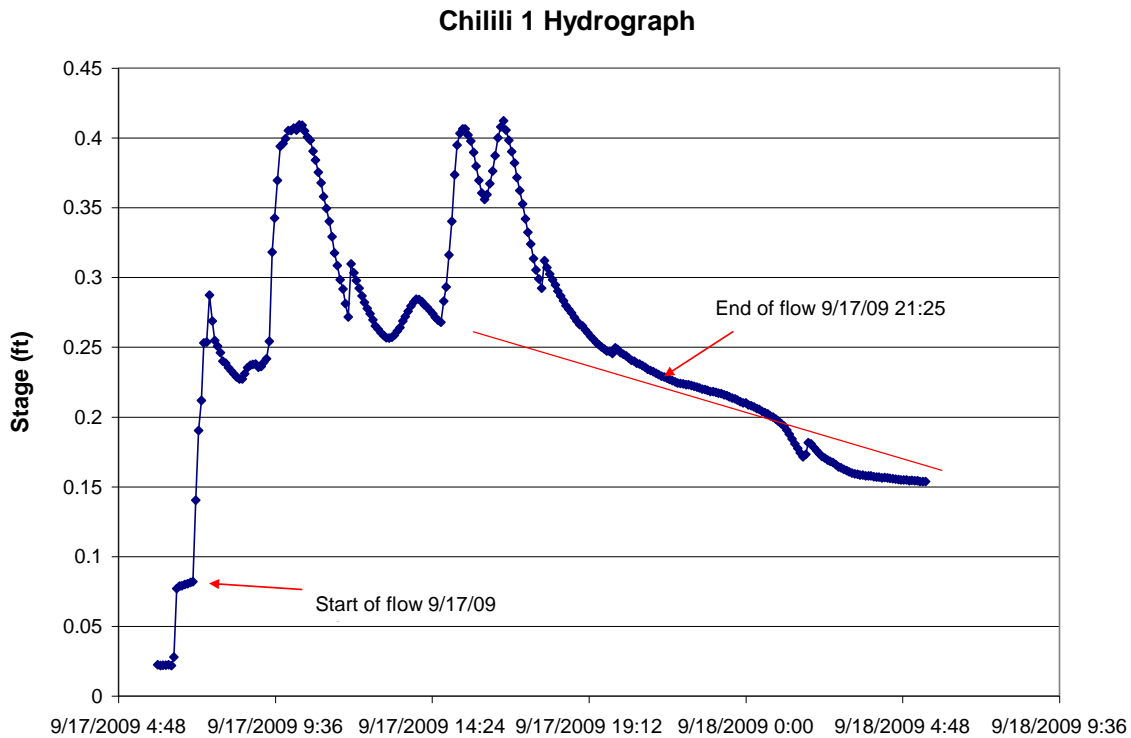
**Figure 2.32. Hydrograph showing a flow event on Chilili subwatershed 1 on September 17, 2009.**

Based on the height of water recorded, the flow can be determined, as can the total volume of water leaving the watershed. Figure 2.32 is a hydrograph from the Chilili plot 1 subwatershed showing a flow event with indicators of when the event started and stopped. The drainage area feeding into each flume has been delineated, and the acreage of each watershed can be seen in Table 2.1 above. Information was then controlled for precipitation, which was accomplished by comparing the flume data with those data downloaded from the WatchDog weather stations installed near each flume. These data also provide an indication of the ratio between total volume of precipitation and total volume of runoff (the rainfall/runoff ratio).

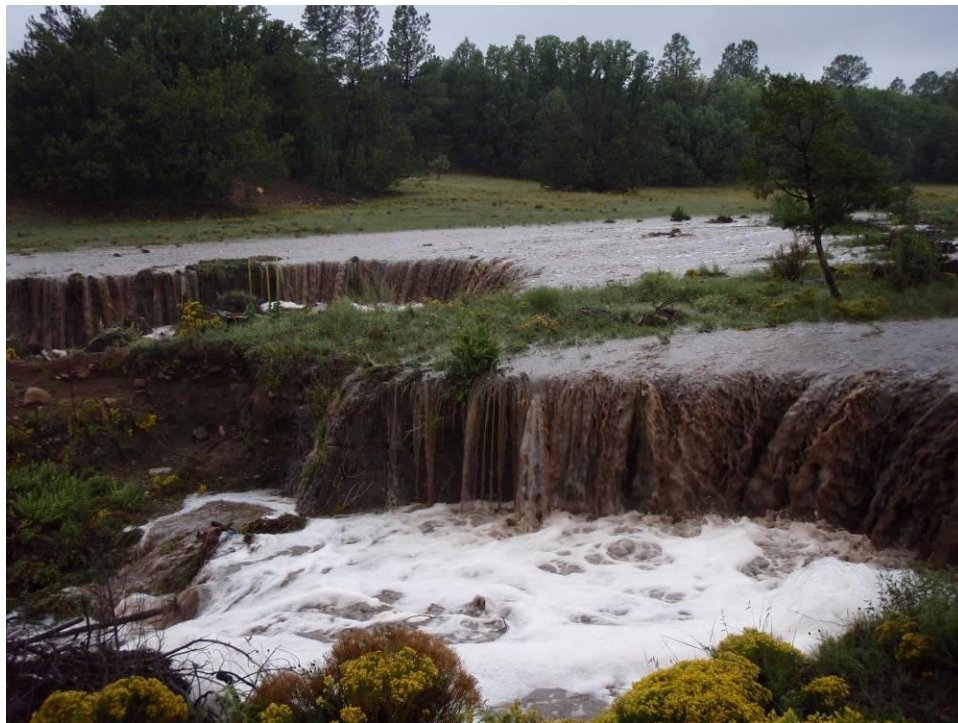
**Figure 2.33. The two-day storm event on September 16–17, 2009, caused high flows to occur at the Vigil site, which recorded nearly 2 inches of rain over the course of 36 hours.**

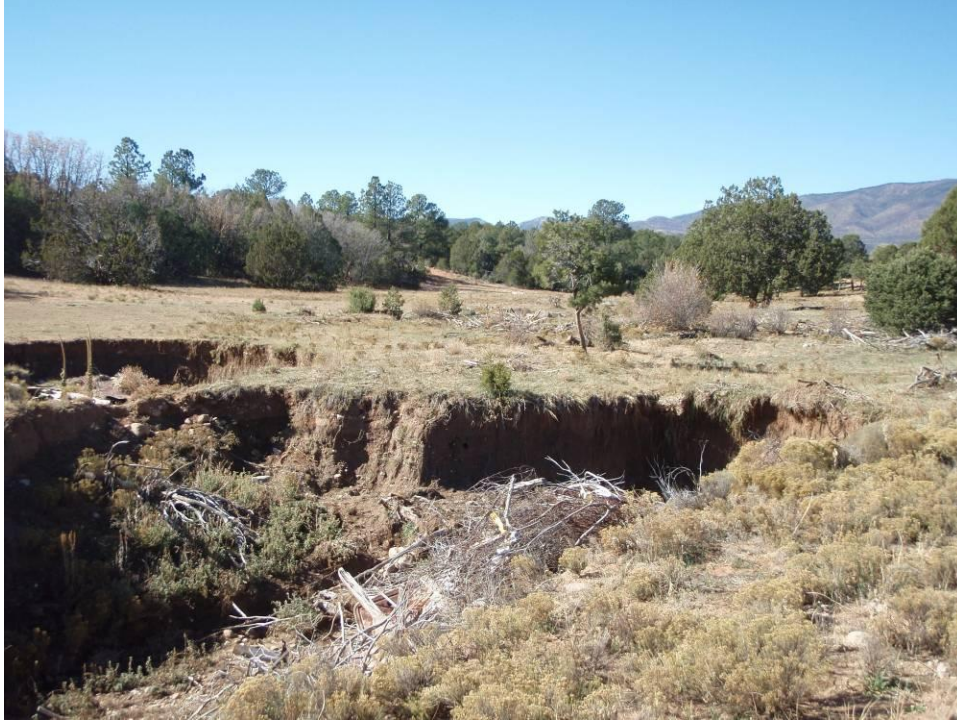
**Figure 2.34.** Photo taken in November 2009 at the Vigil site showing the once-raging arroyo as a dry headcut.

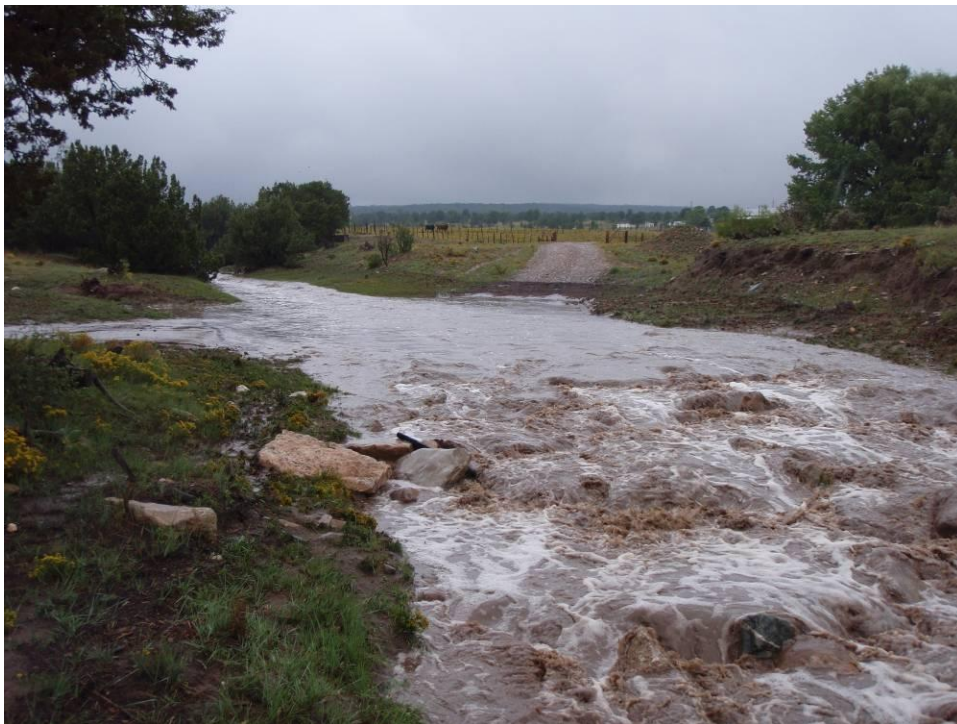
**Figure 2.35.** A normally dry arroyo flows bank full at the Vigil site during the storm occurring on September 17, 2009.

A widespread rain storm event took place on September 16 and 17, 2009, which dropped an average of nearly 2 inches of rain over the eastern slopes of the Manzano Mountains. The precipitation amounts varied across the sites (Table 2.6). Due to the unique nature of each site, not all flumes recorded flow. The largest and longest flow events were seen at Chilili site plot 1; however, since the rain gauge was not recording during this event, it is impossible to say how much precipitation fell on site causing these flows. What is known, however, is that this flow event lasted over nine hours and resulted in a total volume of flow of nearly 8,000 ft<sup>3</sup>. This storm event occurred during the fall sampling period, allowing us to take photographs of this unique hydrologic event. Figure 2.33 and Figure 2.34 show before and after pictures of overland flow occurring at the Vigil site. Figure 2.35 shows a normally dry arroyo flowing at bank full at the Vigil site, while Figure 2.36 shows the Bouton sites during the storm event. Notice the flow is sediment laden, which means high levels of surface or channel erosion was occurring on the surrounding landscape.

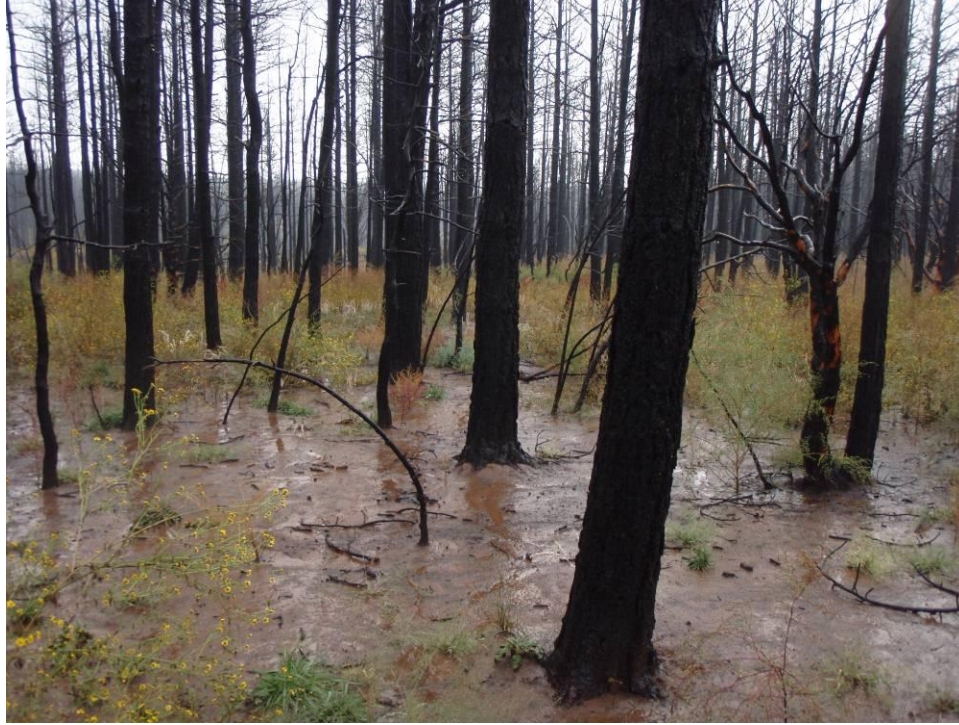
**Figure 2.36. Overland flow and erosion occurring at the burned Bouton site, which received more than 1.8 inches of rain on September 16–17, 2009.**

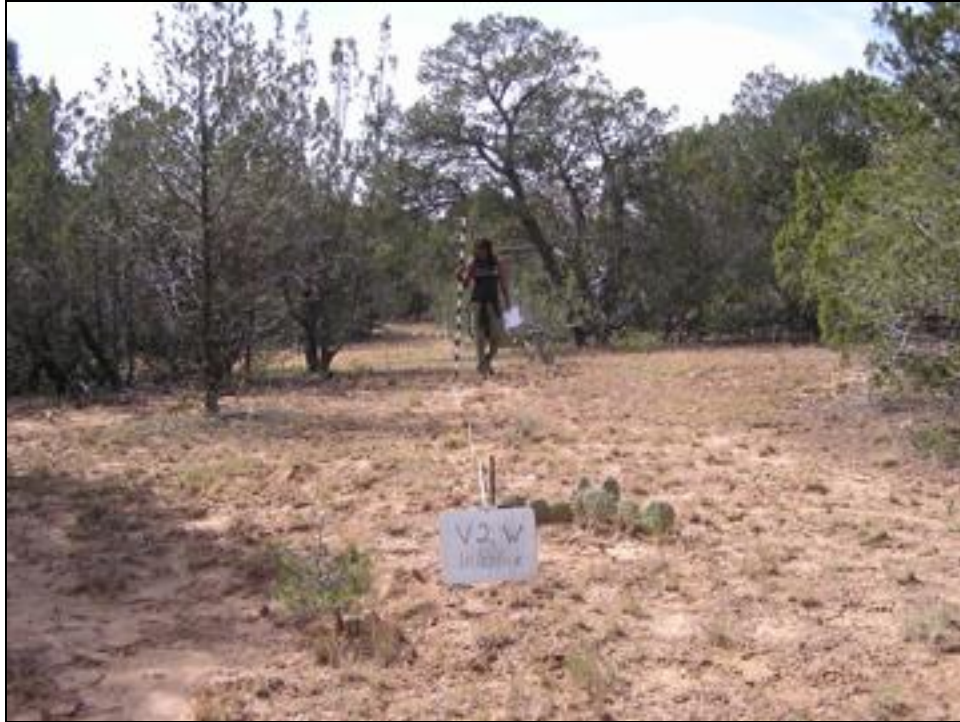
Figure 2.39. Photograph of vegetation structure pole used to quantify vertical vegetation canopy structure (photograph taken in 2008).

Vegetation vertical canopy structure was measured on each of the four vegetation and soils subplots. The method was adapted from Herrick et al. (2005) and consisted of a 2-m-long (6.5-foot-long), 5-cm-diameter (2-inch-diameter) white Polyvinyl chloride (PVC) pipe pole partitioned into three different 2-m (6.5-foot) height layers, each with continuous 10-cm (4-inch) black/white increment markings (Figure 2.39). The 2-m PVC measurement pipe was partitioned into four different vertical 0.5-m segments or heights above the ground surface: segment one = 2.0–1.5 m, segment two = 1.5–1.0 m, segment three = 1.0–0.5 m, and segment four = 0.5–0.0 m above the ground surface. An observer recorded vegetation canopy obstruction of the black and white marked areas on the pole, while another person held the pole vertical at three locations across the center line of each 30-m (98-foot) vegetation and soils monitoring subplots, one reading at 10 m (33 feet), one at 20 m (66 feet), and one at 30 m (98 feet). The observer was located 10 m (33 feet) toward the center of the plot from the pole for each canopy measurement. An overall visual obstruction average score was then calculated for each segment of the pole over each of the three lines per subplot, and an overall average score for each segment was then calculated for each plot. Scores for the Kelly and Wester plots are shown in Figure 2.40. Vertical vegetation structure at all four segments was similar between paired plots at the Kelly piñon/juniper site, and between the plots at the Wester ponderosa pine site. Monitoring vertical vegetation structure profiles is not only important for assessing wildlife habitat, but also for fire fuels structure.

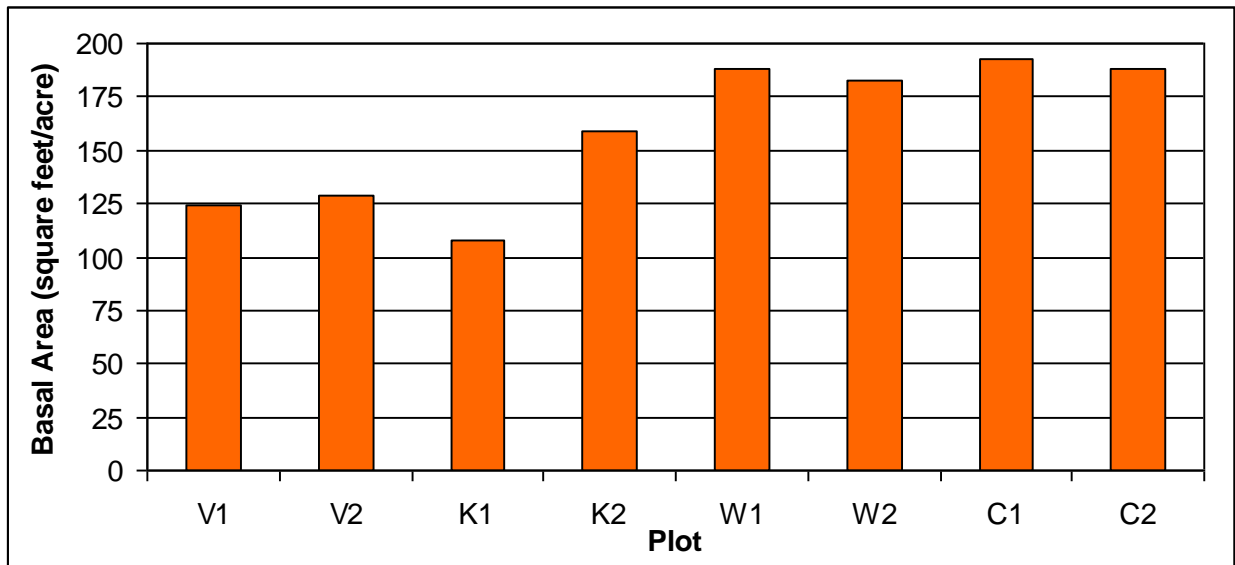
**Figure 2.41. Average basal area for each thinning plot for all species of trees combined, measured using the cruisers crutch method; C= Chilili, K = Kelly, V = Vigil, and W = Wester.**

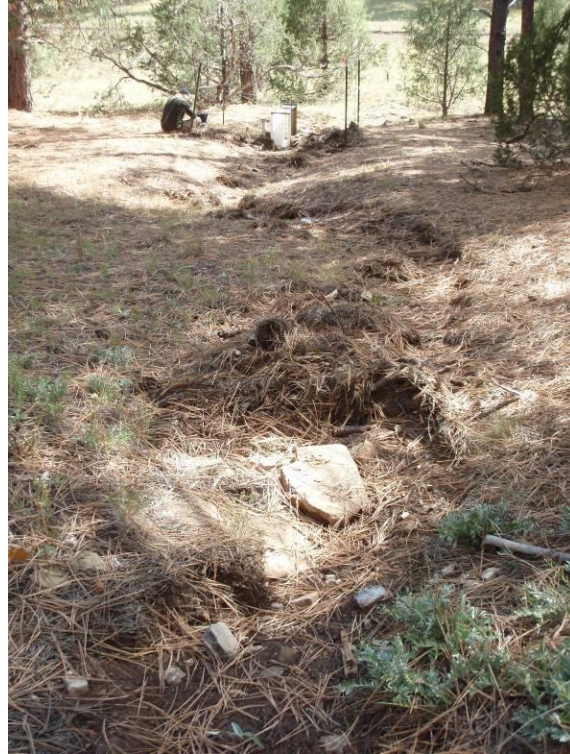
**Figure 2.45. Continuous litter and duff cover and accumulations in an arroyo at Chilili 1.**

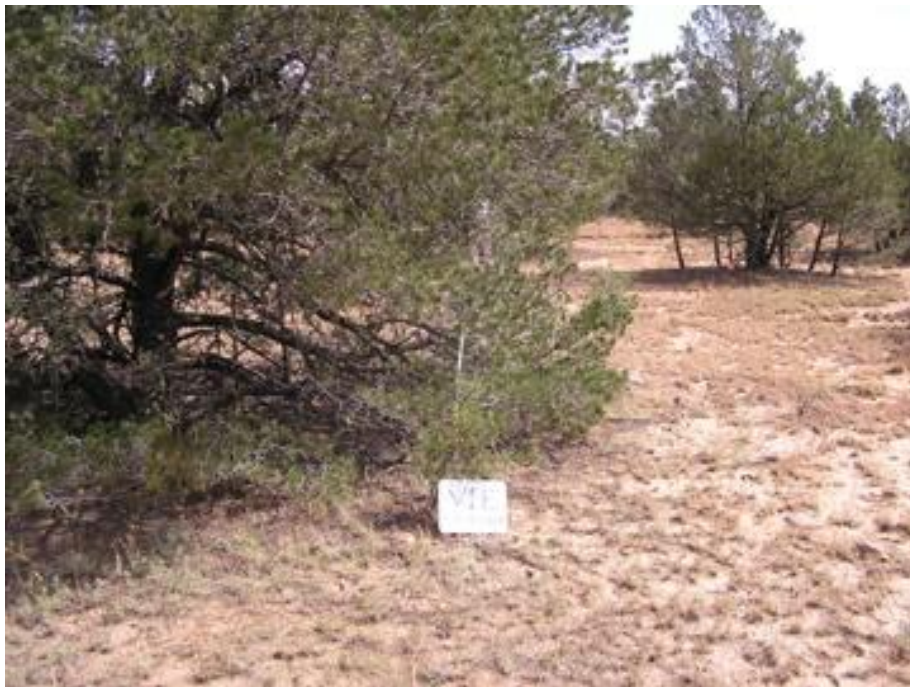
**Figure 2.46. Patchy cover of litter and duff at Vigil 1.**

With reference to Figure 2.43, the piñon/juniper plots tended to have a slightly higher accumulation of 1-hour fuels (fine fuels 0.0–0.6 cm [0.00–0.25 inches] in diameter) compared to the ponderosa plots. Conversely 1,000-hour fuels (woody debris > 8 cm [3 inches] in diameter) were more common at the ponderosa sites, particularly Chilili 2. Each paired plot was relatively consistent in terms of fuel loading by size class (see Figure 2.43). Figure 2.44 shows that Chilili 2 had considerably more duff than the other plots. Interestingly both Chilili plots had greater duff depths than litter, while the Wester site had greater litter than duff. The volume of litter and consequently duff found on the forest floor is related to both productivity and decomposition. The variation in litter and duff between the Wester and Chilili sites could be related to differing decomposition rates as a result of differences in elevation and moisture regimes. Decomposition has been found to be positively correlated with moisture gradient with greater decomposition on more productive sites (Keane 2008), this would explain the greater depths of duff at Chilili (a higher elevation and more productive forest) versus Wester (a lower elevation, dryer and more open stand forest). Overall duff and litter depths were higher on the ponderosa plots (Figure 2.45) than the piñon/juniper sites, which is to be expected since litter and duff cover in ponderosa pine is almost continuous across the landscape while litter and duff is isolated in patches immediately below the canopies of trees in piñon/juniper woodlands (Figure 2.46).

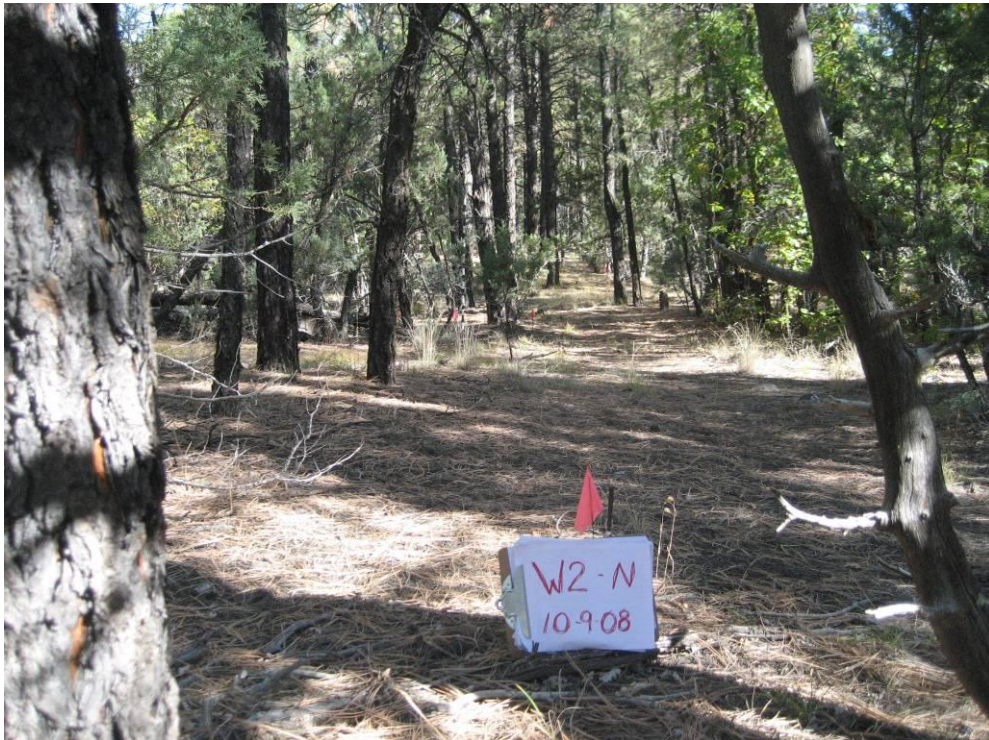
**Figure 2.48.** Wester 2, showing the low fuel loading on the plot and lack of large-diameter dead and downed fuels

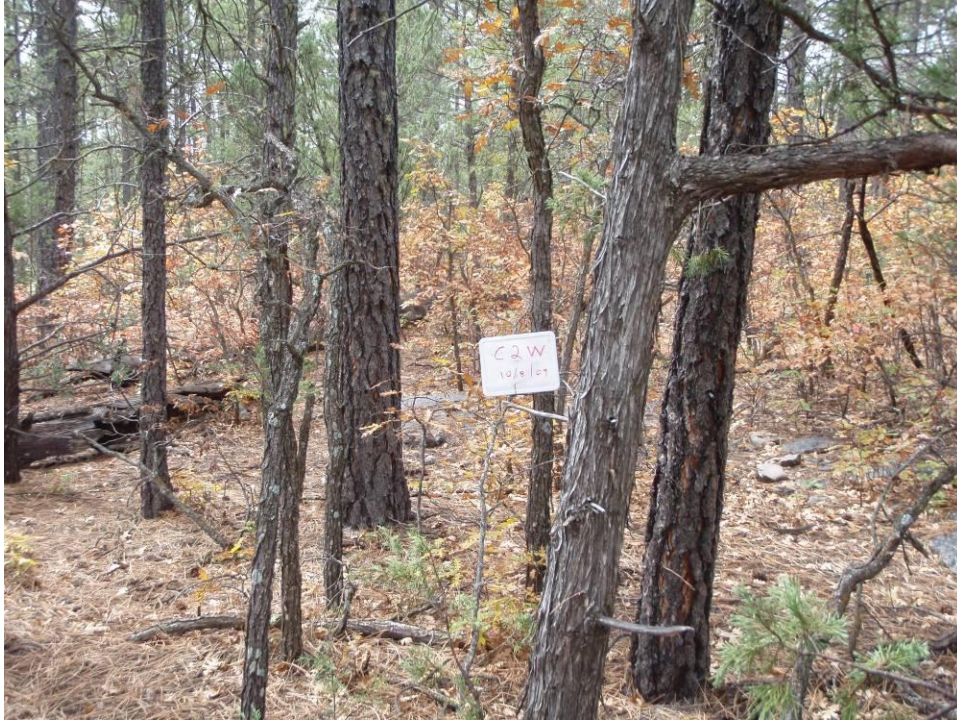
**Figure 2.49. Chilili 2, showing high fuel loading with evidence of large diameter dead and downed fuels.**

loadings than all other sites; this is a dense plot with many more 1,000-hour fuels (many downed trees and stumps) (Figure 2.49), which raised its total tons/acre.

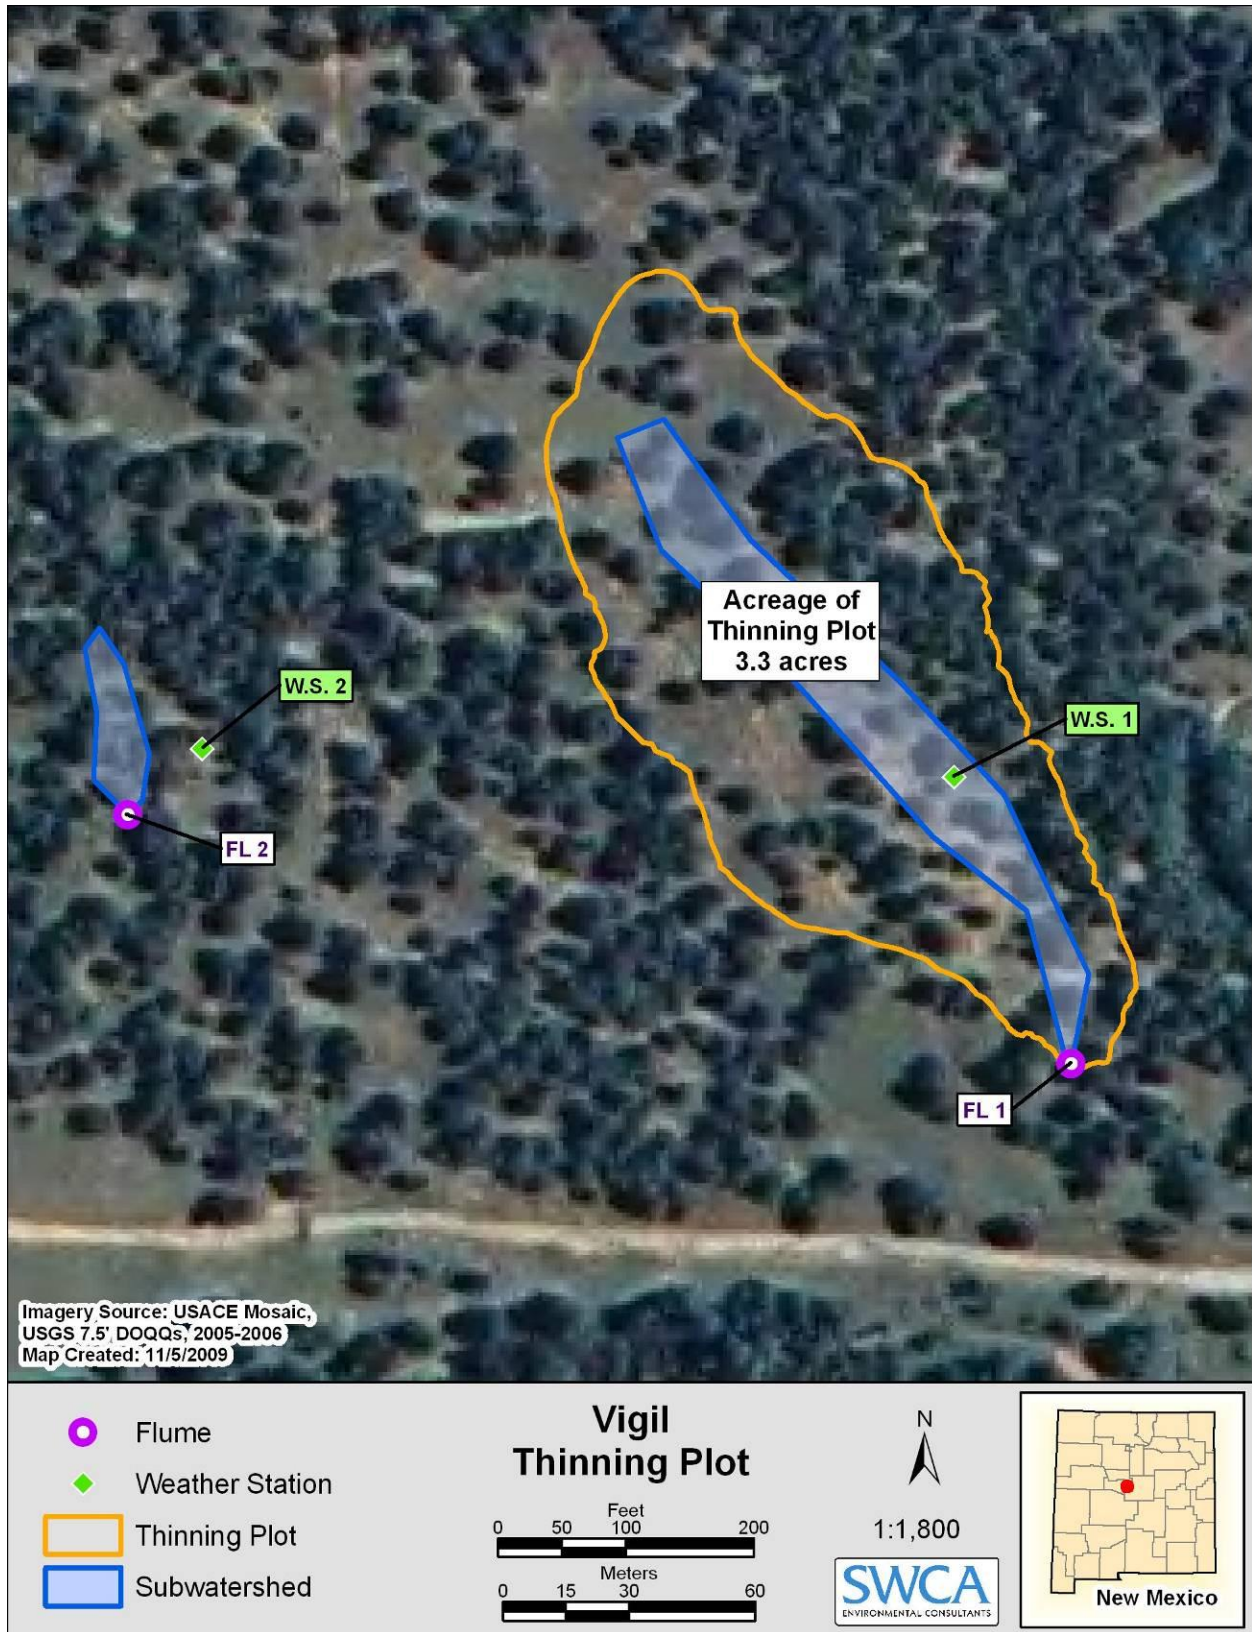
Figure 2.59. Vigil forest thinning monitoring plots showing the proposed thinning treatment boundary around plot 1.

One study plot of each forest thinning monitoring pair (plots 1 and 2) was randomly selected to be treated with the standard prescribed thinning treatment (piñon/juniper or ponderosa pine prescriptions) in early 2010. The minimum proposed area and boundaries for thinning treatments were determined for each of those four plots, and mapped with a sub-meter accuracy global positioning system (GPS) unit in October and November 2009. These GPS coordinates were used to produce geographic information system (GIS) maps of the proposed treatment areas and boundaries for each of the four treatment study plots (Figure 2.57 through Figure 2.60). The proposed thinning treatment areas for each of those plots includes the entire subwatershed that was previously defined and mapped in 2007, the vegetation/soils measurement plot, and the mammal and bird sampling plot, all within the area of each treatment plot to be thinned. A minimum treatment buffer area of 10 m (33 feet) was extended from the boundaries of each subwatershed and study plot to ensure that all areas from which soil, hydrology, vegetation and animal measurements are being collected are thinned on those treatment plots. Actual forest thinning treatments are scheduled to take place during early 2010, prior to spring (May/June) monitoring measurements on the study plots.

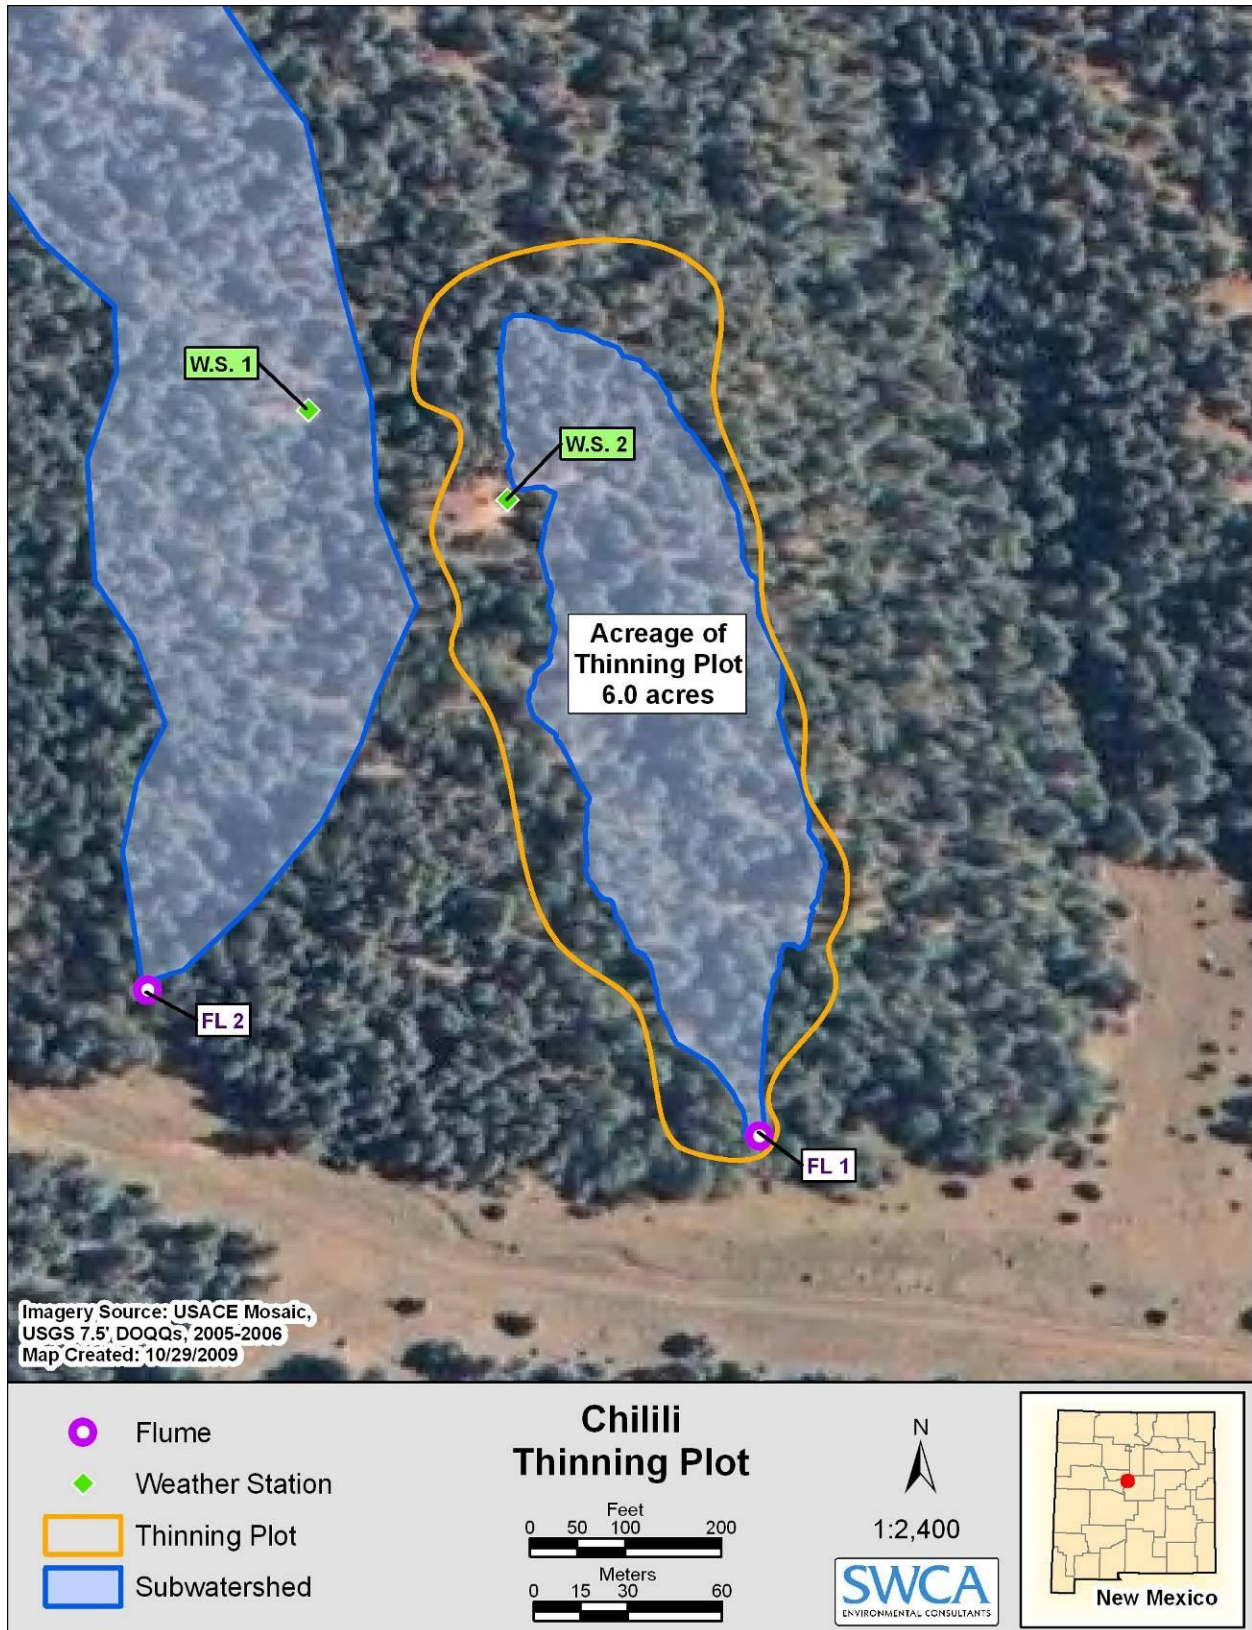
Figure 2.60. Chilibi forest thinning monitoring plots showing the proposed thinning treatment boundary around plot 1.

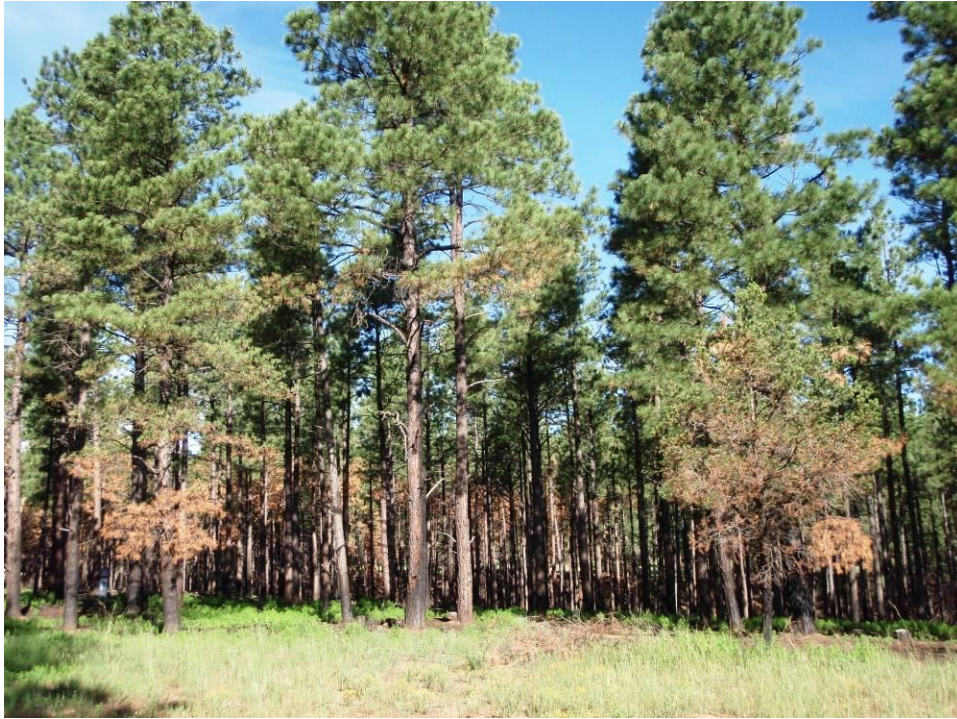
**Figure 3.1.** Typical low burn severity plot in the Trigo burn area.

The Trigo post-fire monitoring plots were selected in Arroyo de Cuervo (Cuervo 1 and Cuervo 2) and in the Arroyo de Manzano (Manzano1) watersheds. Three low-severity (Figure 3.1) and three high-severity (Figure 3.2) plots were identified in each watershed, and three unburned plots were located across the watersheds. With the permission of landowners, the plots were selected on seven different private parcels of land: Bouton (BOU), Sanchez (SAN), Manzano Mountain Retreat (MMR), Salazar (SAL), Candelaria (CAN), Mitchell (MITT), and Neff (NEFF), totaling 21 plots for the entire study (Figure 3.3).
