**ESTANCIA BASIN WATERSHED HEALTH AND MONITORING PROJECT:  
2009 ANNUAL REPORT**

**ESTANCIA BASIN WATERSHED HEALTH, RESTORATION AND MONITORING  
STEERING COMMITTEE**

**SWCA<sup>®</sup> ENVIRONMENTAL CONSULTANTS**

March 2010

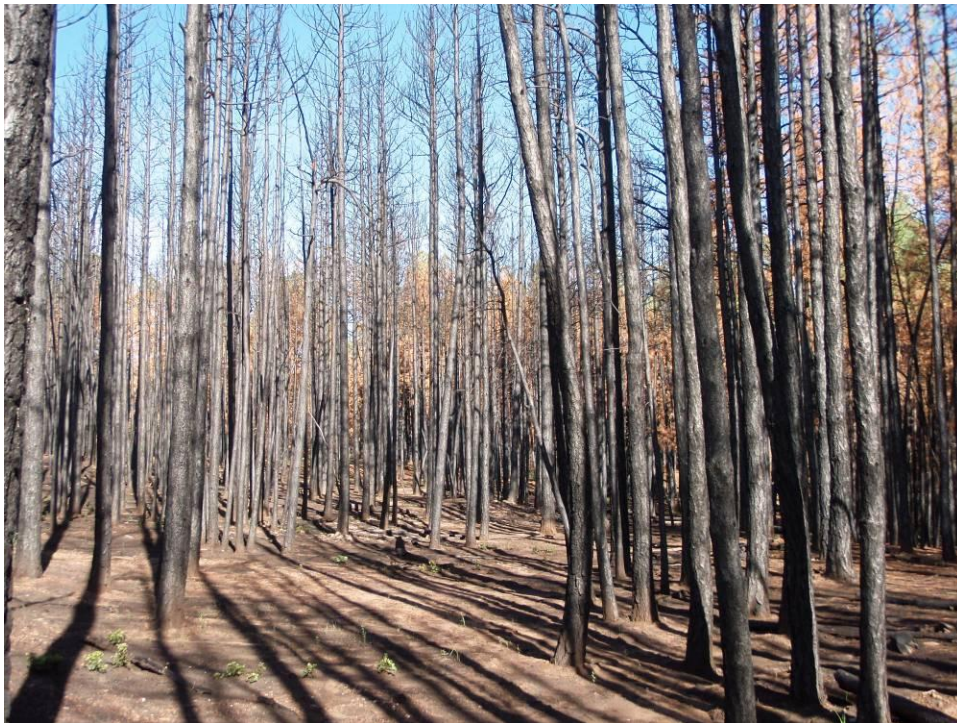
**Figure 3.2.** Typical high burn severity plot in the Trigo burn area.

The Trigo post-fire monitoring plots were selected in Arroyo de Cuervo (Cuervo 1 and Cuervo 2) and in the Arroyo de Manzano (Manzano1) watersheds. Three low-severity (Figure 3.1) and three high-severity (Figure 3.2) plots were identified in each watershed, and three unburned plots were located across the watersheds. With the permission of landowners, the plots were selected on seven different private parcels of land: Bouton (BOU), Sanchez (SAN), Manzano Mountain Retreat (MMR), Salazar (SAL), Candelaria (CAN), Mitchell (MITT), and Neff (NEFF), totaling 21 plots for the entire study (Figure 3.3).

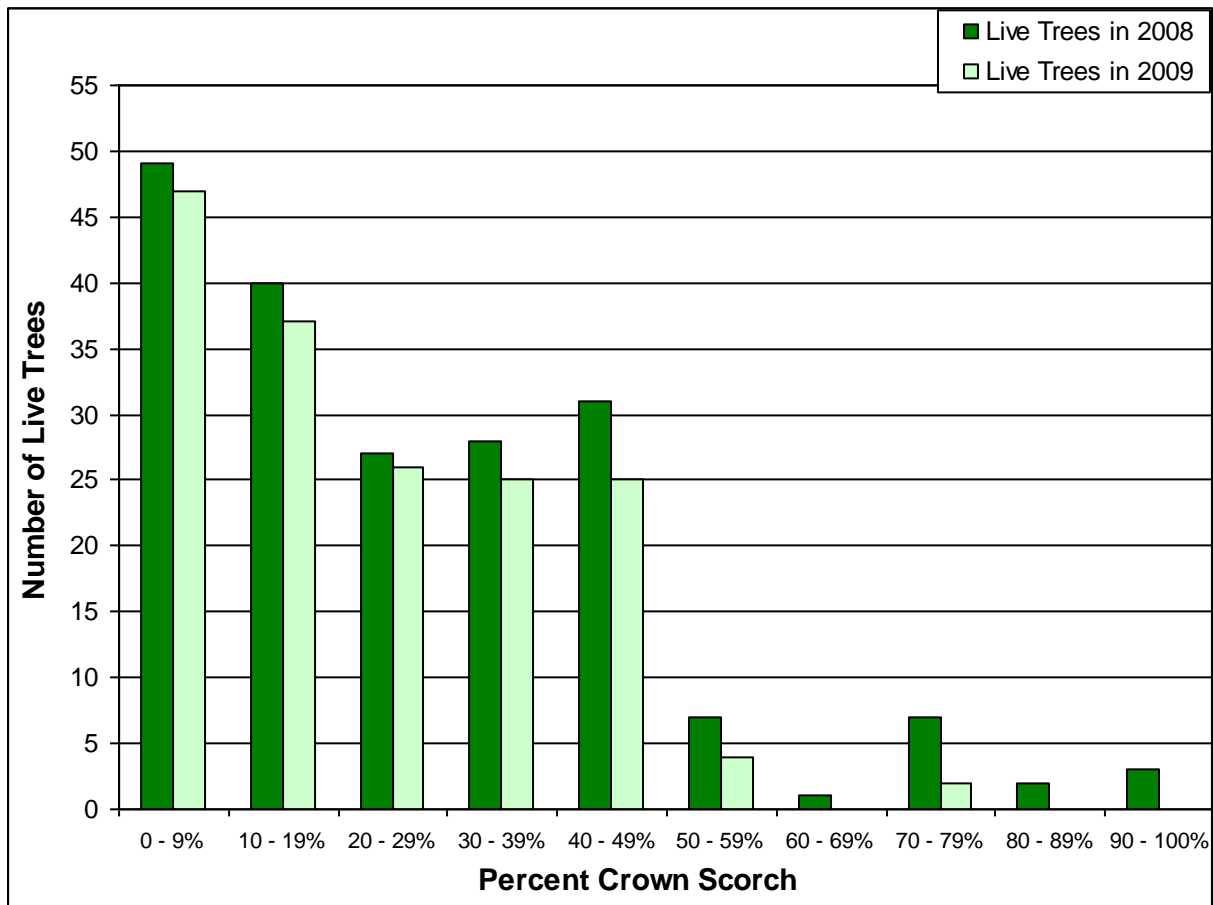
**Figure 3.4. Number of live trees in relation to percent crown scorch recorded during 2008 measurements.**

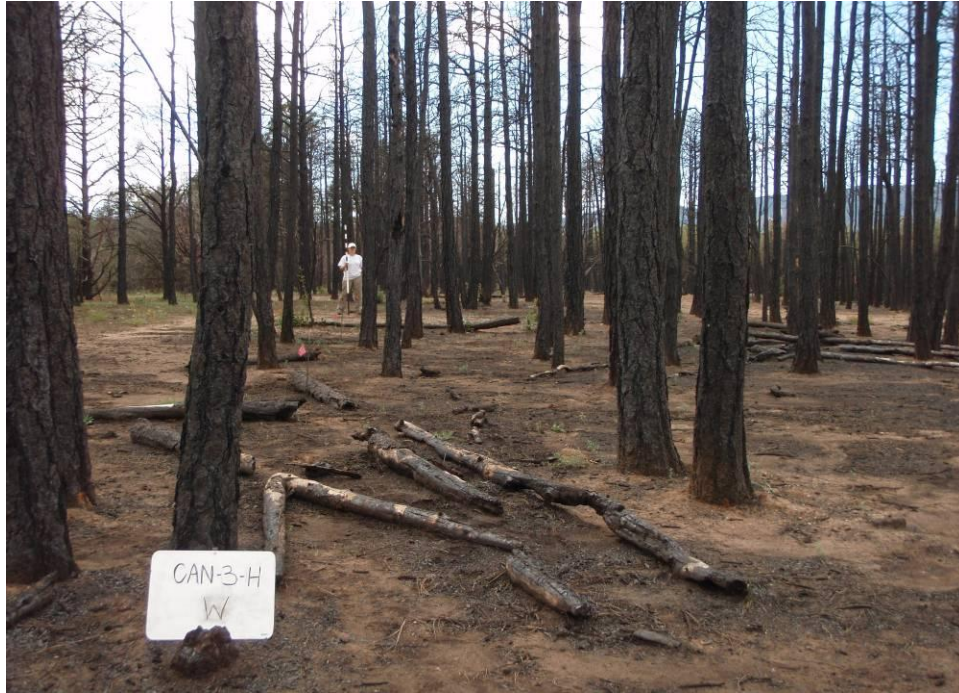
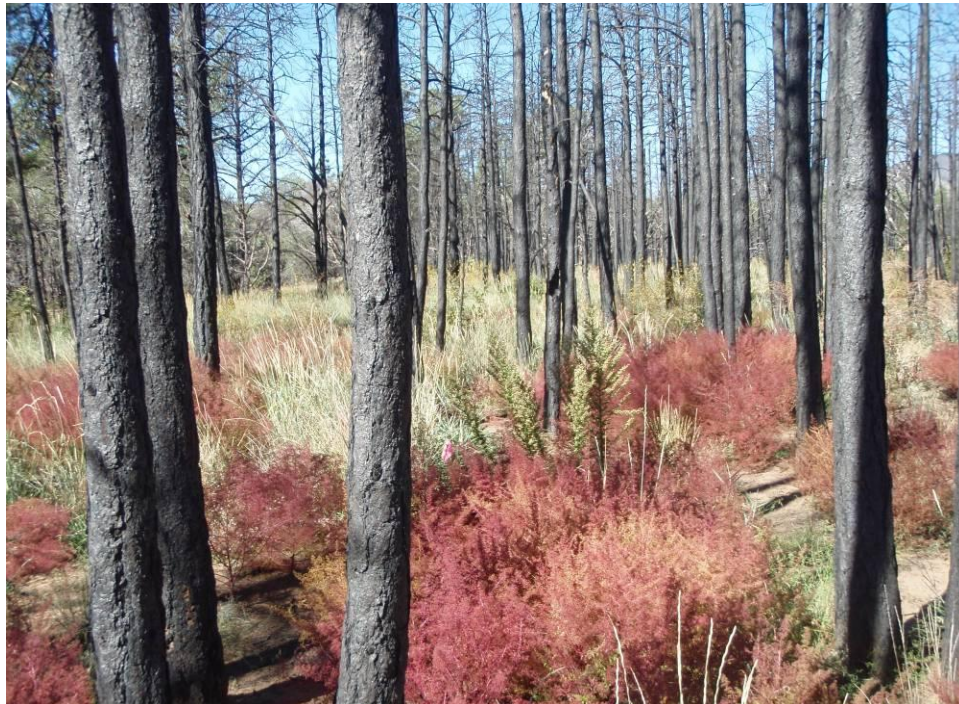
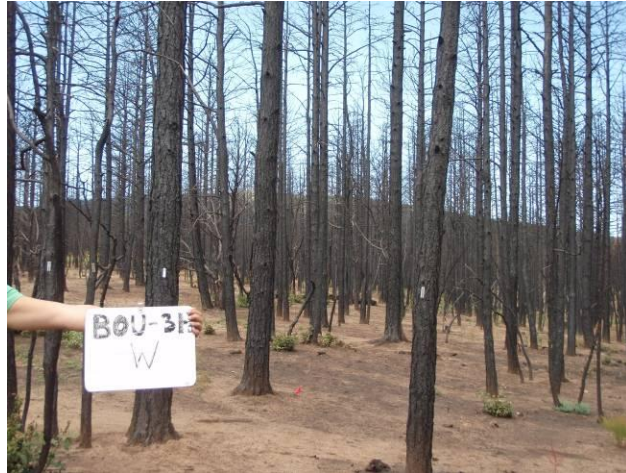
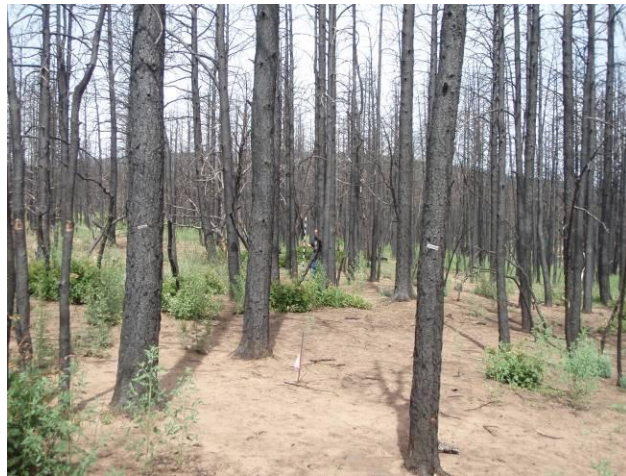
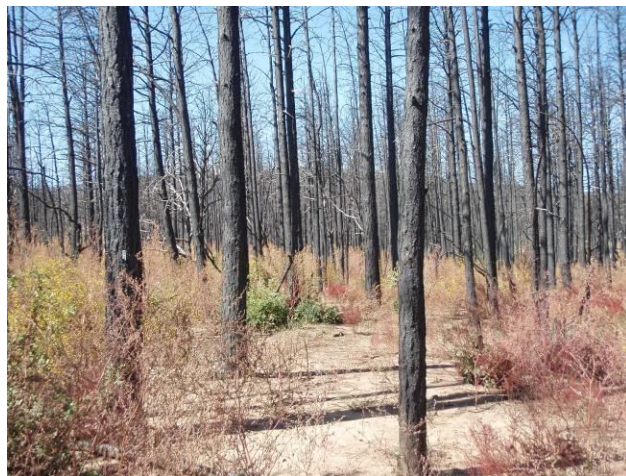
**Figure 3.5. Candelaria high severity (fall 2008).**

**Figure 3.6. Candelaria high severity (fall 2009).**

**Figure 3.7. Bouton 3 High West (fall 2008).**

**Figure 3.8. Bouton 3 High West (spring 2009).**

**Figure 3.9. Bouton 3 High West (fall 2009).**

Herbaceous vegetation measurements were carried out in fall 2008, spring 2009, and fall 2009. Dramatic changes in ground cover were observed over this time period, particularly for the high-severity plots (Figure 3.5–Figure 3.9).

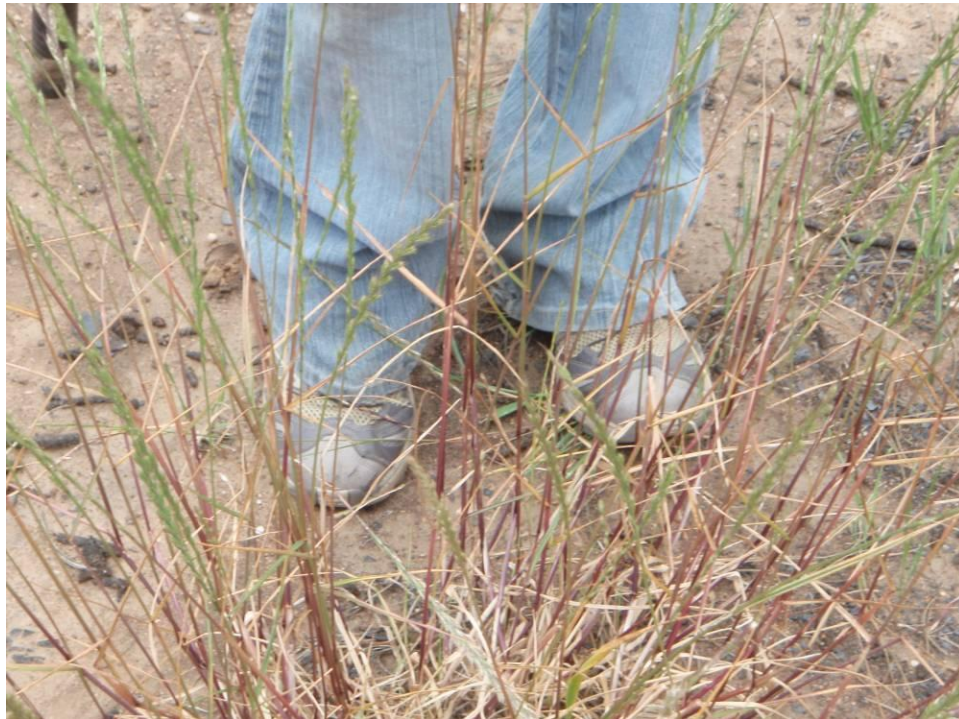
**Figure 3.22. Seeded Italian ryegrass on a high-severity plot, spring 2009.**

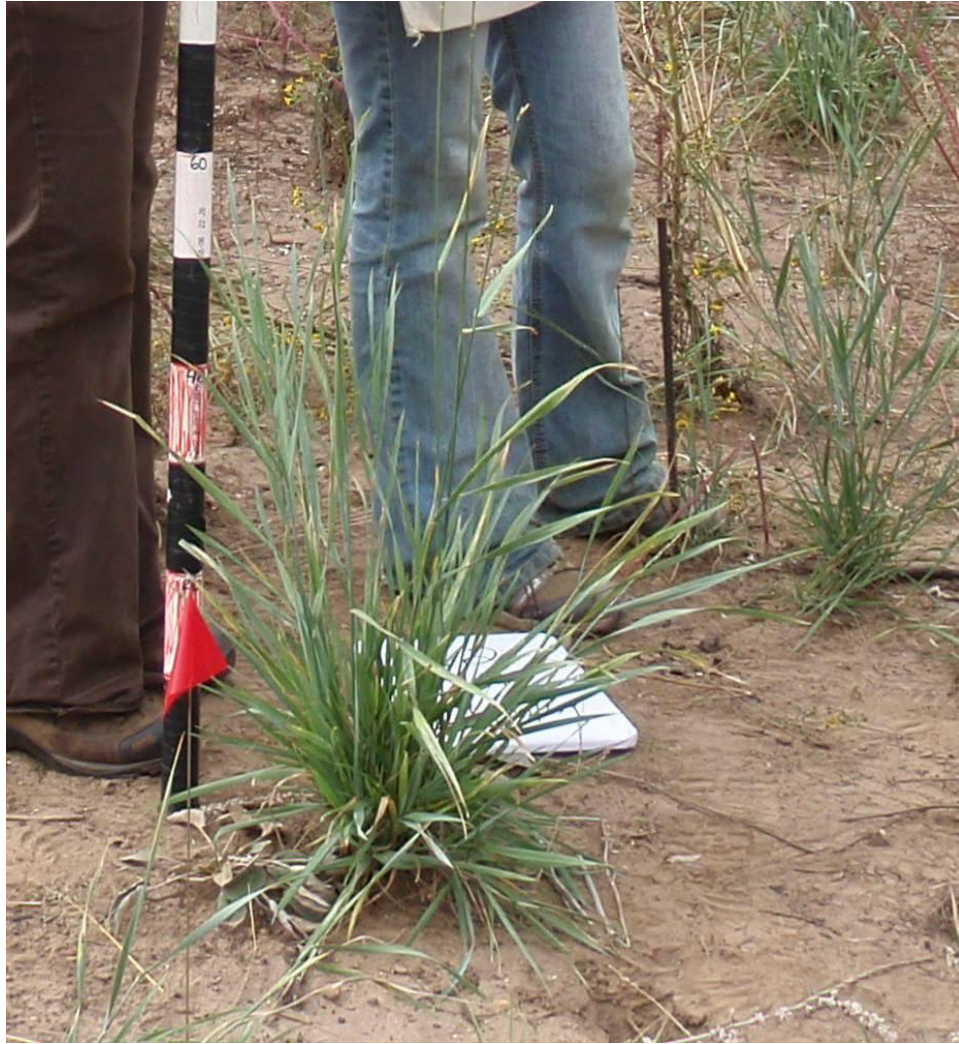
**Figure 3.23. Seeded tall wheatgrass on a high-severity plot, fall 2009.**

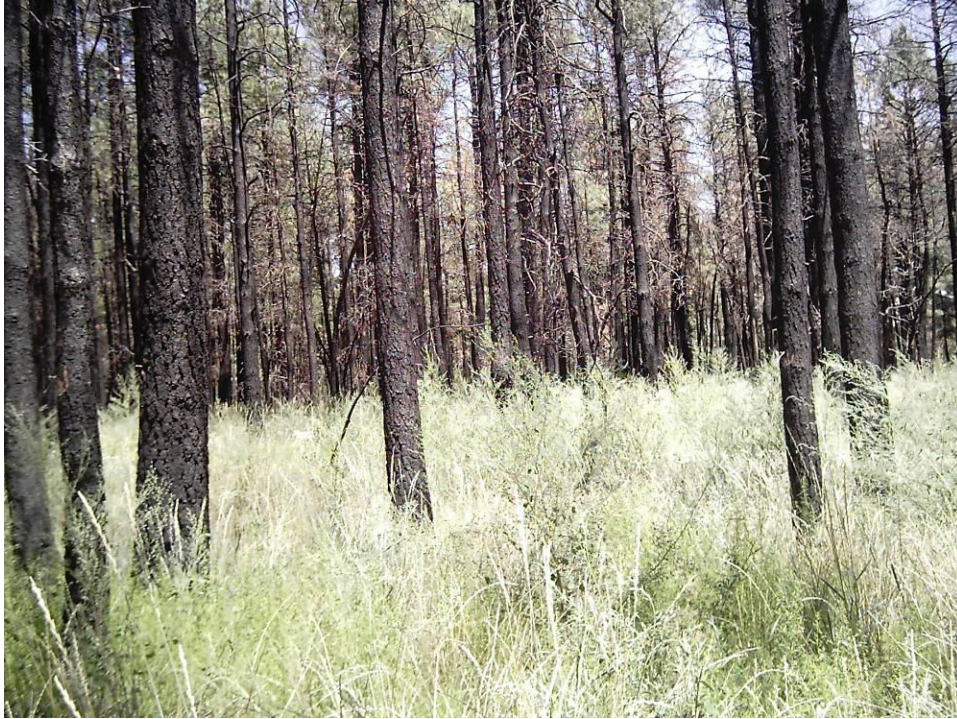
**Figure 3.24. High-severity plot on the Salazar property, showing dominance of grass cover by predominantly seeded grasses, fall 2009.**

From Figure 3.16 through Figure 3.21, the most common species across all plots and seasons were blue grama (*Bouteloua gracilis*), Gambel oak (*Quercus gambelii*), fetid goosefoot (*Chenopodium graveolens*), Wright's deervetch (*Lotus wrightii*), and ragleaf bahia (*Bahia dissecta*). These were all species observed on the unburned plots, suggesting they naturally occur in the area. The high- and low-severity burn sites also exhibited cover of seeded grasses from aerial seeding carried out during rehabilitation efforts in fall 2008. Italian rye grass (*Lolium perenne*) (Figure 3.22) and tall wheatgrass (*Thinopyrum ponticum*) (Figure 3.23) were two large robust grass species present in the seed mix for aerial seeding that were dominant on all plots, particularly on the high- and low-severity plots in fall 2009 (see Figure 3.17 through Figure 3.19). These seeded grasses provided significant cover on the high-severity plots (Figure 3.24).

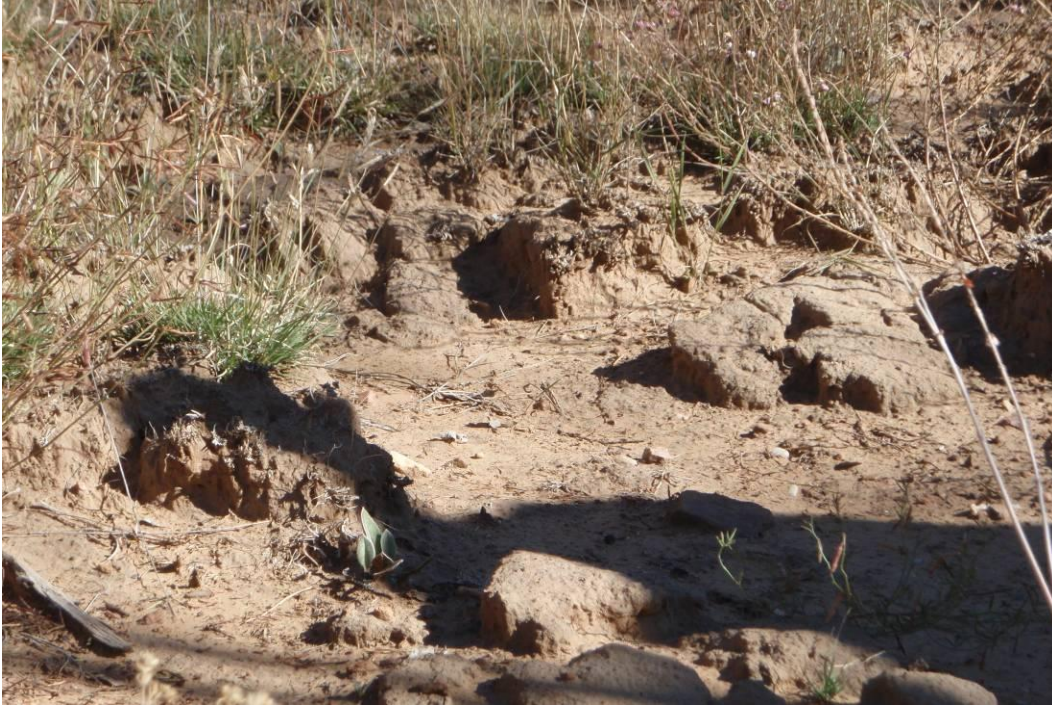
**Figure 3.25. Photograph from the Candelaria site showing the effectiveness of the biological crust in preventing soil erosion.**

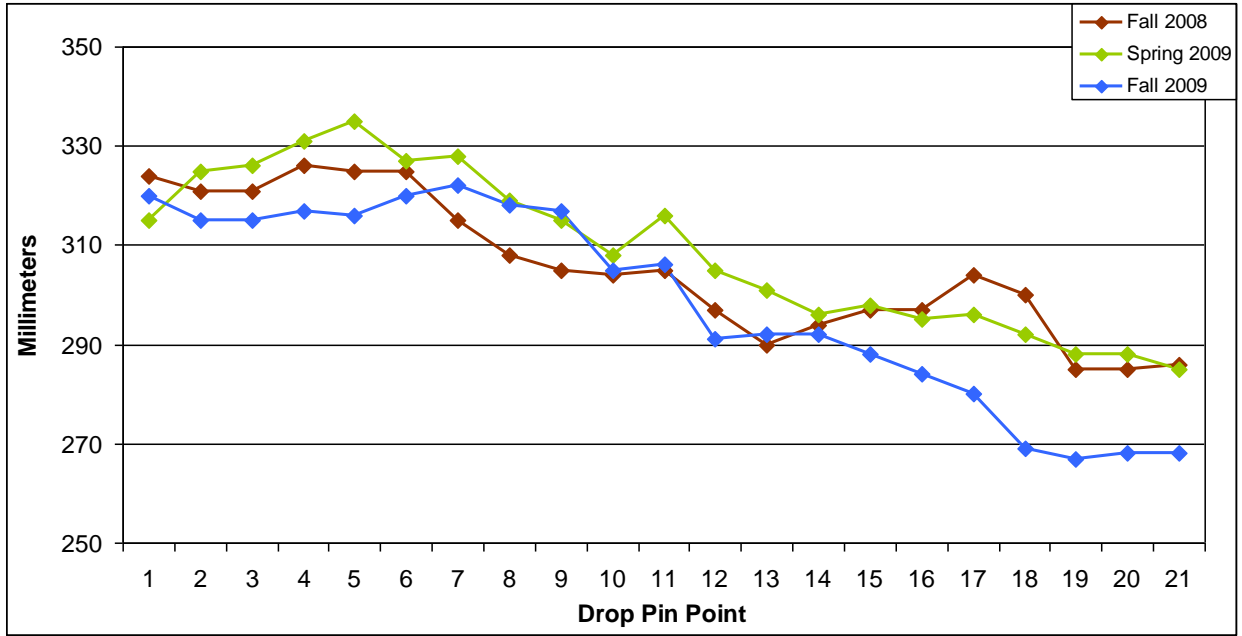
Figure 3.26. Soil movement bridge measurements at BOU 5H.

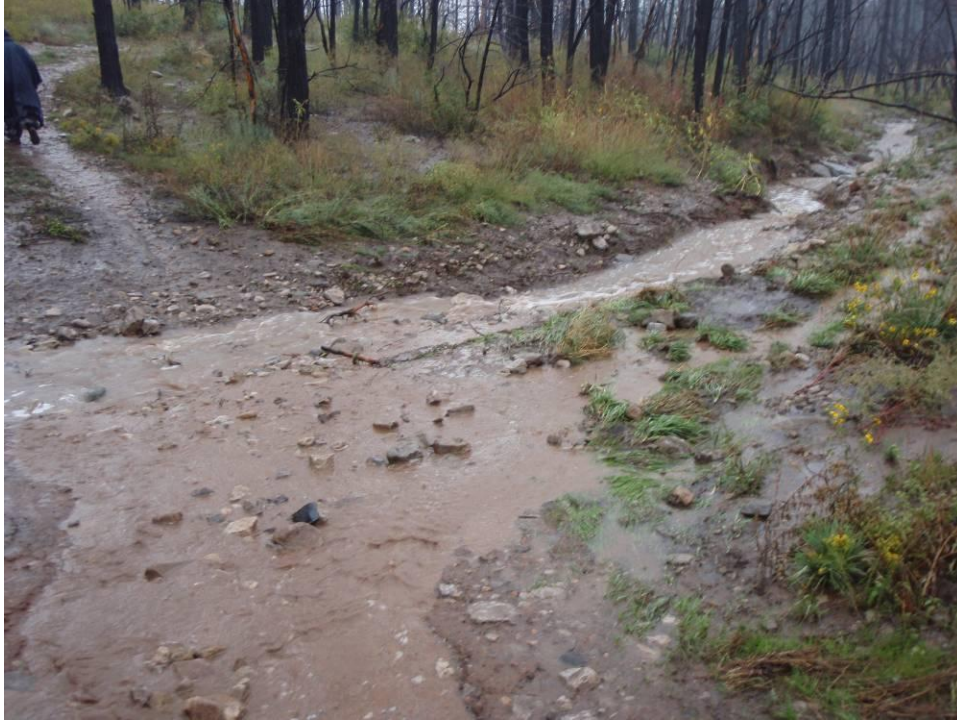
**Figure 3.30. Example of overland flow resulting in sediment-laden flows leaving the Bouton high-severity site in September 2009.**

Soil movement bridges that had been installed in fall 2008 were monitored in spring 2009 and fall 2009. Figure 3.26 through Figure 3.29 demonstrate the changes in the soil surface profiles between 2008 and 2009 for four Bouton plots burned by differing severities. One plot, BOU 5H, was contour felled as part of the Emergency Watershed Rehabilitation Efforts in late fall 2008; fall 2008 measurements were taken prior to this felling treatment. BOU 2H, which was not felled, is included for comparison. Figure 3.30 shows overland flow occurring at the Bouton site, resulting in erosion and sedimentation.

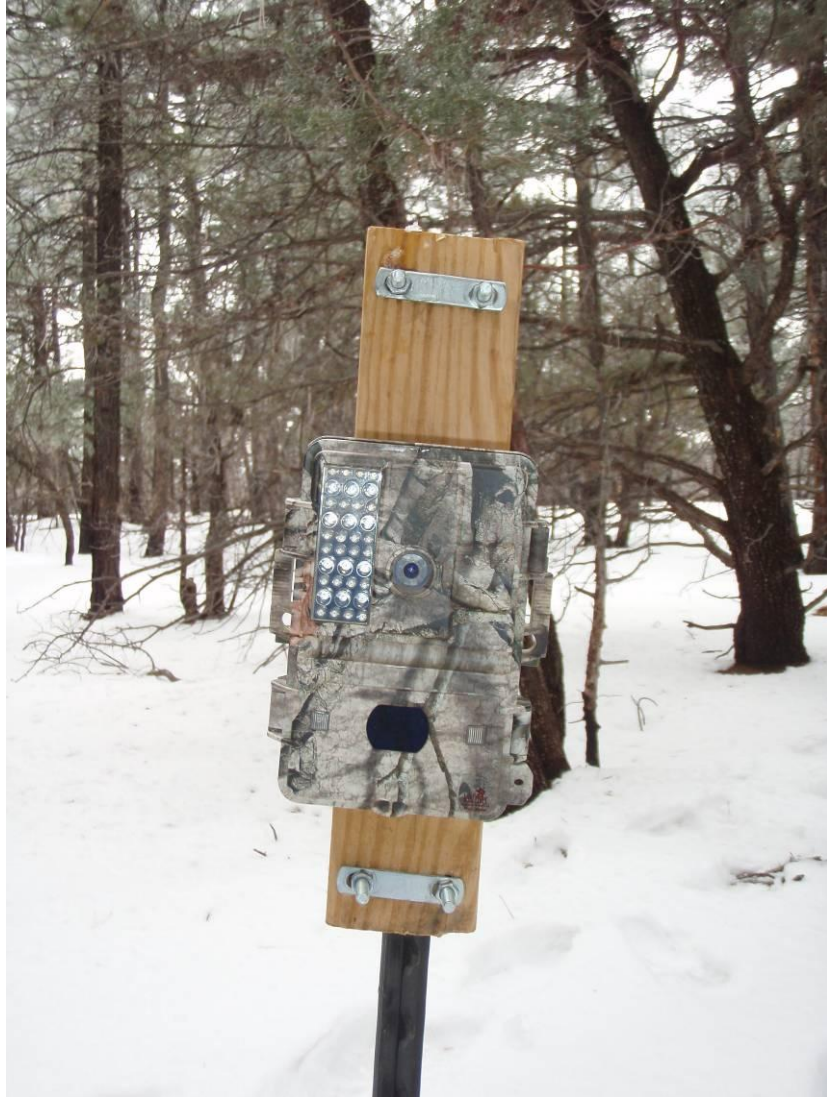
Figure 3.31. Wildlife camera.

Wildlife cameras were established on the fire monitoring plots in March 2009 in order to establish how wildlife is using the burned areas. The cameras were all Leaf River IR5 infrared cameras that had a detection sensor up to 21 m (70 feet). Three cameras were distributed in one watershed between high-severity, low-severity, and unburned plots. The intent is to move the set of cameras between the three watersheds on a quarterly basis. The first two watersheds were the Cuervo 2 and Cuervo1 watersheds. The cameras were set up at the Manzano 1 watershed for the winter 2009/2010 period.

The wildlife cameras were erected in the center of each plot, approximately 1.2 m (4 feet) from the ground and oriented north. The cameras operate during day and night using a movement sensor (Figure 3.31) and infrared flash. To date, the cameras have photographed a number of animals (Table 3.2).

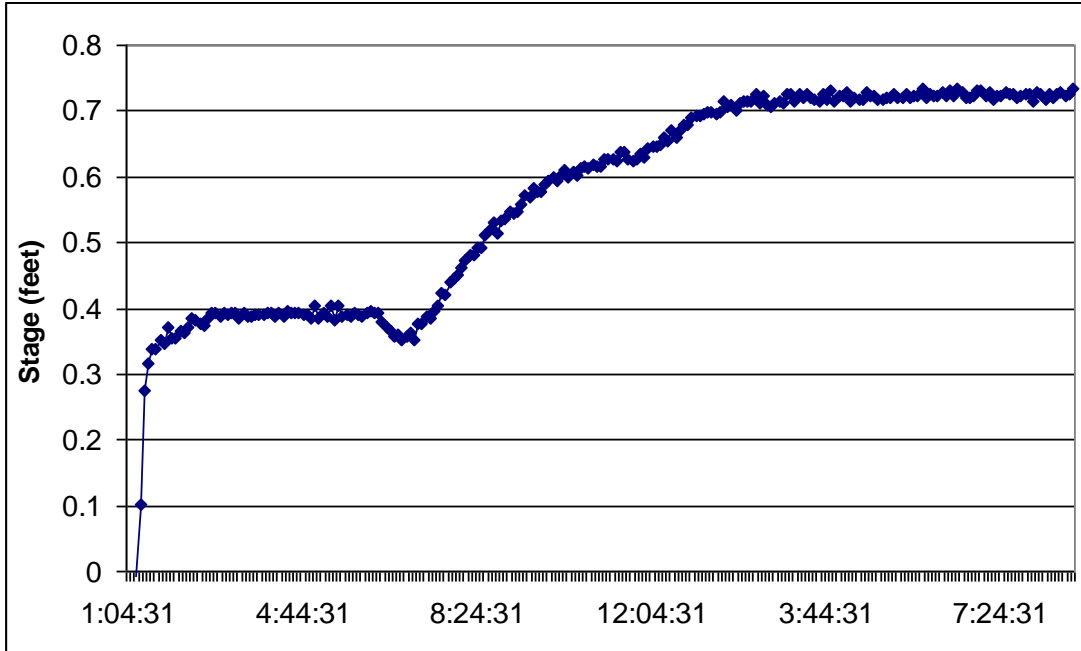
**Figure 4.2.** Hydrograph from the Candelaria piezometer on September 17, 2009, showing a peak stage of nearly 1 foot. However, notice there is no decline to the peak, which is likely caused by the sediment accumulation seen at the site.

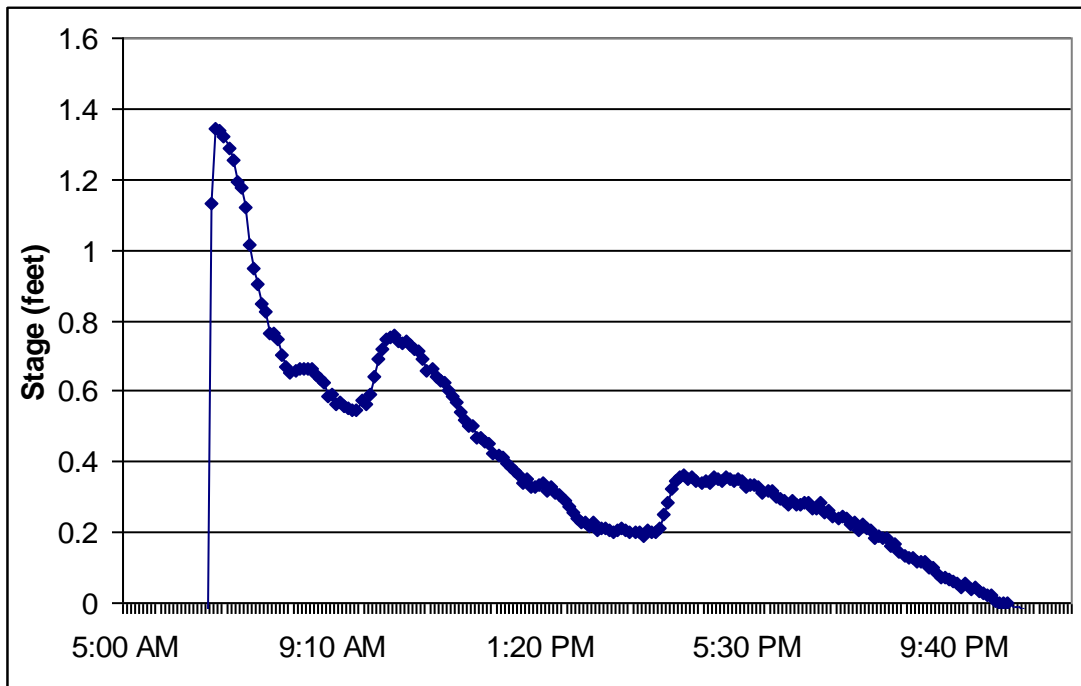
**Figure 4.3.** Hydrograph from Chilili showing a peak stage of nearly 1.5 feet that was reached during the storm event on September 17, 2009.

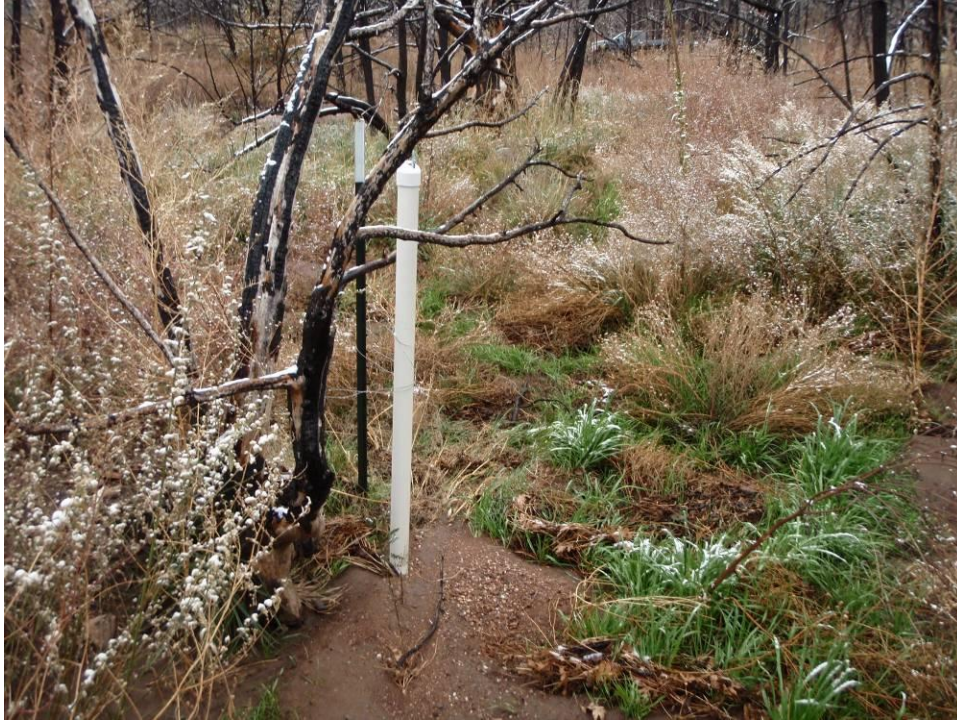
**Figure 4.4.** Large amounts of deposition occurred at the Candelaria site during the summer monsoons. This constantly shifting channel makes calculating volume of flow difficult.

Figure 4.4 through Figure 4.6 show the damage incurred to the stream piezometers during the 2009 season. The piezometer at Chilili was damaged during the 2009 monitoring period either by the large flow event seen in this channel or possibly from cattle or human activity in the channel (e.g., off-road vehicles) (Figure 4.7). The Candelaria piezometer had to be relocated in early 2009 because the site where it was previously installed had flows containing too much debris and subsequently damaged the piezometer during every flow event. Therefore, this piezometer was moved upstream of the source of debris. The transducer at the Vigil site was determined to be malfunctioning and give erroneous data; therefore, it was replaced with a new pressure transducer in October 2009.

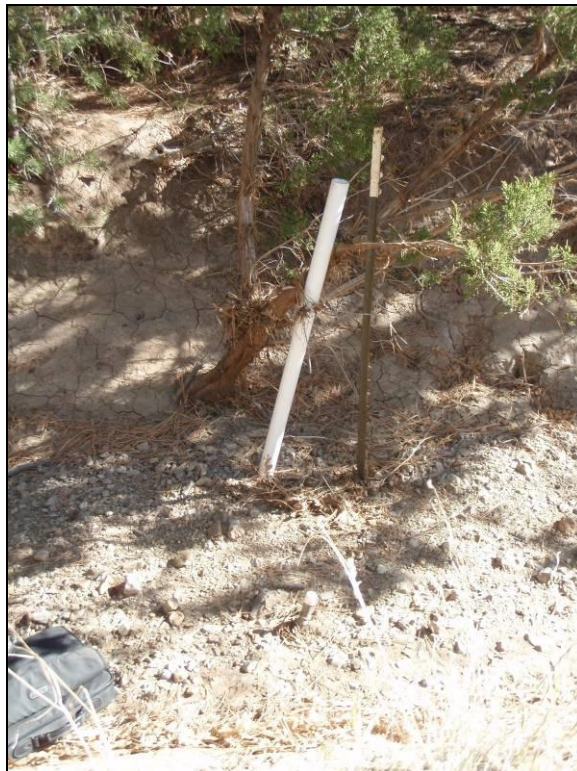
**Figure 4.5.** Large amounts of deposition and debris accumulation at the Vigil piezometer after a storm event in 2008.

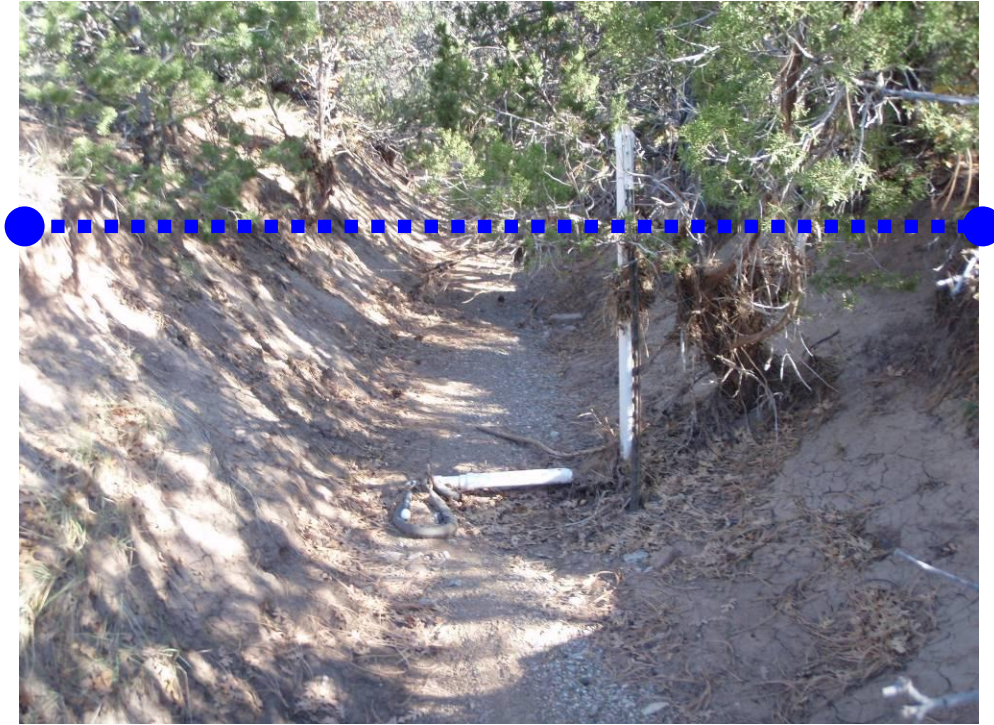
**Figure 4.6.** The Vigil piezometer in the fall of 2009 after a storm event lowered the stream bed level to below the piezometer. The blue line represents the high water line determined by the accumulation of debris in the vegetation.

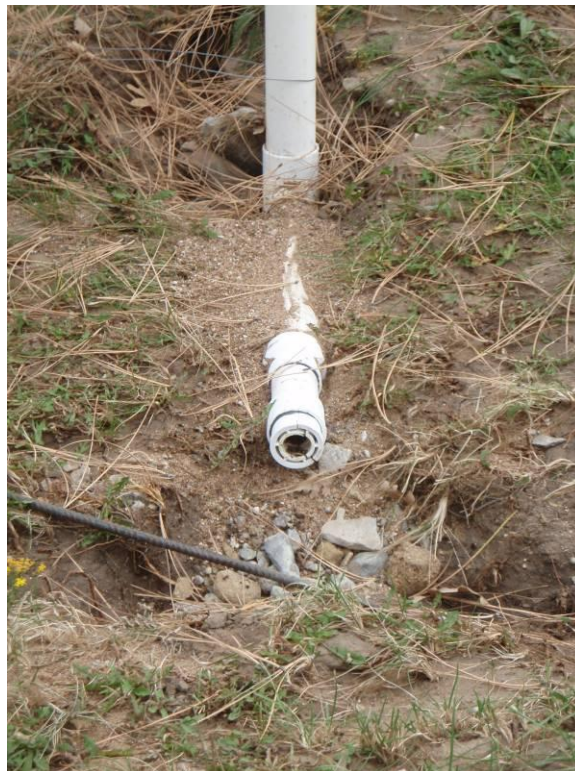
**Figure 4.7.** Damage to the Chilili piezometer in 2009. Even though the end cap was removed, this piezometer was still able to record flow.
