**ESTANCIA BASIN WATERSHED  
HEALTH AND MONITORING PROJECT:  
2014 ANNUAL REPORT**

**ESTANCIA BASIN WATERSHED HEALTH, RESTORATION AND MONITORING  
STEERING COMMITTEE**

**SWCA ENVIRONMENTAL CONSULTANTS**

April 2015

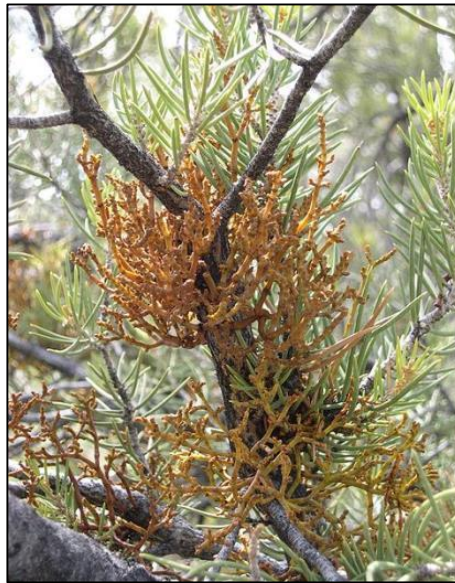
**Figure 2.2. Dwarf mistletoe (*Arceuthobium divaricatum*) growing on piñon.**

Piñon and juniper in the region are also infected with dwarf mistletoe (*Arceuthobium divaricatum*) (Figure 2.2) on pines and true mistletoes (*Phoradendron* sp.) on juniper. They are small parasitic flowering plants that draw water and nutrients from the host tree, impacting the tree’s normal growth and reproductive processes. Increased mortality is associated with severe mistletoe infestations (Mathiasen et al. 2002), but even in minor cases, dwarf mistletoe and true mistletoe are thought to increase the host tree’s susceptibility to other damaging agents such as insect and disease.

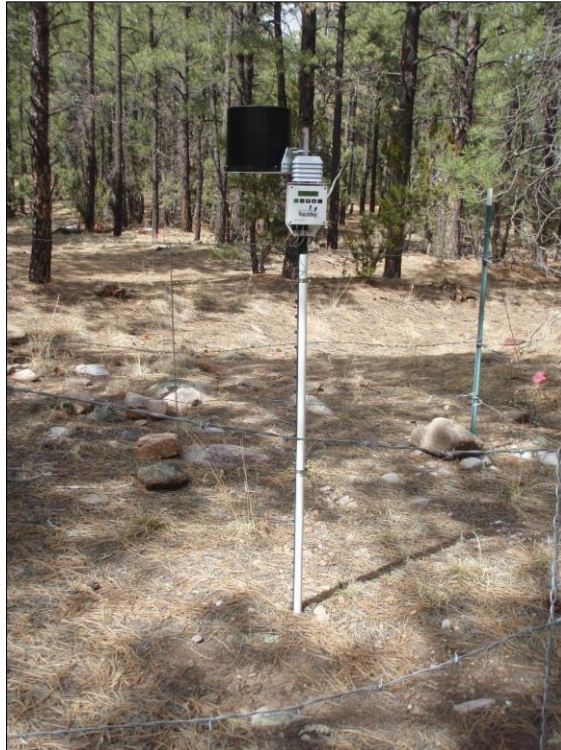
**Figure 2.7. WatchDog mini weather station at the Wester ponderosa pine site.**

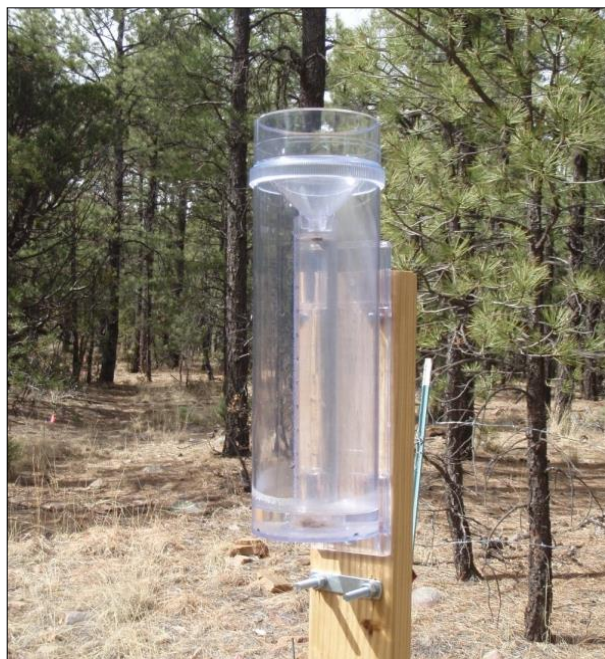
**Figure 2.8. Graduated rain gauges are used for backup in the case of failure of one of the WatchDog weather stations.**

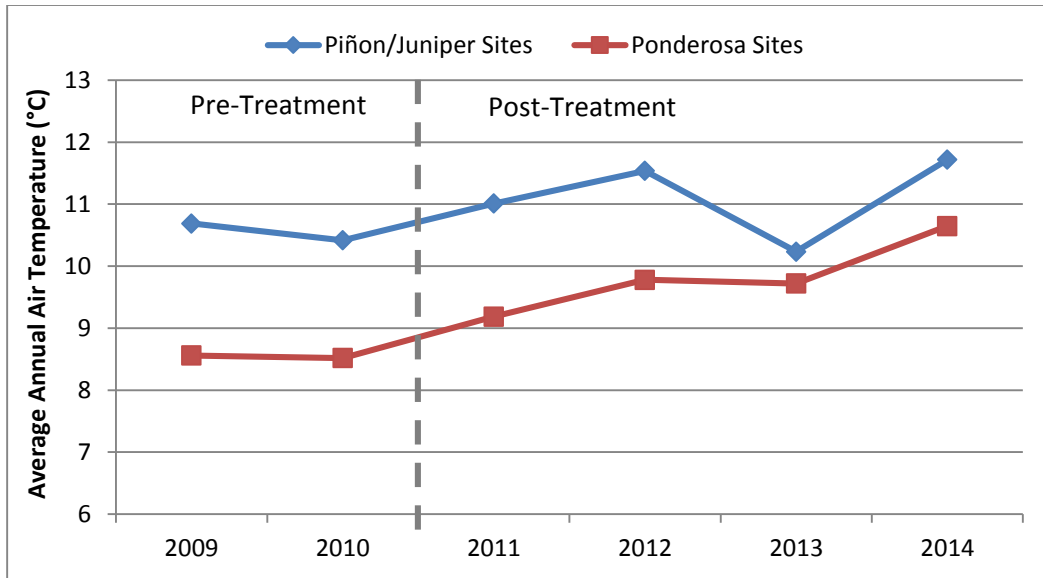
**Figure 2.13. Annual average ambient temperature values at the piñon/juniper and ponderosa pine sites, 2009–2014.**

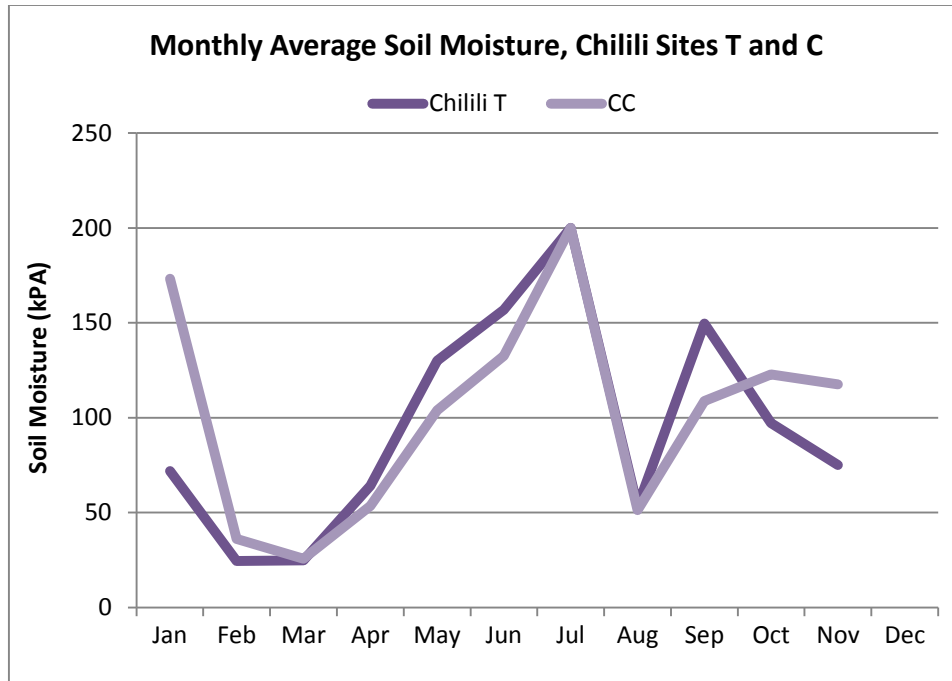
**Figure 2.14. Monthly average soil moisture tensions (–10 cm) from the two paired Chilili ponderosa pine study plots in 2014.**

An example of monthly averages of hourly –10 cm soil moisture readings are presented for the paired study plots at the Chilili ponderosa pine site (Figure 2.14). Soil moisture was measured with Watermark soil moisture probes that measure soil water tension in kilopascal (kPa) values that are directly equivalent to California Bearing Ratio (cbr) values for soil water saturation. Results for paired plots were generally similar. More detailed information on the trends in soil moisture can be found in Section 2.5.1 below on soil TDR measurements.

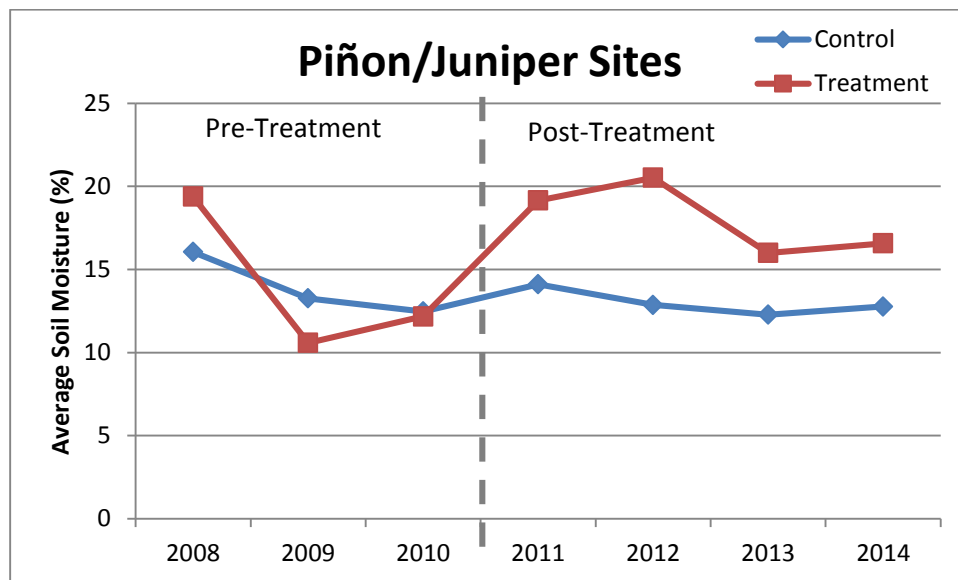
**Figure 2.17. Annual average soil moisture percentage for the piñon/juniper sites, 2008–2014; moisture readings were averaged annually from the monthly readings.**

Average percent soil volumetric water content on the piñon/juniper and ponderosa plots from 2008 through 2014 is displayed below in Figure 2.17 and Figure 2.18. These results show that the piñon/juniper and ponderosa sites are acting in similar fashion prior to the thinning treatments completed in 2011, but after 2012 the piñon/juniper sites showed a decrease in average soil moisture on both control and treatment plots while the ponderosa sites show an increase in average soil moisture on control and treatment plots. Average annual soil moisture between the paired plots is presented below for 2008–2014 from all forest thinning plots (Figure 2.19–Figure 2.22). These figures indicate that the treated sites retain on average more soil moisture throughout the year, especially after storm events and during times of drought. However, when looking at the individual sites different trends are starting to become evident. For example, the Vigil control and treatment plot (see Figure 2.21) had similar soil moistures throughout the 2014 season. This can likely be attributed to the decline in chip cover and increase in bare ground cover. The Kelly piñon/juniper sites showed the converse with the treatment plot retaining more soil moisture than the control (see Figure 2.20). The ponderosa pines sites showed the same trends as previous years with the treatment retaining slightly more soil moisture than the controls. Whether these findings continue to persist into the future remains to be seen.

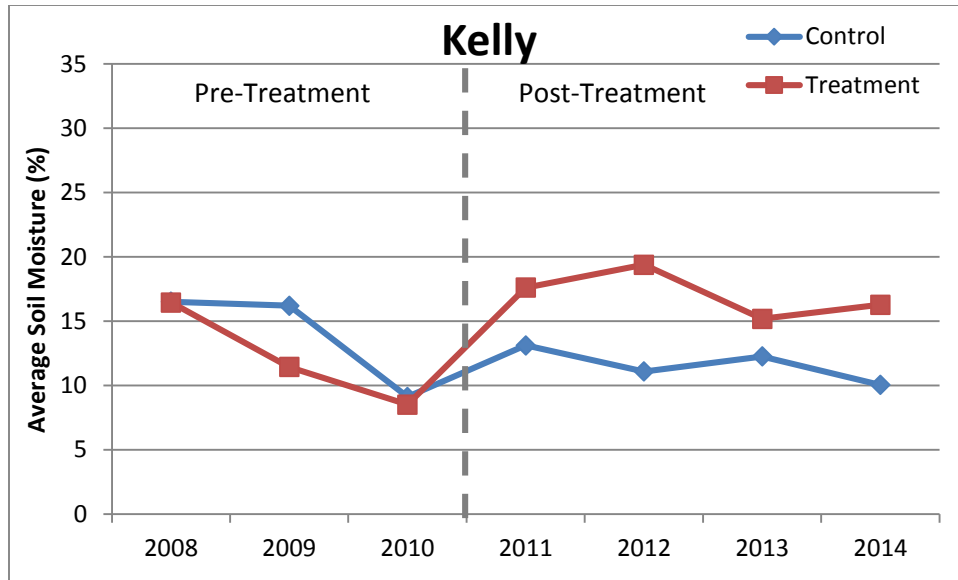
Figure 2.20. Average annual soil moisture readings taken at the Kelly site, 2008–2014.

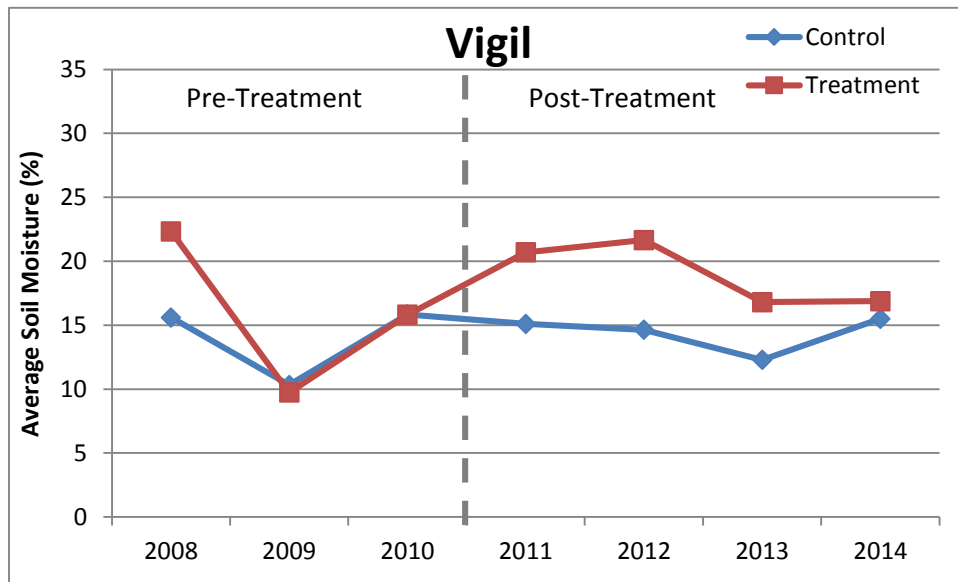
Figure 2.21. Average annual soil moisture readings taken at the Vigil site, 2008–2014.

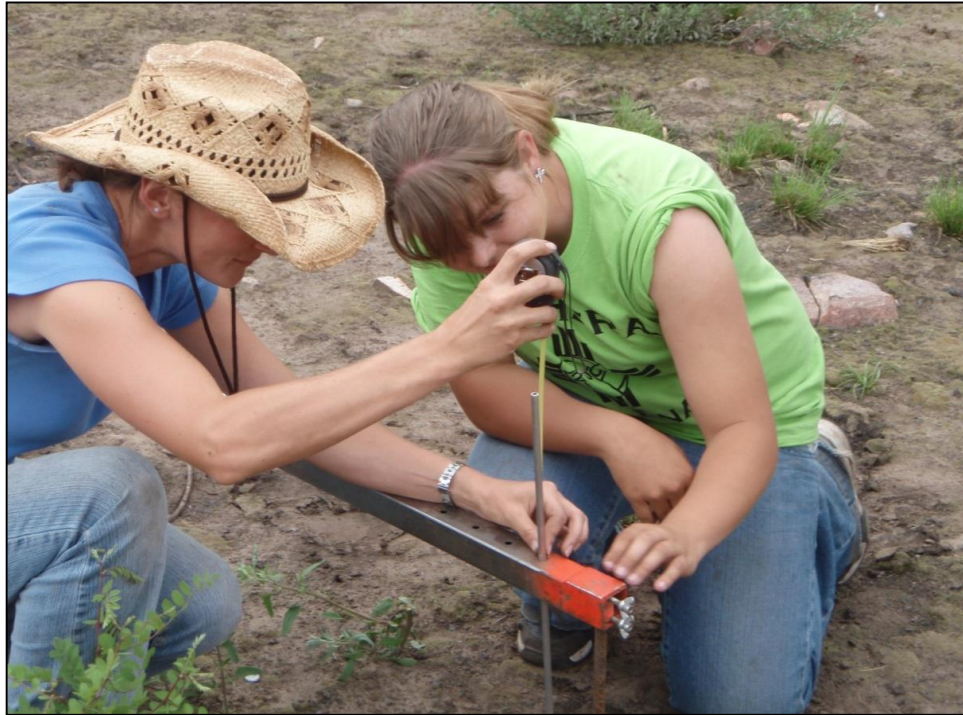
**Figure 2.23. Measurement of soil surface topography using a soil movement bridge helps understand the yearly variability associated with soil topography.**

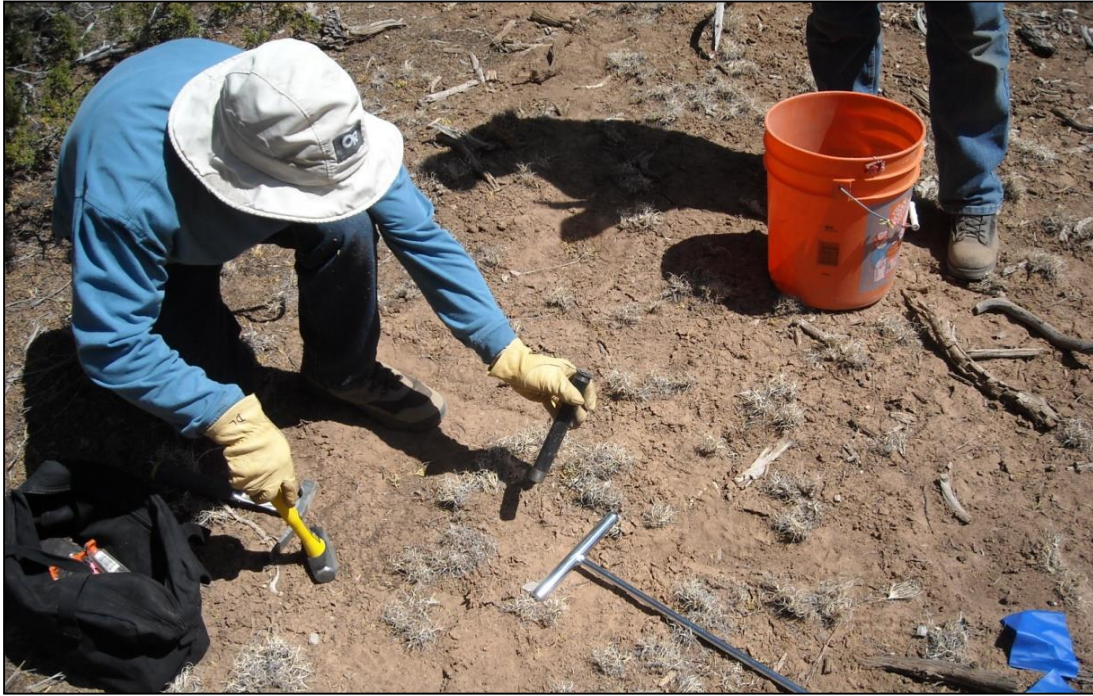
**Figure 2.29. Soil cores were taken using an impact corer, shown above, for chemical analysis.**

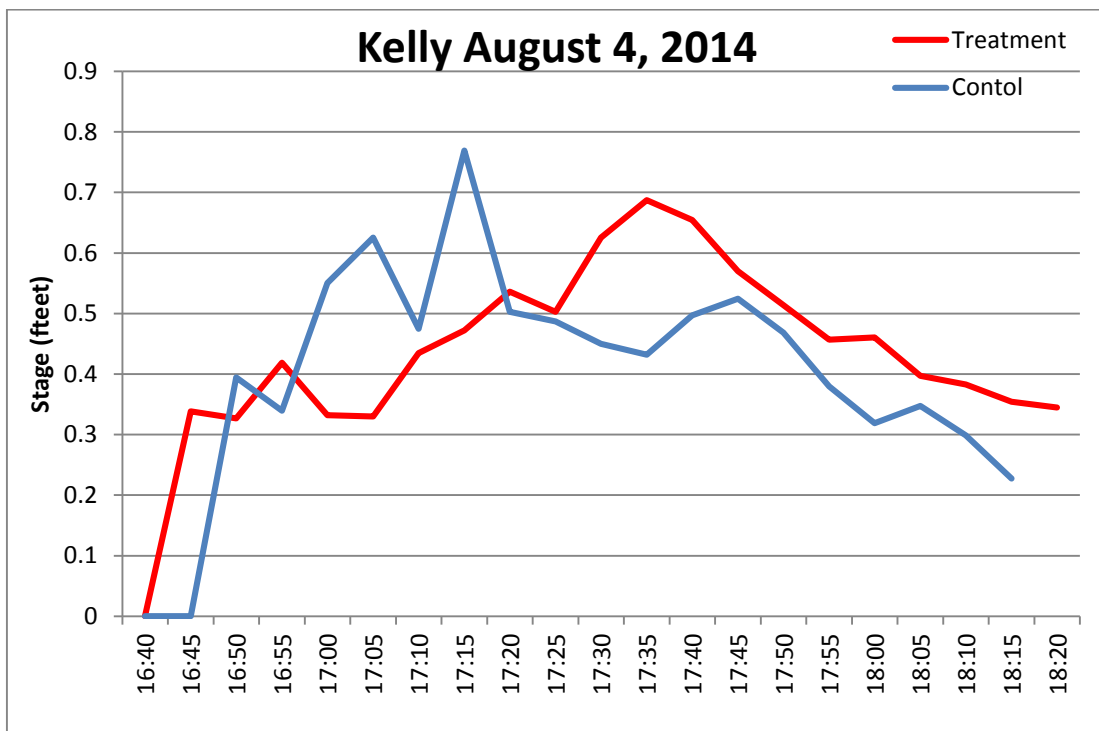
**Figure 2.39. Hydrograph showing the Kelly treatment and control treatment during a storm flow event on August 4, 2014.**

Runoff Parameters	Study Sites	
	Kelly Treated	Kelly Control
Flow start	16:45	16:50
Flow stop	18:20	18:20
Peak stage (feet)	0.687	0.77
Peak flow (cubic feet/second)	0.558	0.662
Flow duration (minutes)	100	90
Total volume of flow (cubic feet)	1819	1606
Watershed area (acres)	0.31	0.29
Volume of flow per acre (cubic feet/acre)	5867	5538
Total rainfall (inches)	2.97	2.85
Total volumetric rainfall (cubic feet)	3,342	3000
Rainfall/Runoff ratio	0.54	0.54

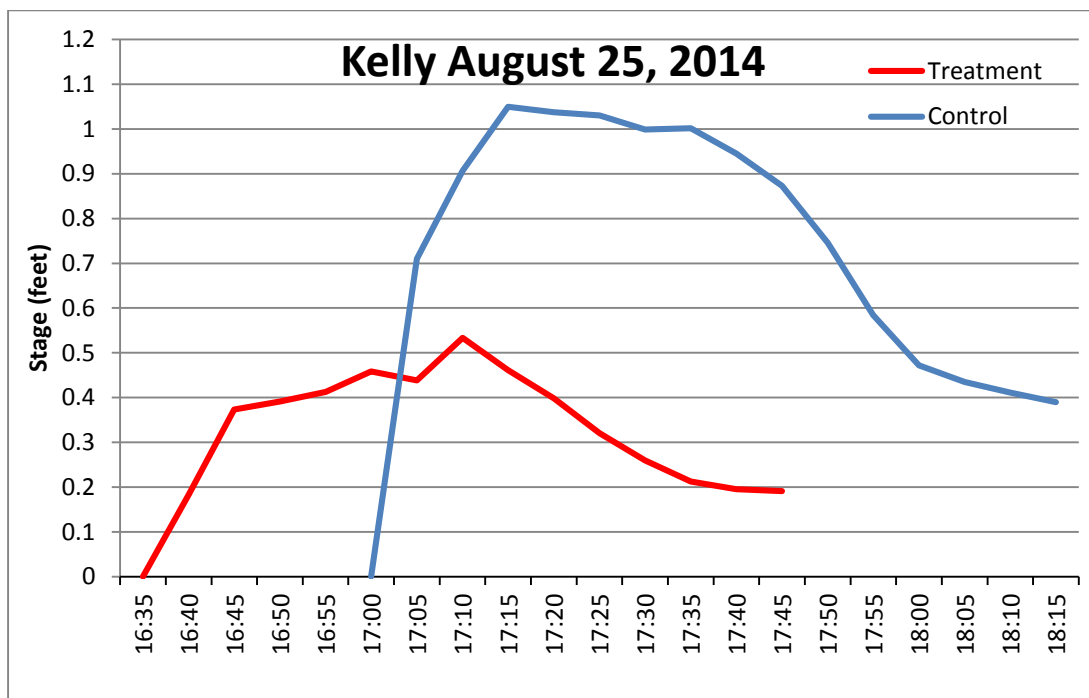
**Figure 2.40. Hydrograph showing the storm flow at the Kelly treatment and control site that occurred on August 25, 2014.**

Runoff Parameters	Study Sites	
	Kelly Treated	Kelly Control
Flow start	16:40	16:50
Flow stop	17:45	18:20
Peak stage (feet)	0.534	1.038
Peak flow (cubic feet/second)	0.371	1.039
Flow duration (minutes)	70	85
Total volume of flow (cubic feet)	836	3246
Watershed area (acres)	0.31	0.29
Volume of flow per acre (cubic feet/acre)	2697	11,193
Total rainfall (inches)	1.93	1.93
Total volumetric rainfall (cubic feet)	2172	2032
Rainfall/Runoff ratio	0.38	1.6

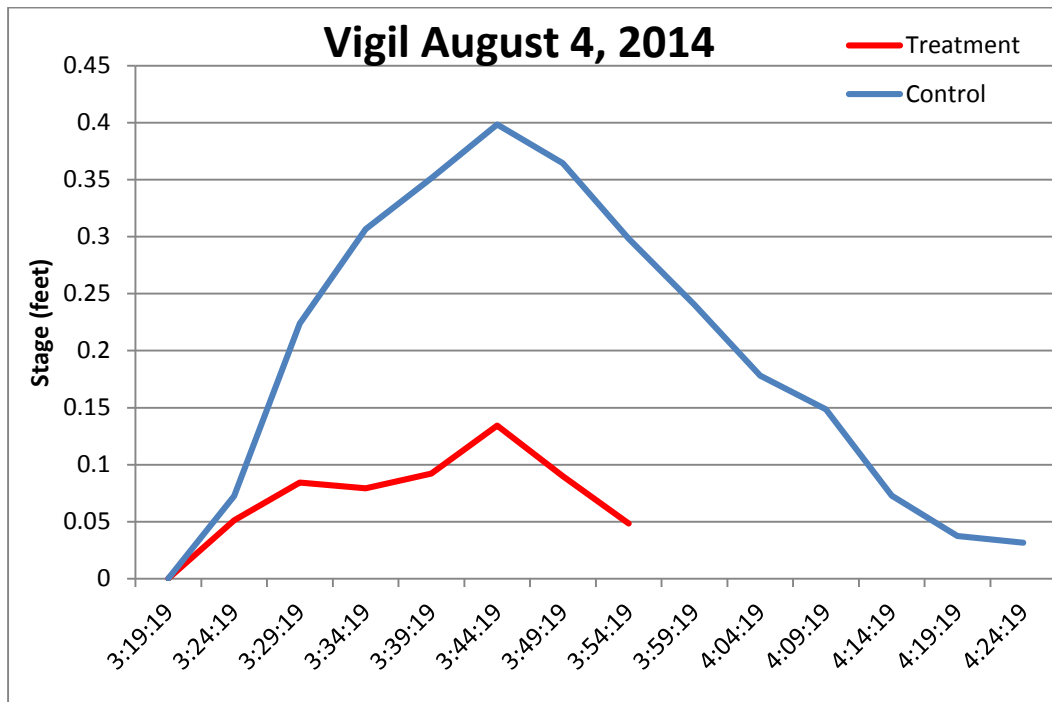
**Figure 2.41. Hydrograph showing the storm flow at the Vigil treatment and control r site that occurred on August 4, 2014.**

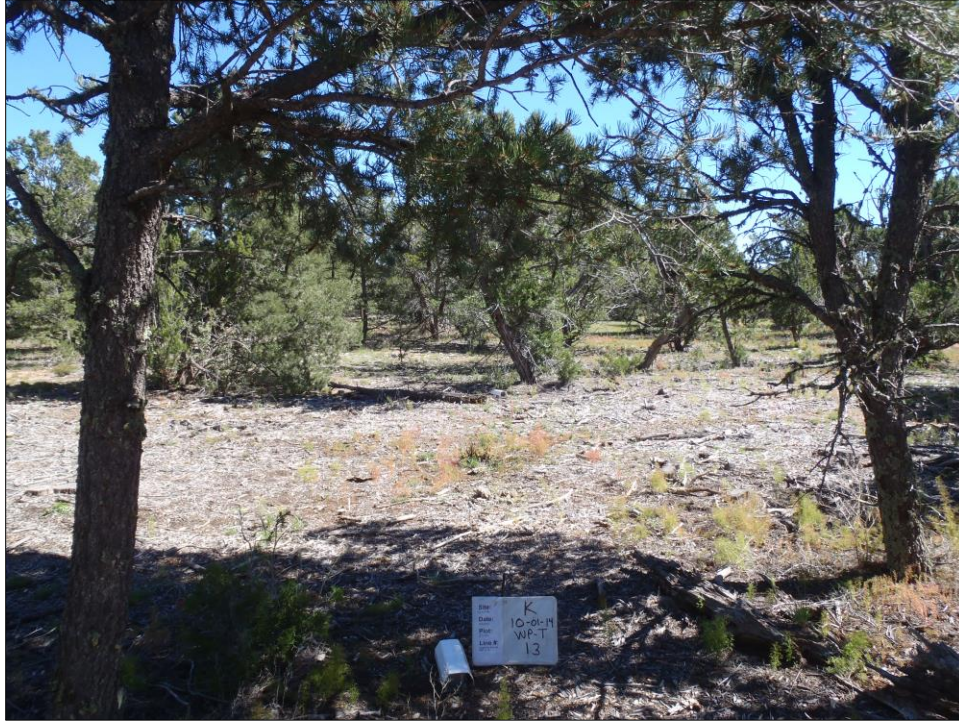
**Figure 2.49. Forbs growing on disturbed soils and wood chips at the Kelly site treatment plot, October 2014. The visible dominant species is native annual forb, fetid goosefoot (*Chenopodium graveolens*). Note that 13 on the white board refers to the location not the year.**

Forb canopy cover was significantly higher on the treated plots at both of the piñon/juniper sites from 2011 through 2014, but not at either of the ponderosa pine sites (see Figure 2.48, f–h). Forb cover at the Vigil site continued to increase even greater on the treatment plot than the control plot through 2014, but declined on the treatment plot relative to the control plot at the Kelly site in 2014. The majority of forb species were summer annual plants that grew on disturbed soils and wood chips. All of the dominant species were native, and no exotic invasive forb species were found through 2013. However, in 2014, three species of exotic invasive weeds were found represented by one plant only, and only on piñon/juniper treatment plots. Those weeds were prickly Russian thistle (*Salsola tragus*) (one plant on the Vigil treatment plot), redstem storks bill (*Erodium cicutarium*) (one plant on the Kelly treatment plot), and puncture vine (*Tribulus terrestris*) (one plant on the Vigil treatment plot). All three of these weed species are common in the entire area and have been observed along roadsides and near the study sites since 2008. An example of the forb growth at the Vigil treatment plot in 2014 is provided in Figure 2.49.

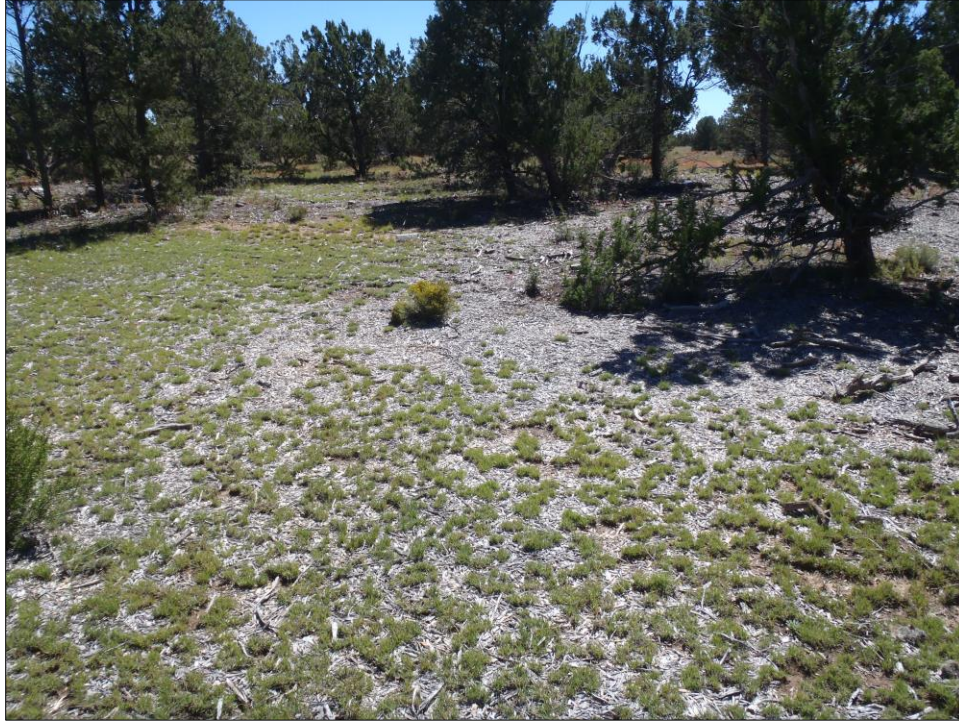
**Figure 2.50. Perennial blue grama growing through wood chips (foreground) at the Kelly piñon/juniper site treatment plot in 2014. Note that the blue grama had been grazed down by livestock.**

Grass canopy cover has tended to increase overall from 2011 through 2014, but not consistently on all plots. Grass cover was significantly higher only on the treated plots at the Vigil piñon/juniper site and at the Wester ponderosa pine site in 2014, but there were not significant differences in grass cover at the Kelly and Chilili sites (see Figure 2.48, i–l; Table 2.10). Grass cover increased steadily on the treated plot at the Vigil site from 2010 to 2014 with significantly greater cover on the treatment plot since 2012. Grass cover was significantly higher on the treated plot at the Wester ponderosa pine site even before thinning treatments in 2010. However, through 2014, grass cover on the treatment plot has continued to increase more rapidly and proportionately more so than on the control plot, indicating a positive response to the thinning treatment. Dominant grasses at the two piñon/juniper sites that responded positively to tree thinning were perennial species such as blue grama (*Bouteloua gracilis*) and James’ galleta (*Pleuraphis jamesii*). Those grasses grew through the wood chips from existing individual plants that were in place prior to thinning treatments, unlike annual forbs that colonized the disturbed soils and wood chips. Blue grama growing through wood chips at the Vigil site is shown in Figure 2.50.

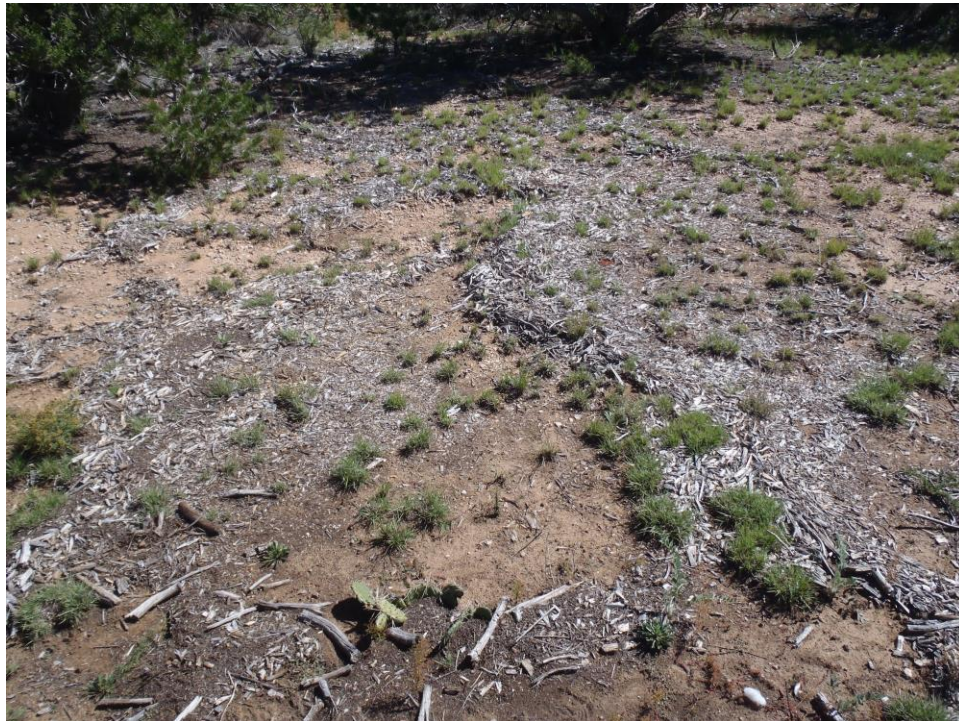
**Figure 2.51. Wood chips from tree thinning treatment redistributed over the ground surface by heavy summer rain runoff at the Kelly treatment plot in 2014. The wood chips also formed small debris dams to retain soil surface water runoff, likely increasing infiltration and reducing soil erosion.**

Wood chips have remained significantly higher on all treated 2011 following thinning treatments (see Figure 2.48, y–bb; Table 2.10). No wood chips existed prior to thinning treatments in 2010, and they were applied only to the treated plots in late 2010. Wood chip cover on the treated plots declined by about 20% on all plots between 2011 and 2012, indicating some decomposition or redistribution and/or increased herbaceous plant canopy cover over wood chips. Since 2012, wood chip cover has remained fairly constant at the two piñon/juniper sites. In 2014, wood chip cover increased back up to about 20% cover at the two ponderosa pine sites. No new wood chips have been added at those sites. Such fluctuations are believed due to redistribution of chips following heavy rain and runoff events, and shifts in relative ground surface cover with other cover features. Figure 2.51 shows an example of wood chips that have been redistributed on the ground surface from heavy rain and runoff on the Kelly treatment plot in 2014.

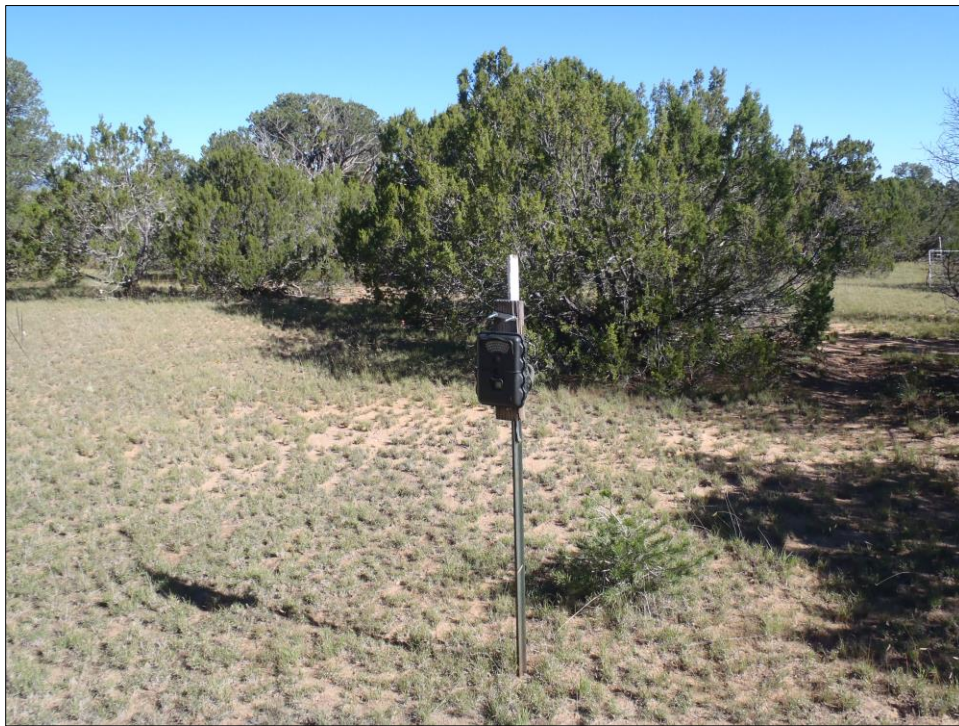
**Figure 2.66. Automatic wildlife camera (Truth Cam, model 63010).**

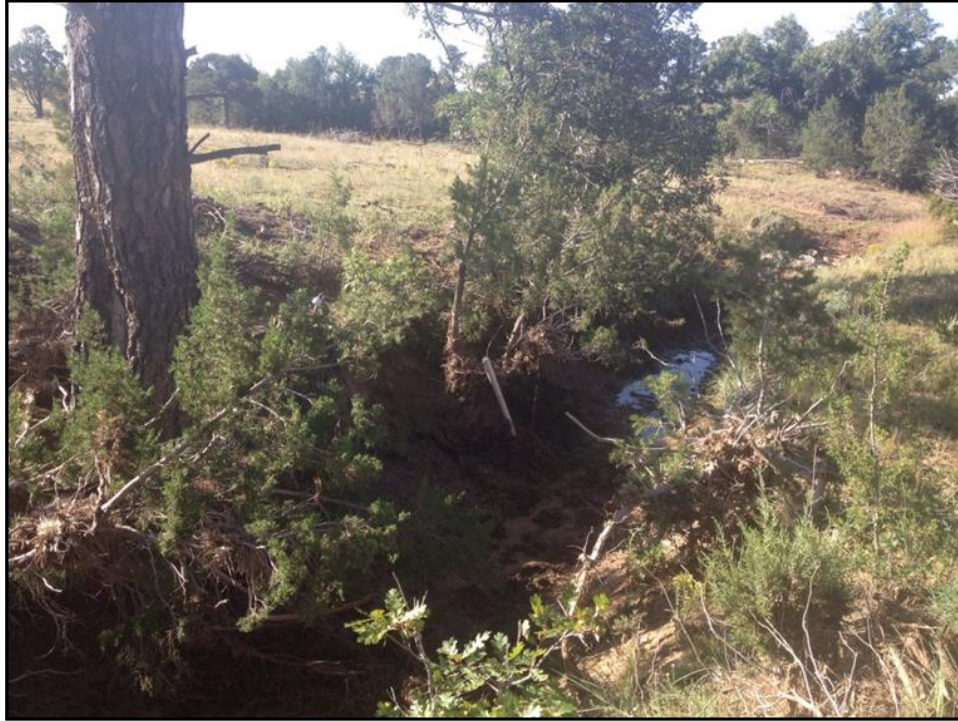
**Figure 3.2. The Kelly piezometer in the fall of 2014 after a storm event compromised the gauge.**
