## Introduction

- The Estancia Basin Watershed Health, Restoration and Monitoring Steering Committee (Steering Committee) oversees forest thinning projects and monitoring of forest and watershed health in the Estancia Basin in coordination with the New Mexico Forest and Watershed Restoration Institute. The primary goals of the Steering Committee are to improve forest health and create defensible space from wildfire. Funding for this project has been provided by the New Mexico Water Trust Board.

- SWCA Environmental Consultants (SWCA) was awarded a contract in 2007 to conduct monitoring for forest thinning effectiveness on the eastern slopes of the Manzano Mountains for the Steering Committee. SWCA finalized a comprehensive monitoring plan in March 2008 which is available online at the New Mexico Forest and Watershed Restoration Institute's website ([http://www.nmfwri.org/images/stories/pdfs/Estancia\\_Basin\\_Monitoring/EstanciaBasinMonitoring.pdf](http://www.nmfwri.org/images/stories/pdfs/Estancia_Basin_Monitoring/EstanciaBasinMonitoring.pdf))—that provides background information, research questions, and a discussion of methods relative to forest thinning and monitoring.

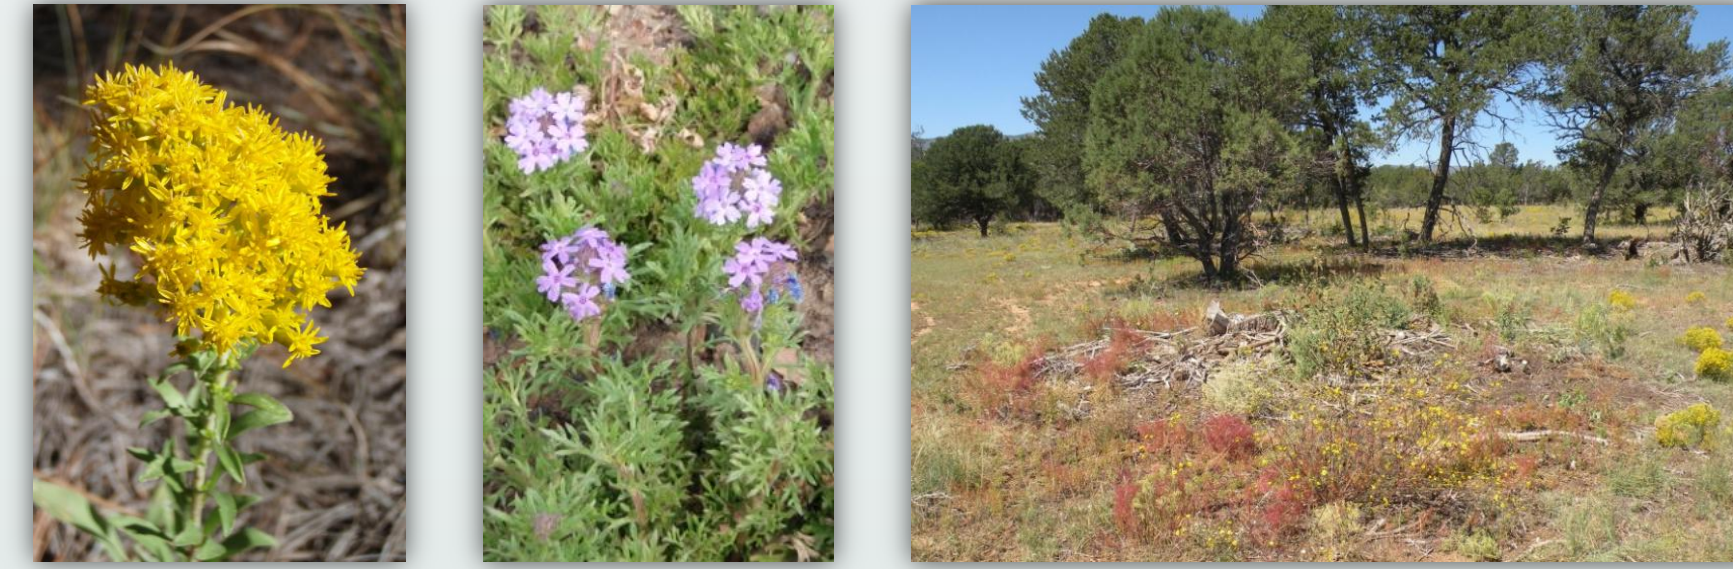
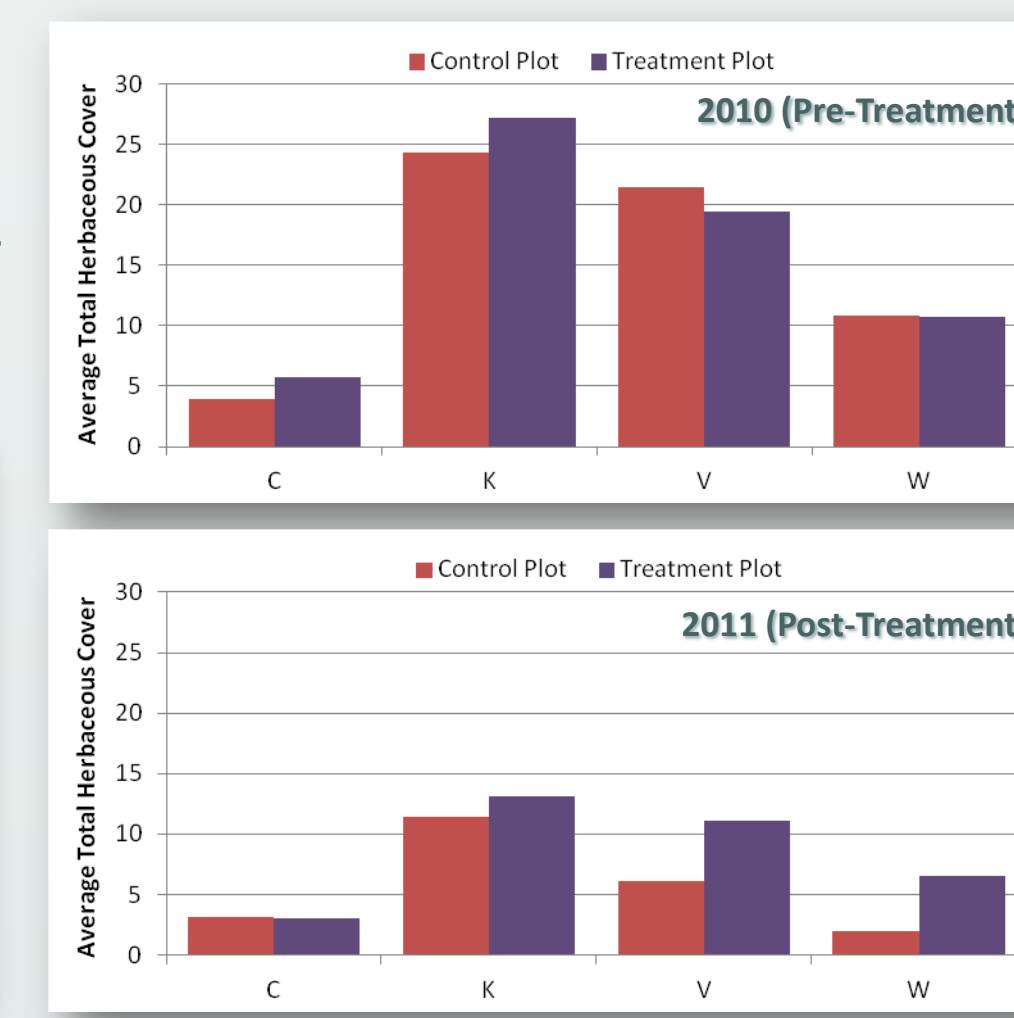
The graphs at right show the average herbaceous cover (grasses and forbs) for each Wildlife Plot from 2010 and 2011. Rainfall, plant growth, and cover were greater in 2010 than 2011. Despite drought conditions in 2011 herbaceous cover increased at one of the ponderosa sites and one of the piñon-juniper sites after thinning treatments. The Wester ponderosa site is the only site not grazed by livestock, and had the greatest herbaceous vegetation canopy cover in response to thinning.

Study Plot  
 C – Control Plot  
 T – Treatment Plot  
 Piñon/Juniper Site  
 K – Kelly Site  
 V – Vigil Site  
 Ponderosa Pine Site  
 C – Chilli Site  
 W – Wester Site

- Soil moisture was higher on treated plots** than control plots, especially during dry periods following rainfall events.
  - Herbaceous vegetation canopy cover was higher on half of the treated plots** compared to the control plots.
