*A Guide for Planning Riparian
Treatments in New Mexico*

**New Mexico Natural
Resources Conservation
Service**

September 2007

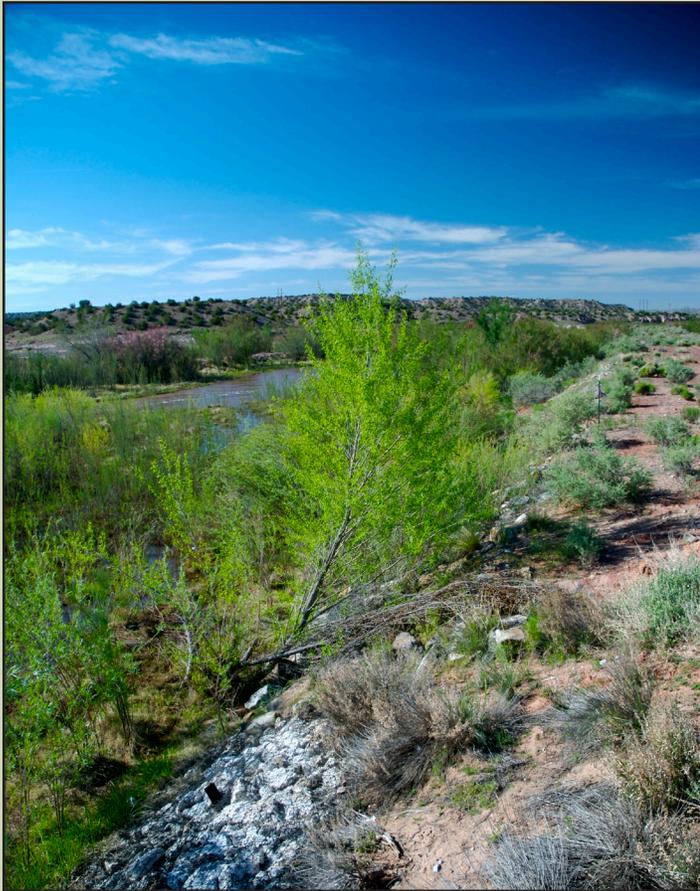
Photo 1 – Levee restricting the flood plain width, Jemez River, Sandoval County

Hydrologic Alteration – Streams function to move sediment and water down gradient. Alterations to the hydrologic regime, channel morphology, and watershed condition all affect the ability of the stream to perform its intended functions. Hydrologic alterations such as dams, levees, berms, channel straightening, and rip-rap adversely affect the ability of the stream to distribute energy and material. Functioning streams must have access to their natural floodplains in order to distribute excess sediment and energy in support of sustainable riparian ecosystems.

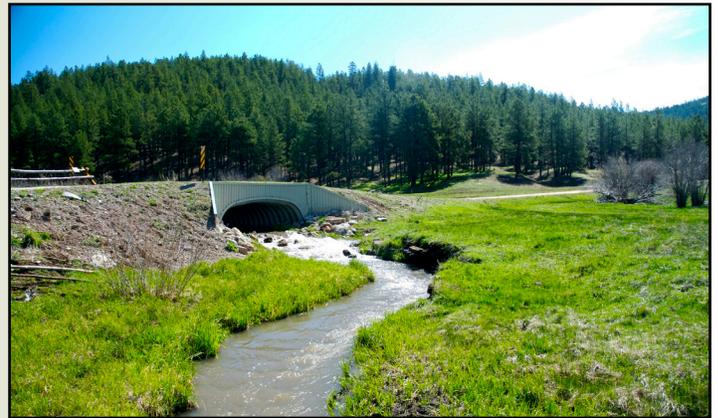
Photo 2 – Rio Guadalupe Bridge Crossing with associated armoring which reduces meandering and increases bank erosion, Sandoval County

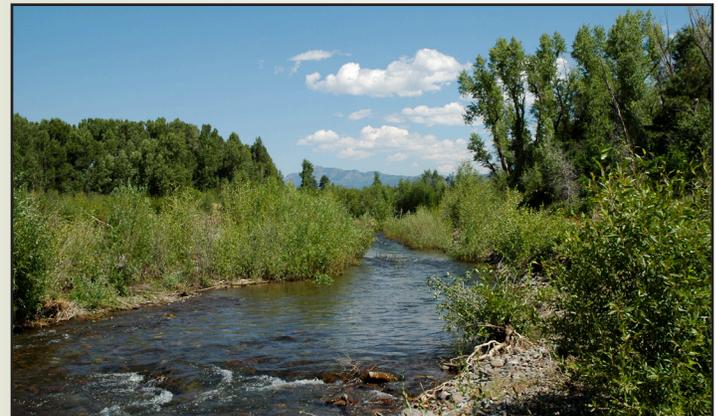
Photo 3 – No hydrologic alterations, Rio Chama, Rio Arriba County

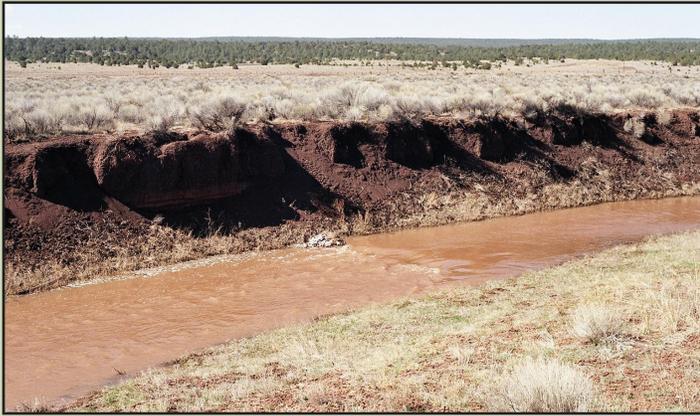
Photo 4 – Incised channel with unstable banks, Cottonwood Creek, McKinley County

Channel Condition – Channels that are stable are in balance with their landscape position. Channel form is dependent on gradient, substrate size, and watershed discharge. Depending on stream type, a healthy channel has a characteristic width to depth ratio, access to its floodplain, and incisement ratio.

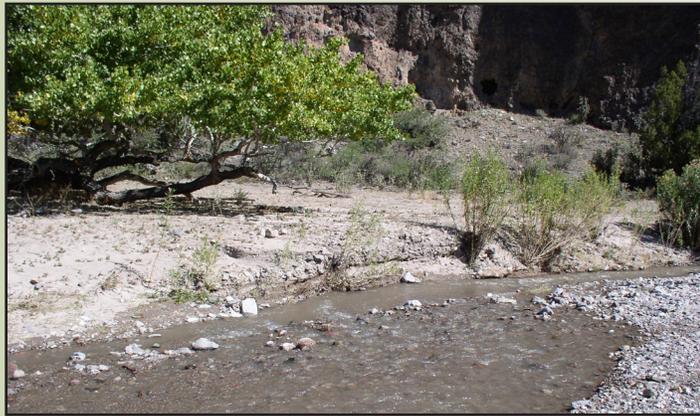
Photo 5 – Poor width to depth ratio, wide and shallow channel resulting in poor sediment transport capacity, Alamosa Creek, Sierra County

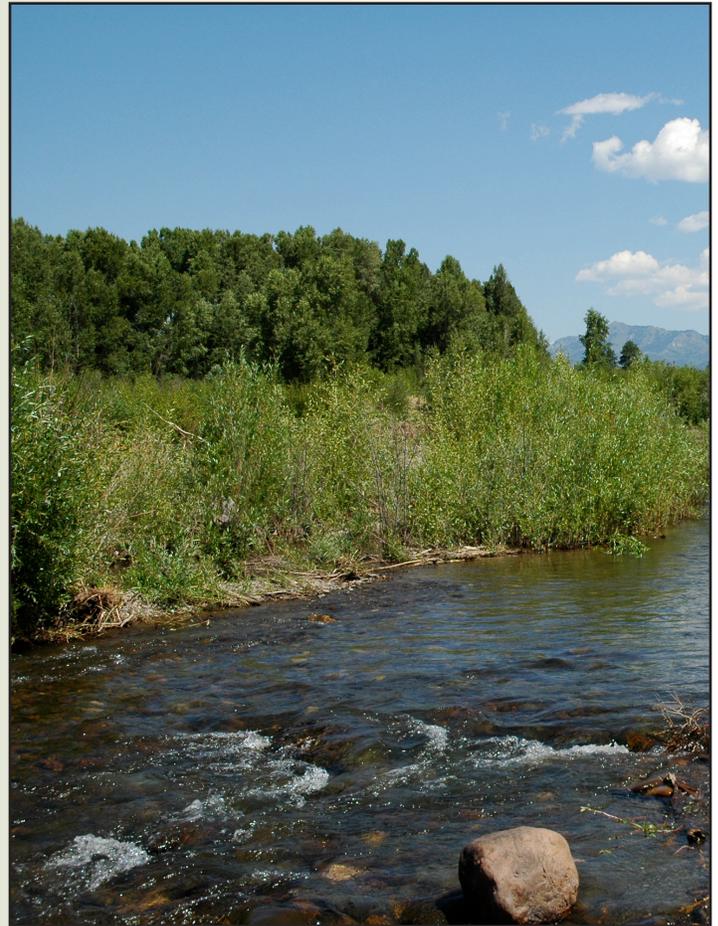
Photo 6 – Healthy channel, Rio Chama, Rio Arriba County

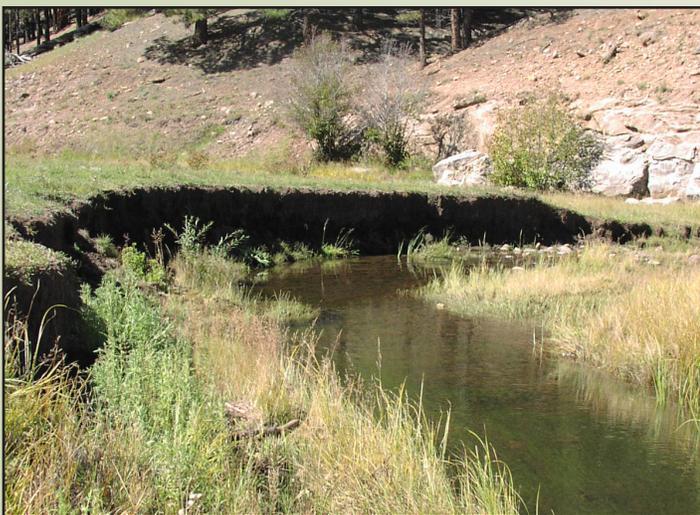
Photo 7 – Unstable bank, Rio de las Vacas, Sandoval County

Bank Stability – Stable banks assist in maintaining stream form and function in appropriate channel types and geomorphic settings.

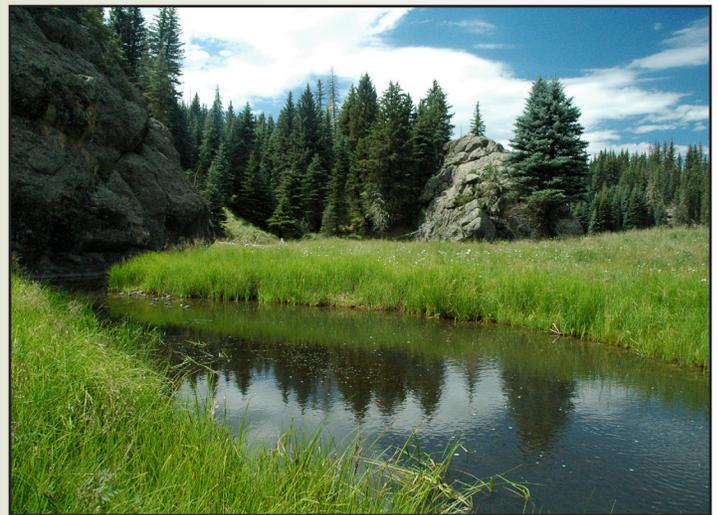
Photo 8 – Stable bank, East Fork of Jemez River, Sandoval County

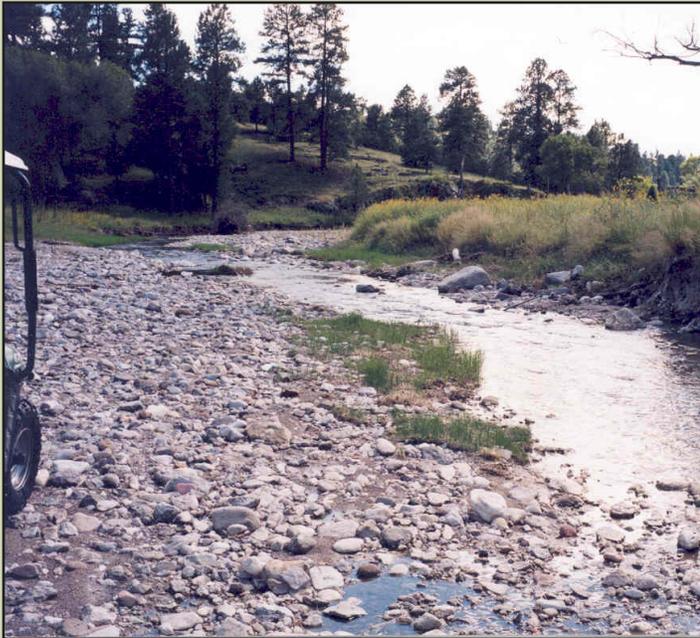
Photo 9 – Inadequate riparian zone width, Taylor Creek, Catron County

Riparian Zone Width – A healthy riparian zone will widen until it reaches the maximum extent possible. The widening can be inward (as the stream channel narrows), outward (towards the adjacent uplands), or both. The maximum extent is limited by topography, geology, soil type, and hydrologic factors.

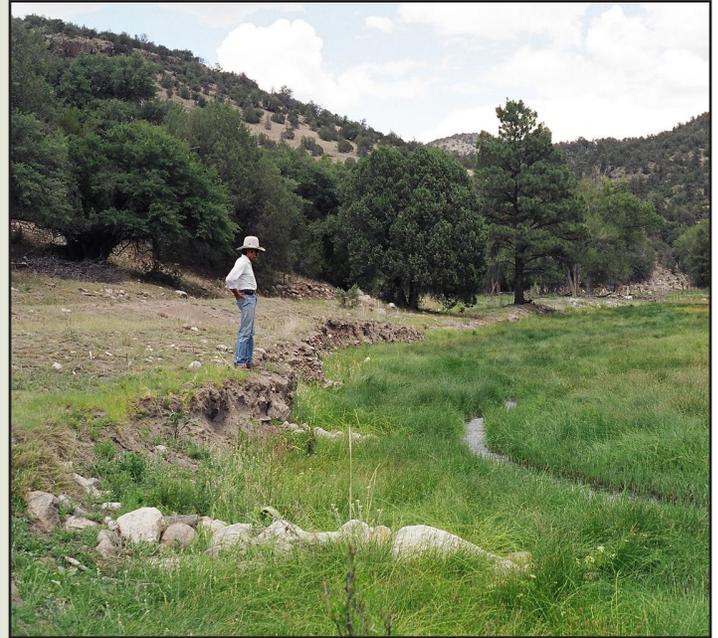
Photo 10 – Riparian area widening inward, channel narrowing, Taylor Creek, Catron County

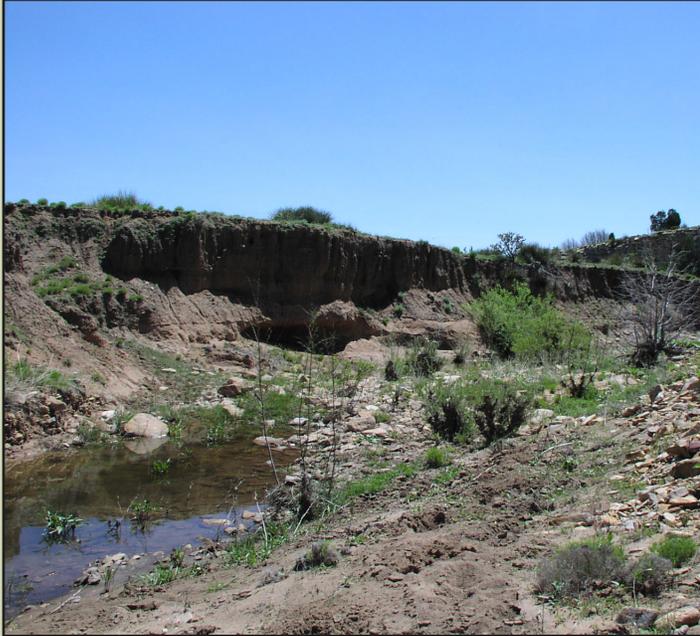
Photo 13 – Poor rooting medium due to erosion of channel and flood plain materials, Harding County

Soil Characteristics / Rooting Medium – Soil type and water holding potential are critical factors in determining the sites potential.

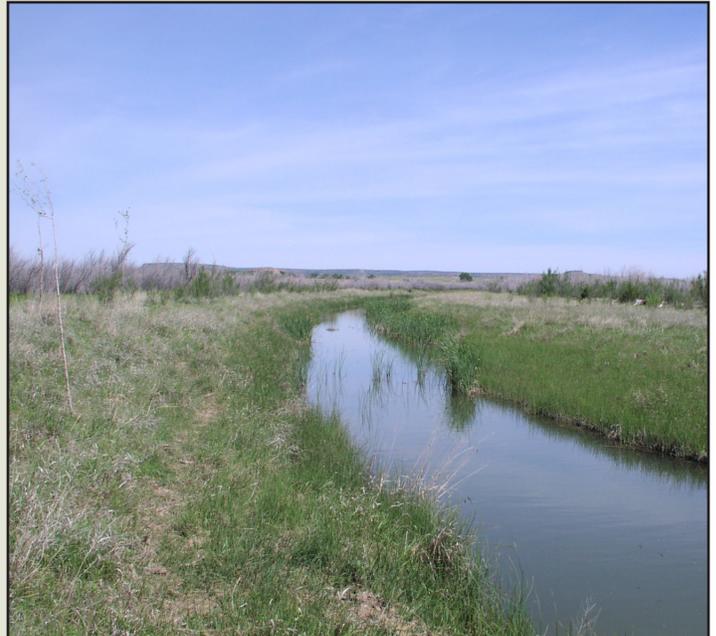
Photo 14 – Adequate rooting medium, Ute Creek, Harding County

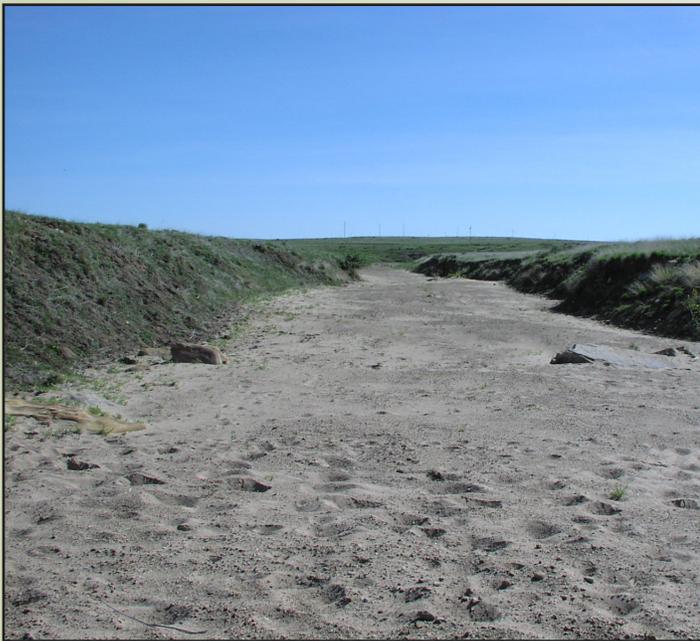
Photo 15 – Greater than 50% bare ground, Union County

Exposed or Bare Ground – Riparian vegetation acts as a ground cover to reduce erosion, insulate the soil, provide cover and habitat, and it provides a sediment filter during flow events.

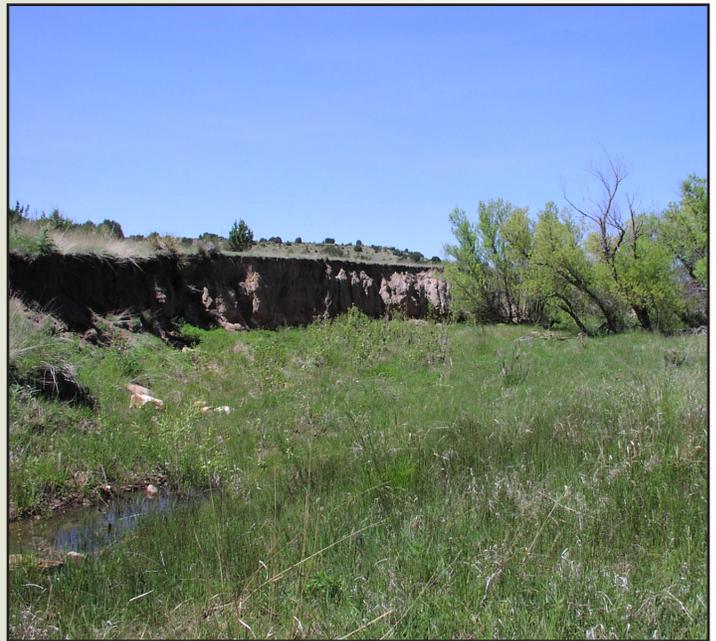
Photo 16 – 10% to 20% bare ground, Harding County

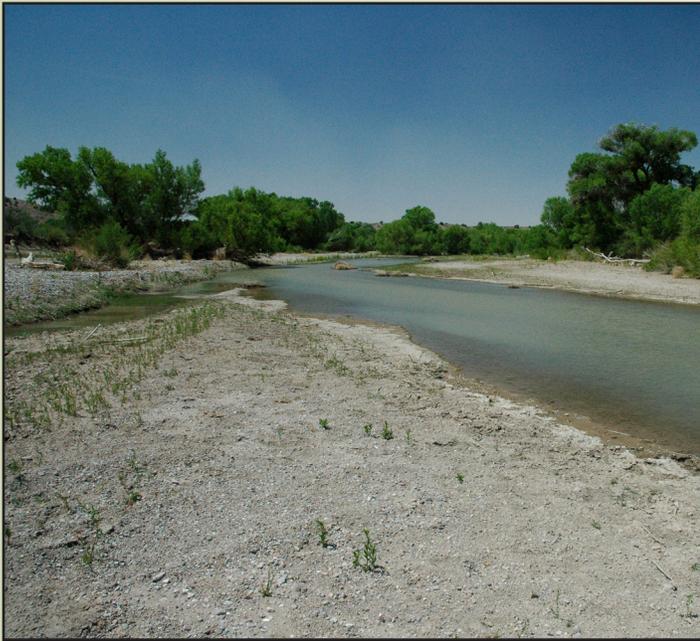
Photo 17 – Little micro-topographic variation, Gila River, Grant County

Topographic Variance or Surface Expression on Floodplain – Micro-topography increases surface roughness to dissipate energy and collect new sediment.

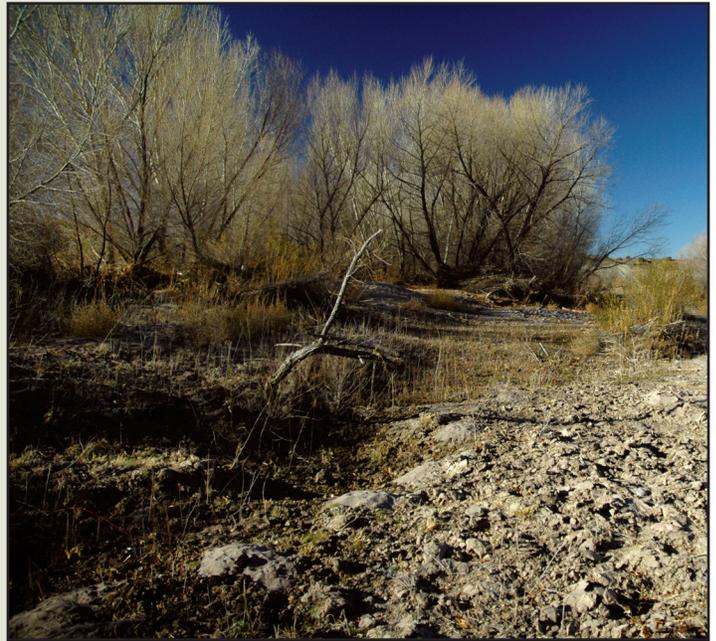
Photo 18 – Rock and large wood present, creating micro-topographic variation, Gila River, Grant County

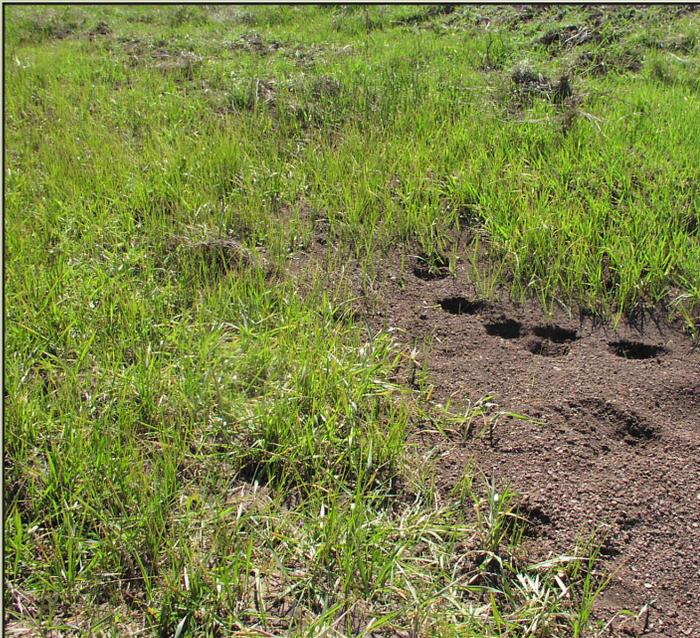
Photo 19 – No rock armor increases the opportunity for channel and bank erosion, Cottonwood Creek, McKinley County

Streambank Rock Armoring – Natural rock armor can lessen streambank erosion. Not all stream types and settings have rock armor. In some stream types, bank stability is provided exclusively by vegetation.

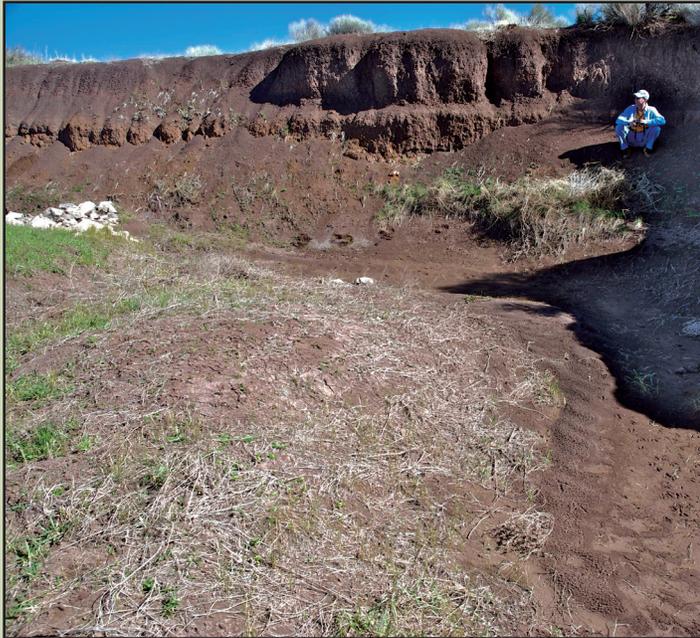
Photo 21 - Unstable point bars lead to unstable channels, Cottonwood Creek, McKinley County

Point Bar Revegetation – Point bars are indicative of a stream with a balanced channel width. New vegetation should begin to grow on newly deposited substrate.

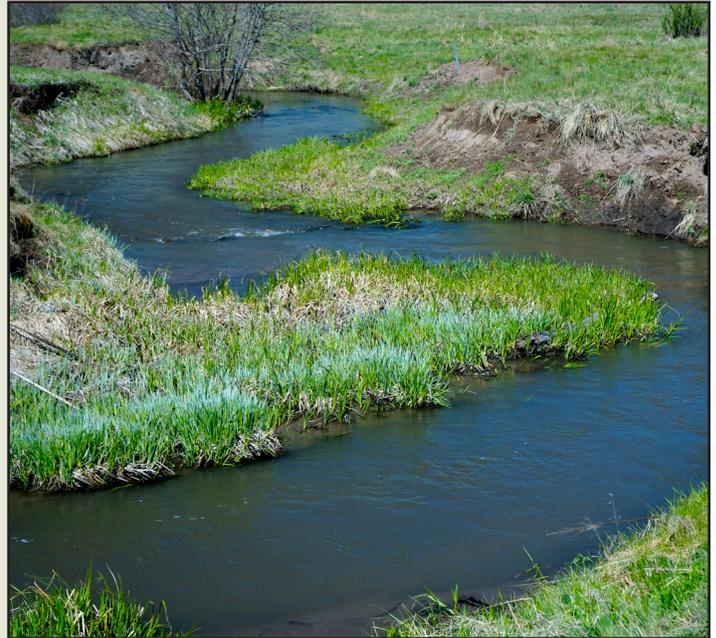
Photo 22 - Stable point bars are indicative of healthy channel width and function, Rio Guadalupe, Sandoval County

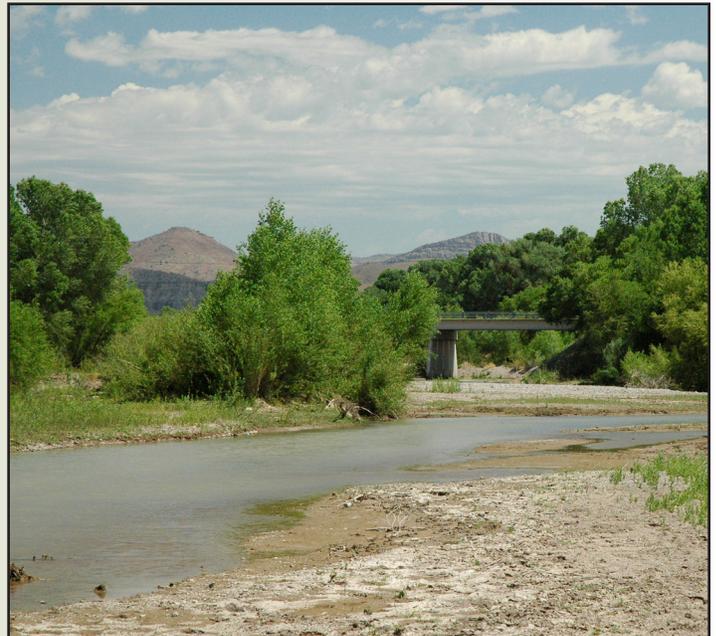
Photo 24 - Multi-aged, diverse species occupy healthy riparian corridors, Gila River, Grant County

Diverse Age Class Distribution of Trees – On stream types where trees are part of the natural community, age diversity is indicative of riparian health and stability.

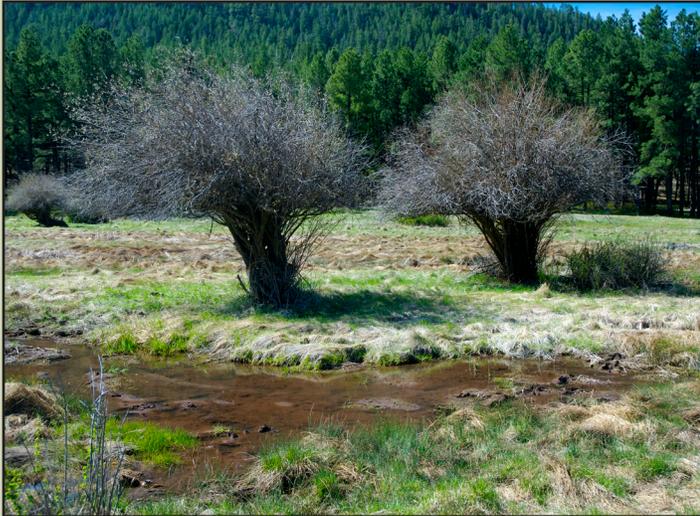
Photo 25 – Decadent willows, no seedlings or saplings, Rio Guadalupe, Sandoval County

Diverse Age Class Distribution of Shrubs – On stream types where shrubs are part of the natural community, age diversity is indicative of riparian health and stability.

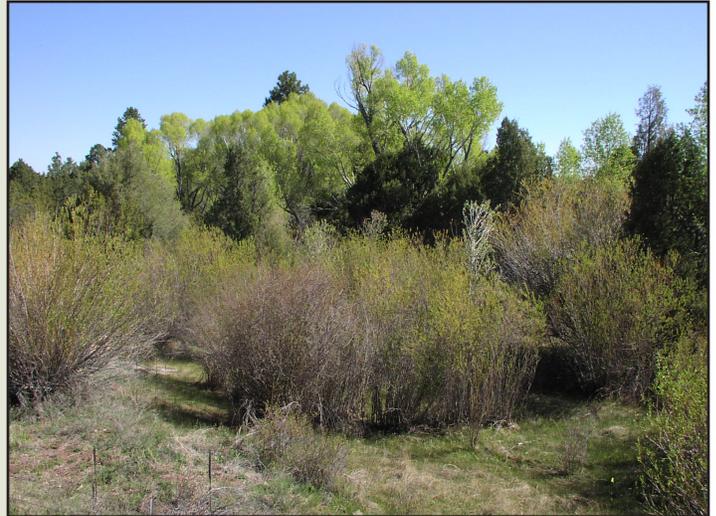
Photo 26 – Diverse age class and species composition, Sawyer Creek, McKinley County

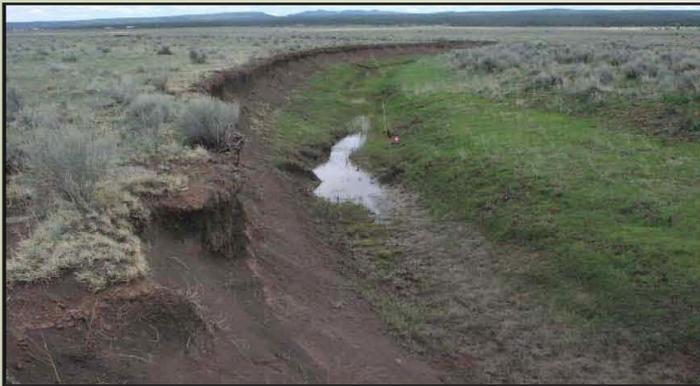
Photo 27 – Less than 50% groundcover, Cottonwood Creek, McKinley County

Total Ground Cover of Grasses and Forbs – Vegetation reduces the affects of erosion and captures sediments during overbank events.

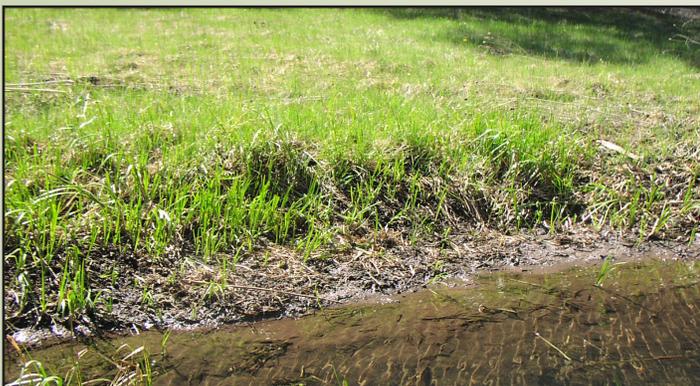
Photo 28 – 75% to 95% groundcover Bluewater Creek, Cibola County

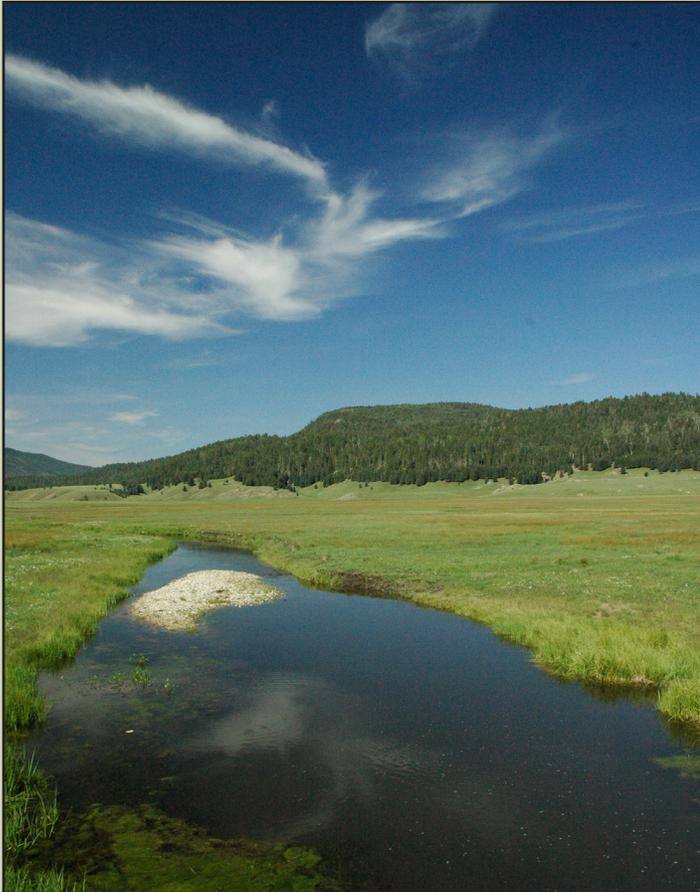
Photo 30 – Greater than 95% coverage, East Fork Jemez River, Sandoval County

Bank Stability – Stable banks result in less sedimentation and can be better protected with vegetation.

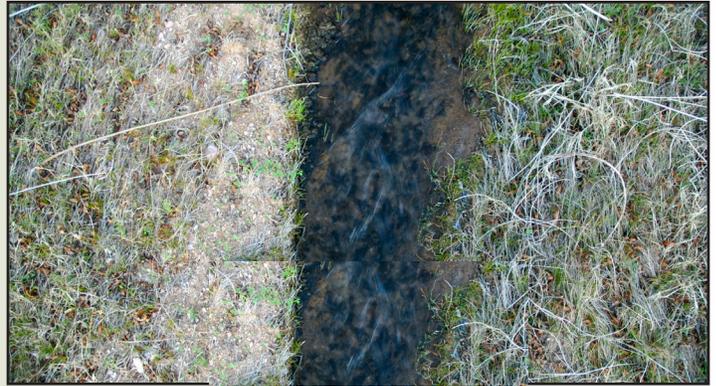
Photo 31 - 50% to 75% coverage, Burro Cienega, Grant County

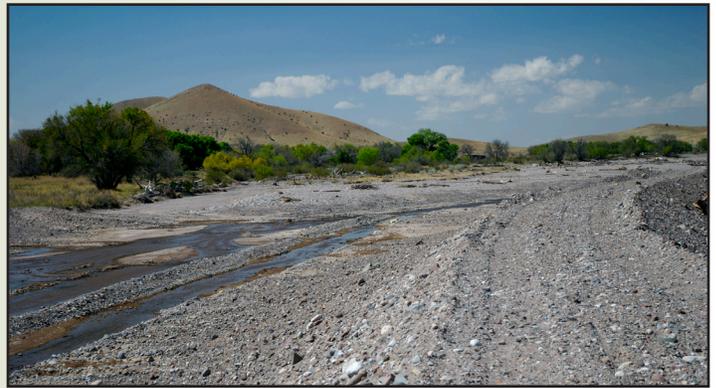
Photo 32 – Less than 50% coverage, Mimbres River, Grant County

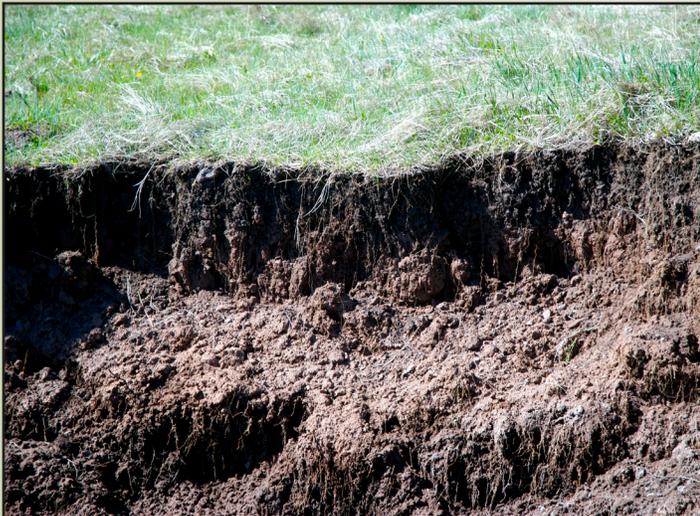
Photo 33 – Less than 25% of the bank with deep binding root mass (pasture grasses), Rio Guadalupe, Sandoval County

Percent of the Streambank with a Deep, Binding Root Mass – Riparian species with high root densities lead to greater bank stability.

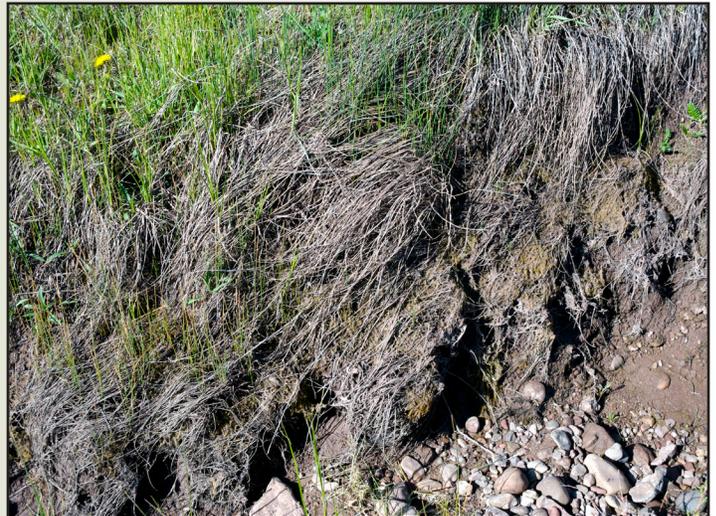
Photo 34 – Greater than 75% of the bank with a deep binding root mass (sedges), Cottonwood Creek, McKinley County

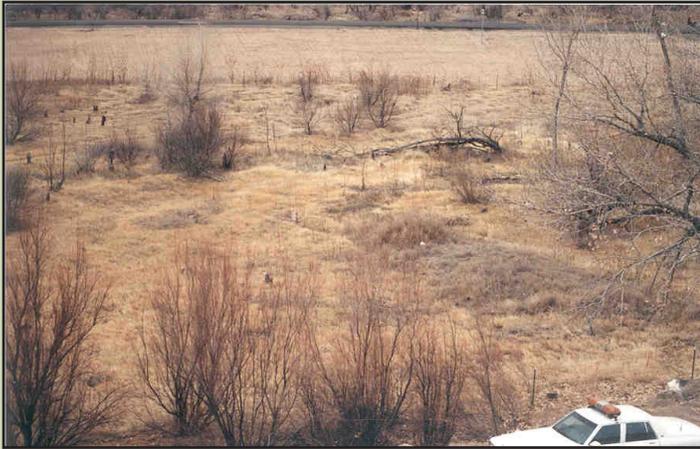
Photo 37 – A Saltcedar/salt grass meadow in Hernandez, NM before a pond is excavated where the annual precipitation is about 11 inches.

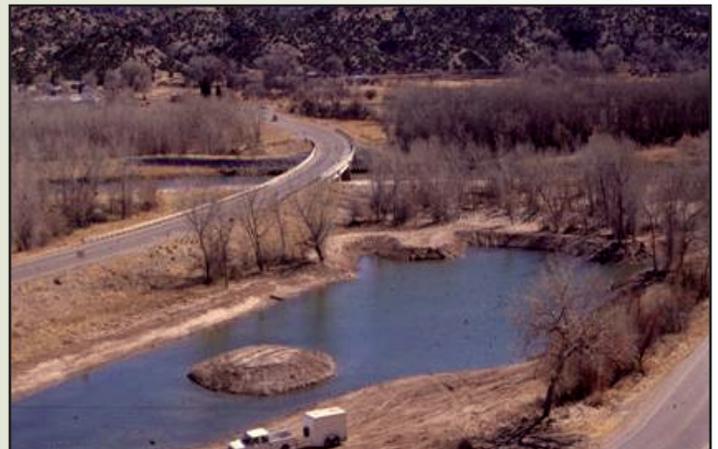
Photo 38 – Before planting, the perimeter of the pond was only vegetated on the south bank with mature cottonwood trees which were left untouched.

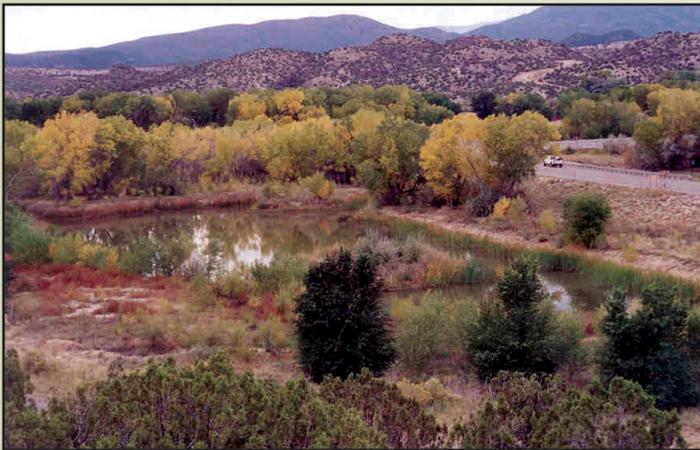
Photo 39 – The planting included: 2,000 wetland plants (bulrush, sedge, spike rush and rushes), 4,000 coyote willow, 500 cottonwood and black willow pole cuttings, and 200 longstem shrubs. Survival of the plant materials averaged about 70% after ten years. No supplemental water has been provided

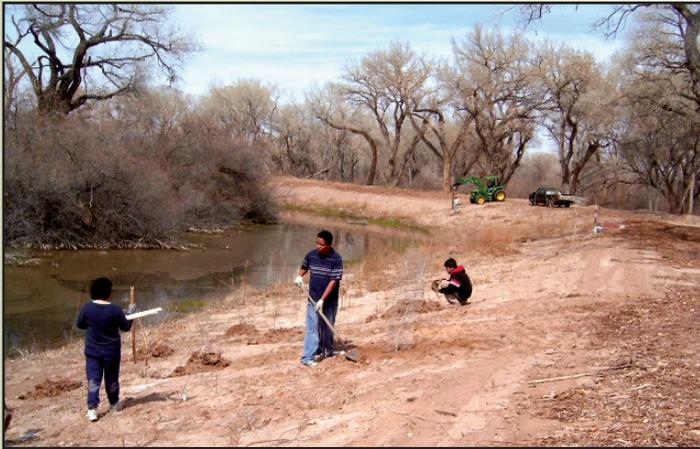
Photo 41 – 125 long-stem transplants, and 50 cottonwood and black willow poles cuttings were planted in February.

Saltcedar, Russian olive, Siberian elm were mechanically removed from a pond bank in Belen, New Mexico, where the annual precipitation is less than 10 inches. The slope of the pond was reduced to control erosion.

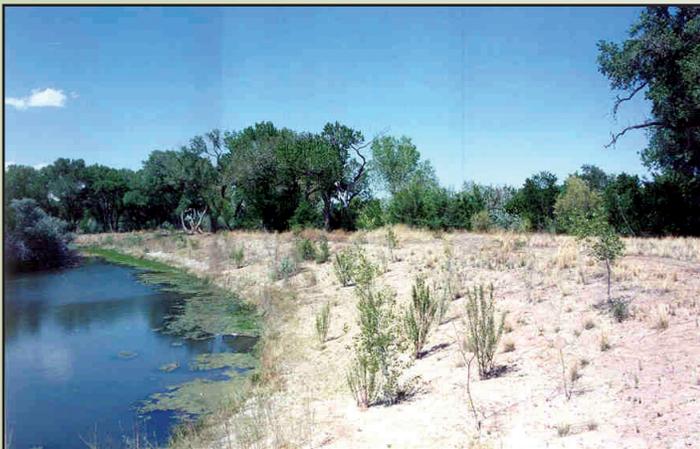
Photo 43 – By the end of the second growing season, transplants, pole cuttings, and grasses seem to be well established. The shrub and pole cuttings had a better than 80% survival with only one initial irrigation.

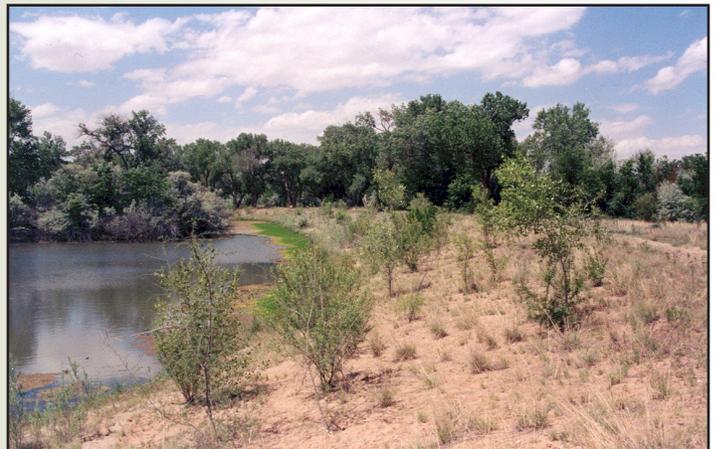
Photo 44 – By the fourth growing season, the vegetation seemed to be at a maturity stage where surface erosion may be controlled.

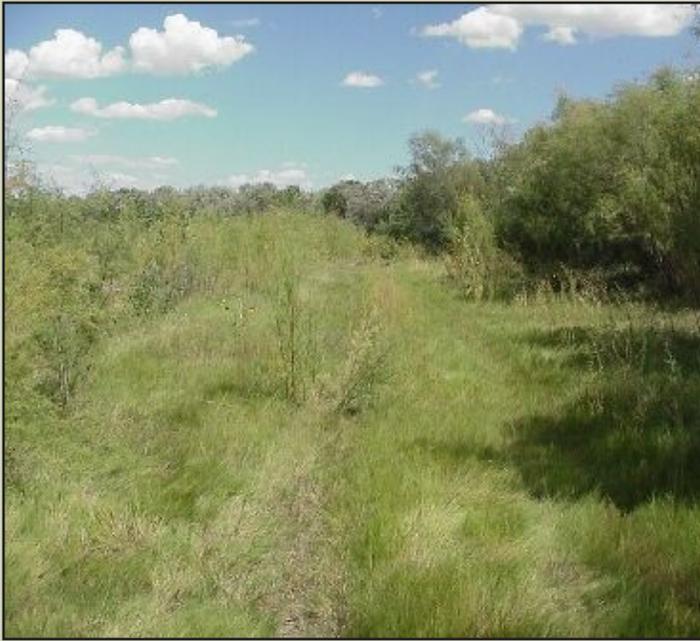
Photo 45 – Saltcedar and Russian olive were treated using the cut stump method with the chemical Triclopyr to control resprouting of the stumps on the San Juan River near Farmington, New Mexico. The annual precipitation averages less than 10 inches at this location.

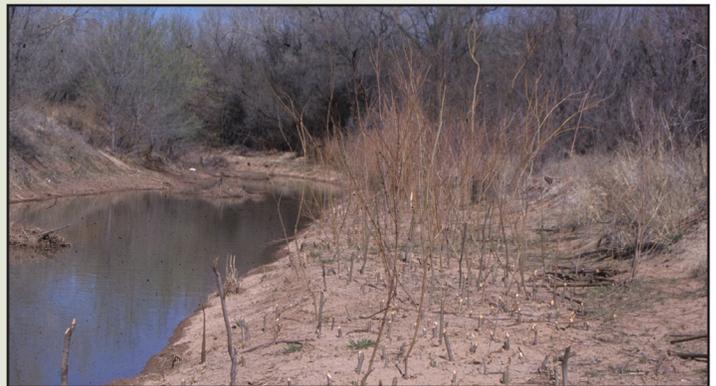
Photo 49 – Beaver predation of planted willow is common. However, because a 30 inches stem is planted, there is plenty of stem carbohydrate reserves available for re-sprouting.

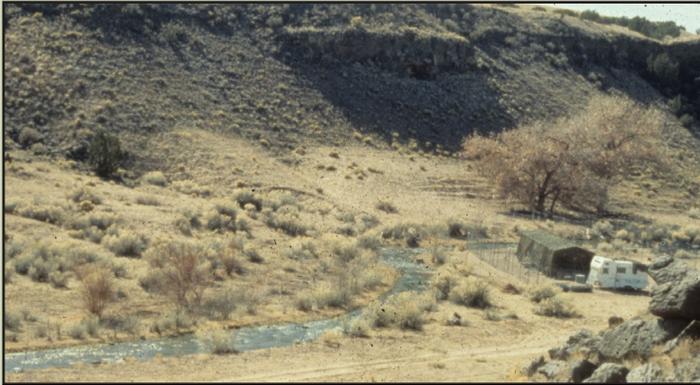
Photo 50 – A fence was built around this 7 acre planting site to protect it from cattle grazing on the Rio Santa Fe near Pena Blanca, New Mexico, where the annual precipitation is less than 12 inches.

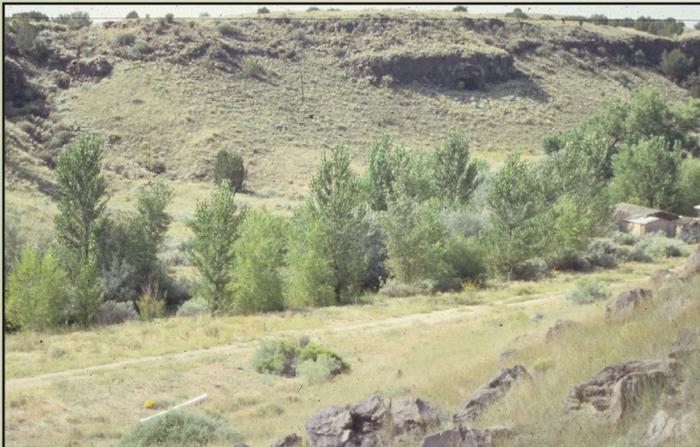
Photo 51 – A total of 350 cottonwood and black willow pole cuttings, 1,000 coyote willow whips, and 200 transplants were planted.

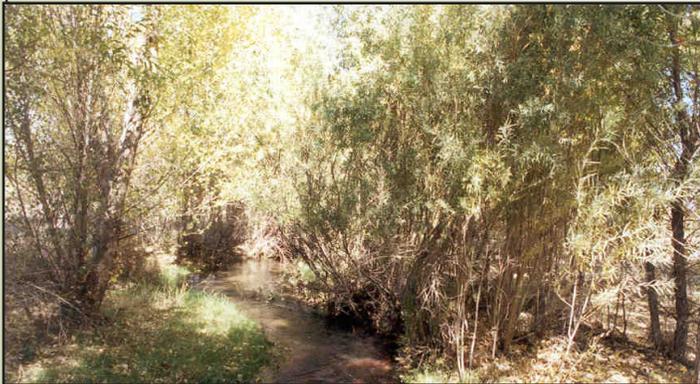
Photo 52 – By the tenth year, survival of all plants averaged about 75% and provided a closed canopy, shading the stream and enhancing fish habitat. Three supplemental irrigated treatments were provided only to the transplants: two treatments the first year and a third treatment the second year.

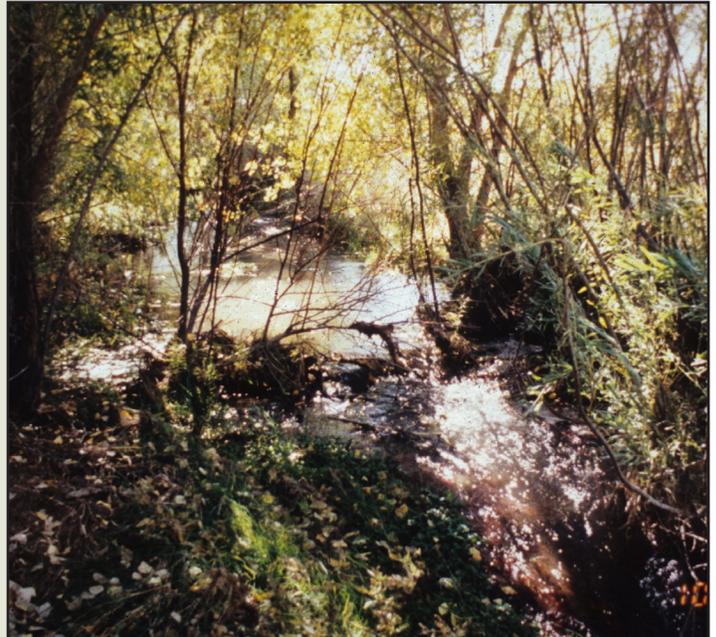
Photo 53 – Woody debris from the planting often falls in the river and may form log jams causing step pooling.

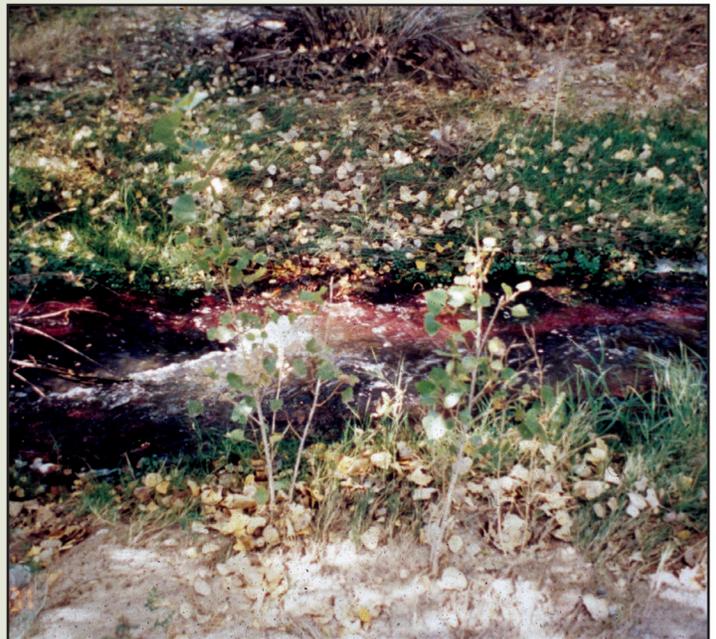
Photo 54 – Step-pooling resulted in some overbank flooding, providing the environment for natural recruitment of cottonwood seedlings.

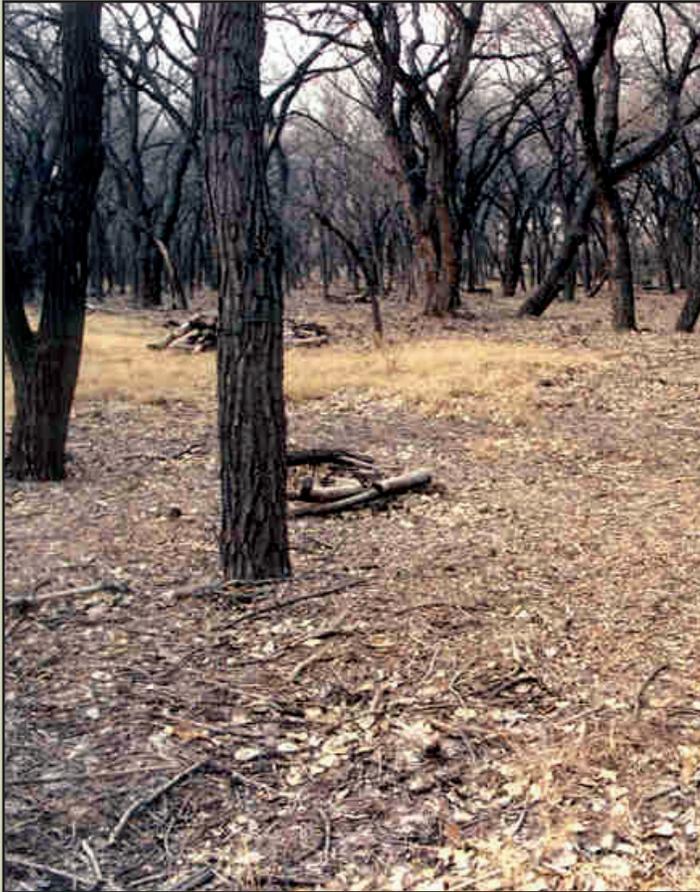
Photo 55 – 3,000 long-stem transplants were planted on this forty acre site. Plants were grouped by species and planted in mosaic patterns over the area. Plant species included screwbean mesquite, golden current, skunkbush sumac, false indigo, netleaf hackberry, New Mexico olive, and false willow. After three years, survival is averaging 85%, no supplemental water has been provided to the plants.

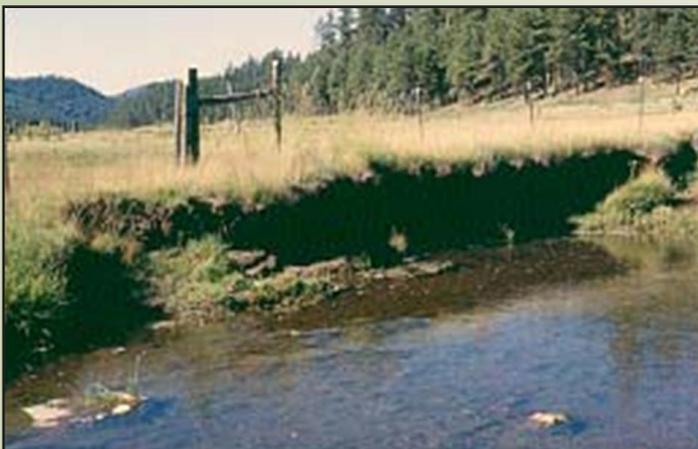
Before treatment in 1999, Rio de las Vacas, Sandoval County

Assistance was requested by the landowner to address an eroding streambank that was undermining a property line fence. The initial site investigation was conducted in August, 1997. The stream exhibited some incision which was limited by cobble to boulder armoring in the streambed. Excessive lateral erosion had occurred and was aided by the removal of riparian woody vegetation on the privately owned lands. Cutbanks can be observed throughout the valley, removing valuable topsoil from some of the pastures. The stream flow, while perennial, can fluctuate greatly depending on the amount of winter snowpack and the number and intensity of summer thunderstorm events.

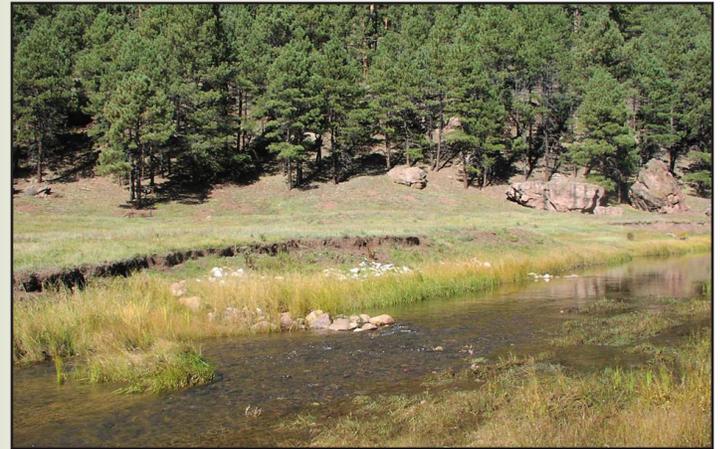
Treated site in 2006, Rio de las Vacas, Sandoval County

The project has been in place for over ten years. It has performed during spring runoff events with minimal damage. The only repairs have consisted of restacking some of the rocks from the nose of several of the barbs. These rocks had been rolled off of the barbs during high and extended flows, but overall the damage has been minimal. Woody riparian vegetation has not recovered due to continued grazing. The herbaceous species, including sedges and rushes, have increased in frequency and density. Some trampling and trails behind the barbs have continued to have detrimental effects on the treated streambanks.

This project has functioned as designed for ten years. The treated streambank has remained relatively stable although there has been minor recession as the bank reaches a stable angle of repose. The fence remains in place and has not been moved as was required before the treatment. The bank has more vegetation and more desirable riparian species than before the treatment. The stream barbs have been effective in keeping the lateral movement of the stream in check and also capturing new coarse sediment behind the barbs. The project continues to be monitored and photographed yearly.
