# Assessing Aquatic Habitat Quality in Restored Arroyos at Rio Mora National Wildlife Refuge

*Eliza Montoya and Dr. Edward Martinez*

Department of Natural Resource Management, New Mexico Highlands University

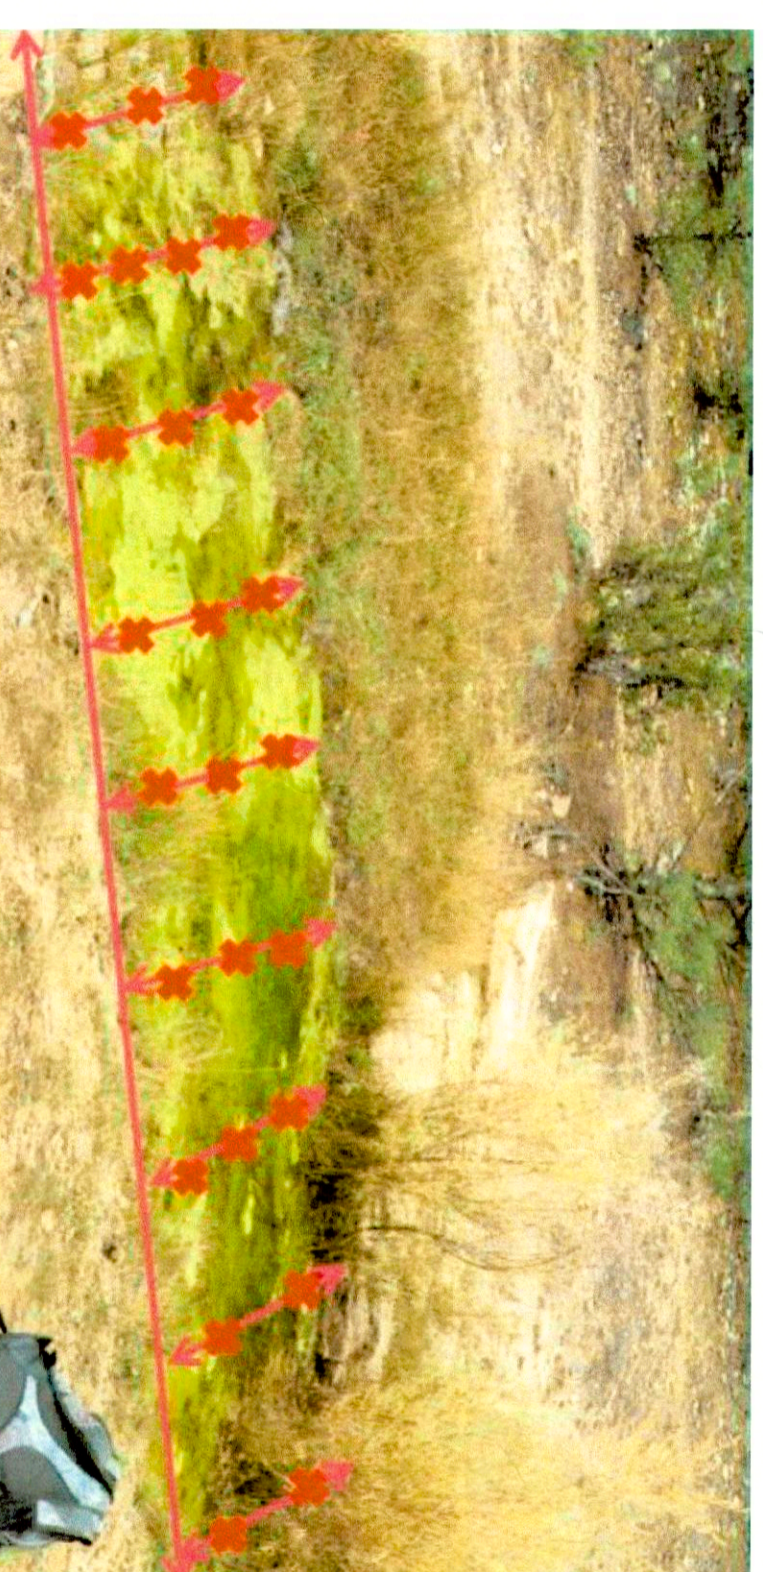
Figure 2. Weekly pool morphology surveys were completed by measuring the width, length, and depth of each study pool.

- Length, width, and depth were measured in order to calculate relative volume during seasonal fluctuations.

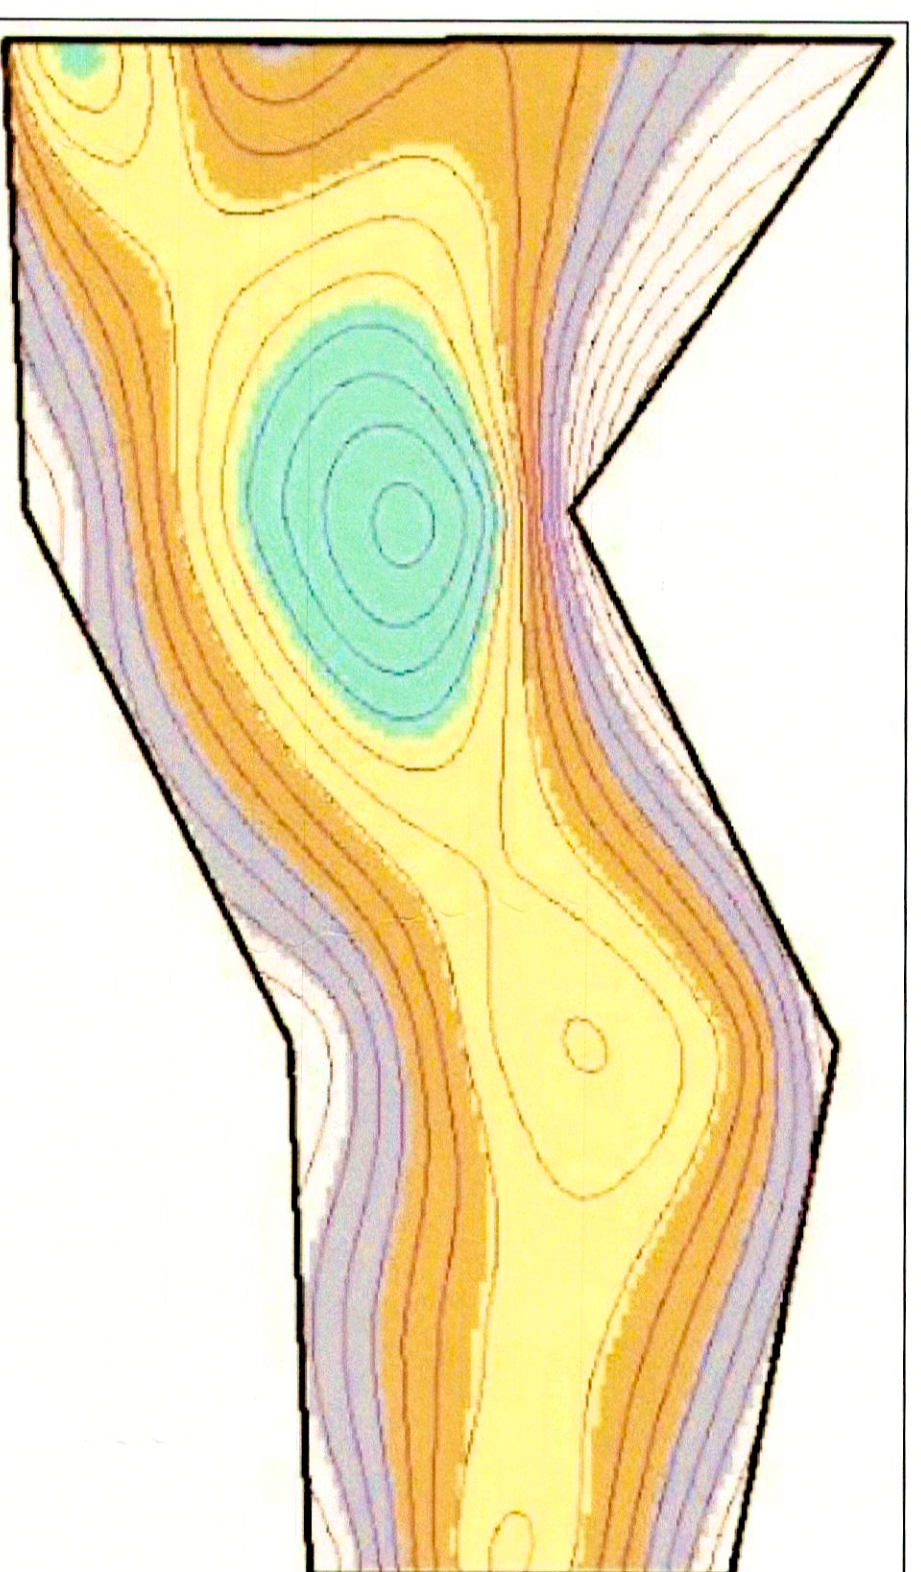
Figure 3. Study pool spline image created in ArcMap 12.2.2.

- Excel spreadsheets are added to a new map in ArcMap 10.4.1.
- A polygon is created around the pool where depth measurements were taken.
- The spline tool is used to interpolate depths between known points.
- Relative volume is calculated using the 3-d analysis tool, surface volume.

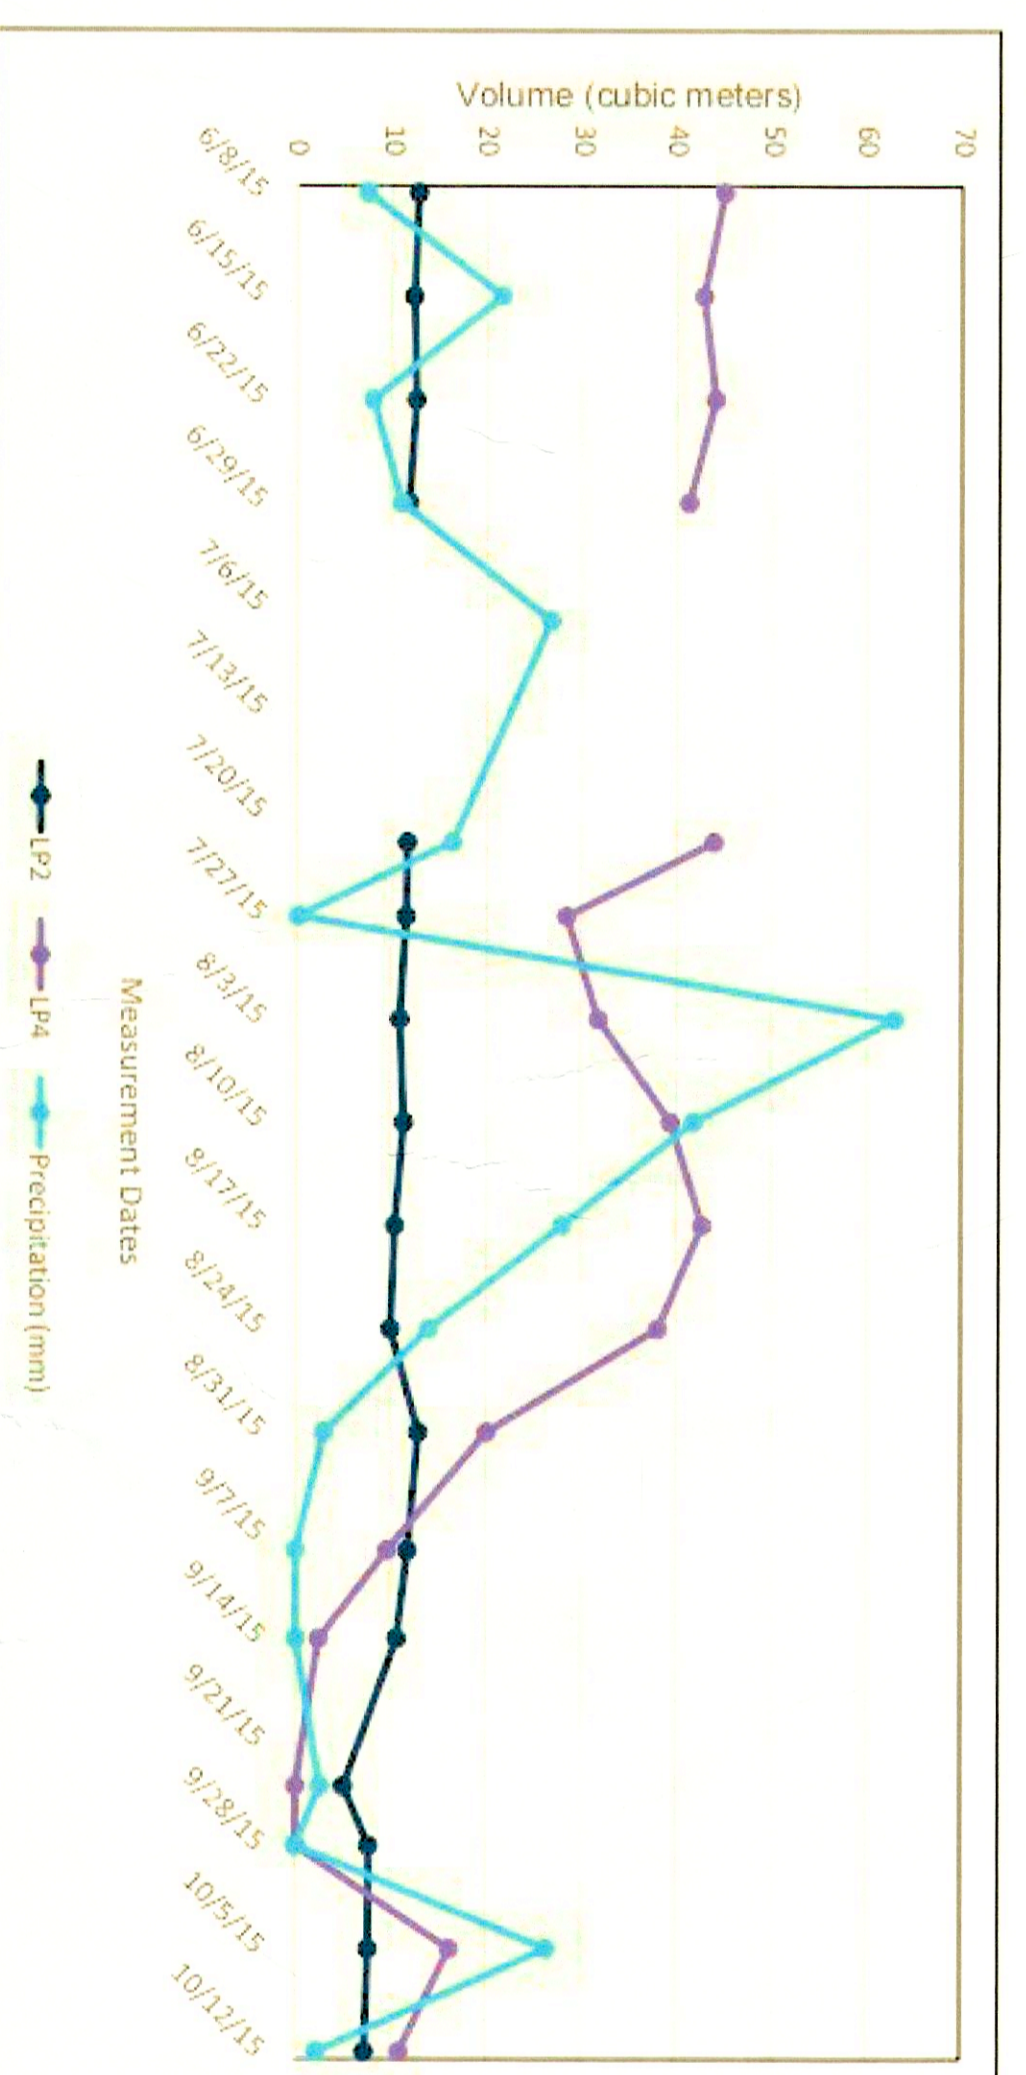
Figure 2. 2015 Relative volume (m<sup>3</sup>) measured at Loma Parada from LP2 and LP4 study pools, Rio Mora NWR, NM and weekly precipitation measurements in Loma Parada.

Pools created by grade control structures were mostly ephemeral. In large study pools (>5 m<sup>3</sup>) during 2015, relative volume was consistent. However, during a five-week dry period (8/31/2015-9/28/2015), large study pools experienced a decrease in relative volume. One large study pool (LP4) completely dried out during this period. Smaller study pools (<5 m<sup>3</sup>) had more fluctuations in relative volume throughout the 2015 sampling season. These smaller pools did not dry out during the five-week dry period. LP1A did not hold any water during the 2016 season due to being filled in with sediment when the dam above blew out in 2015.

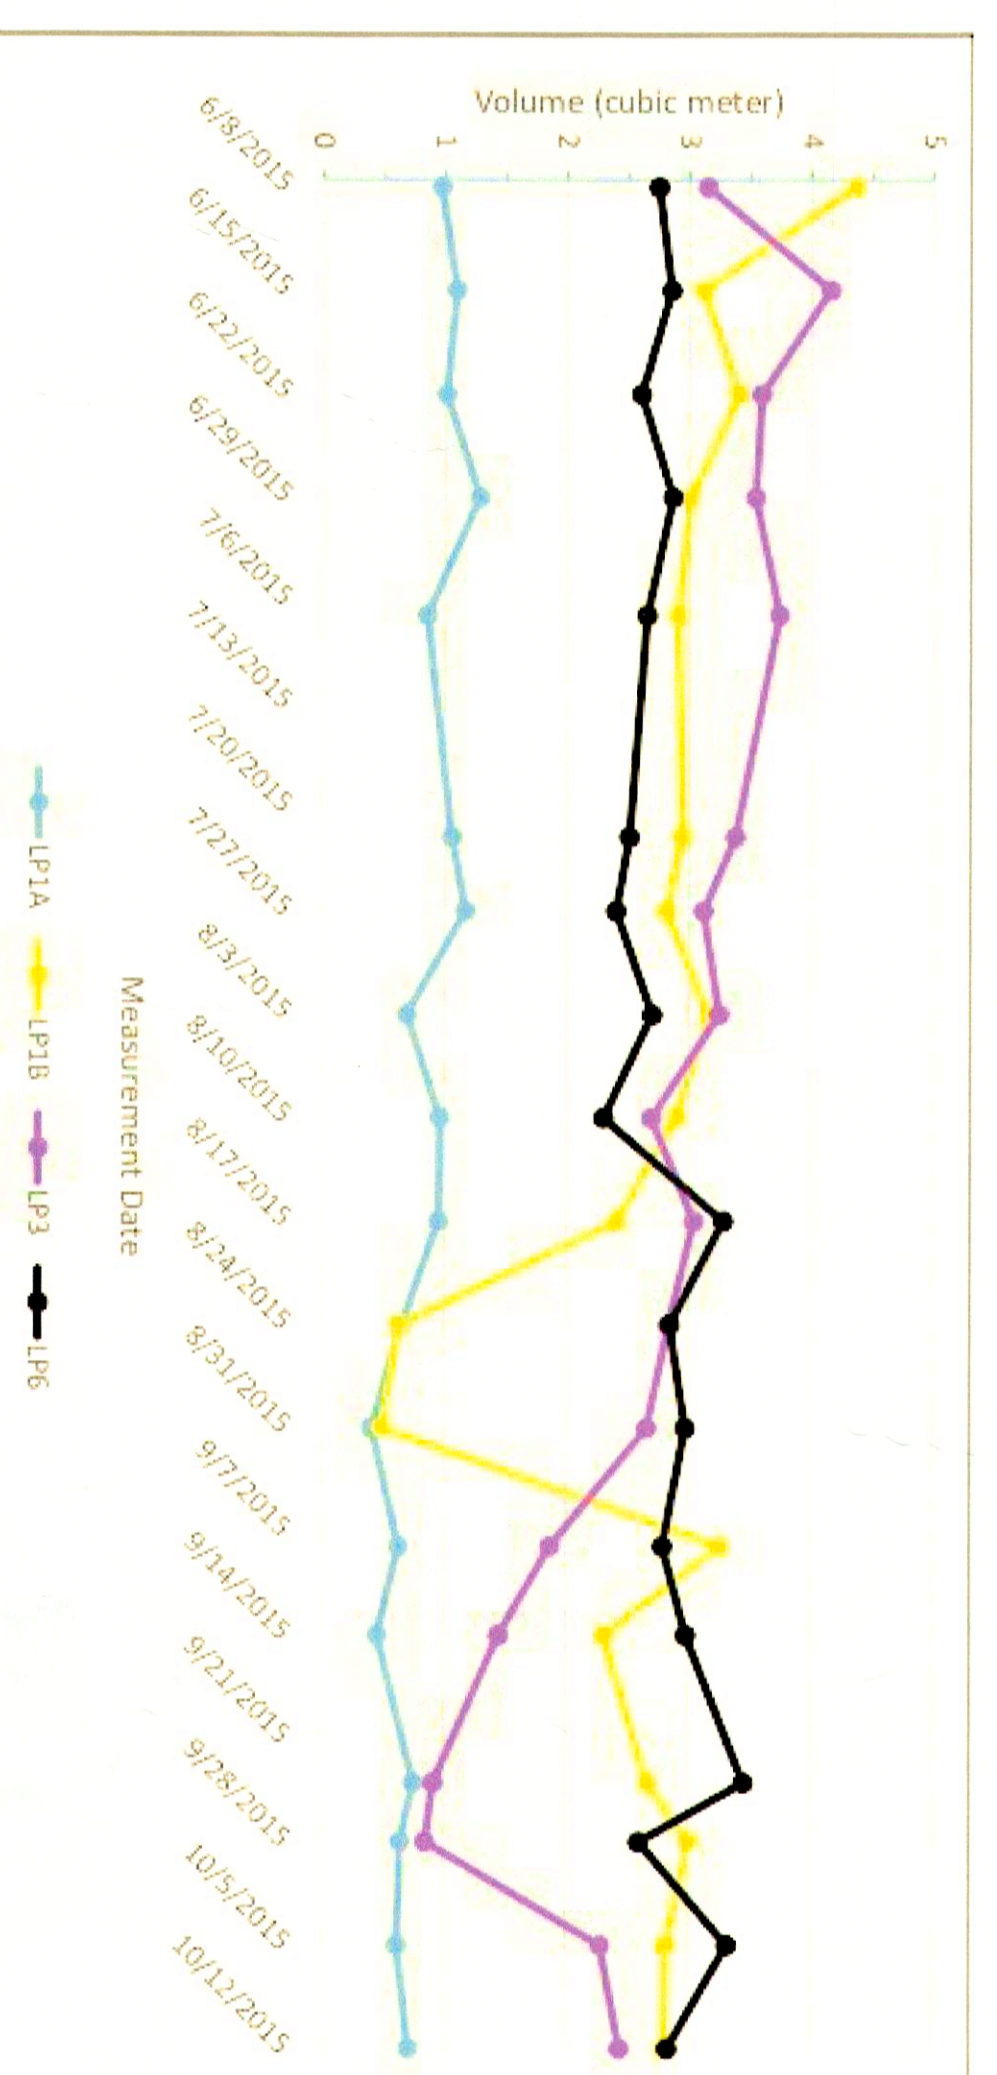
Figure 3. 2015 Relative volume (m<sup>3</sup>) measured at Loma Parada from LP1A, LP1B, LP3 and LP6 study pools, Rio Mora NWR, NM.

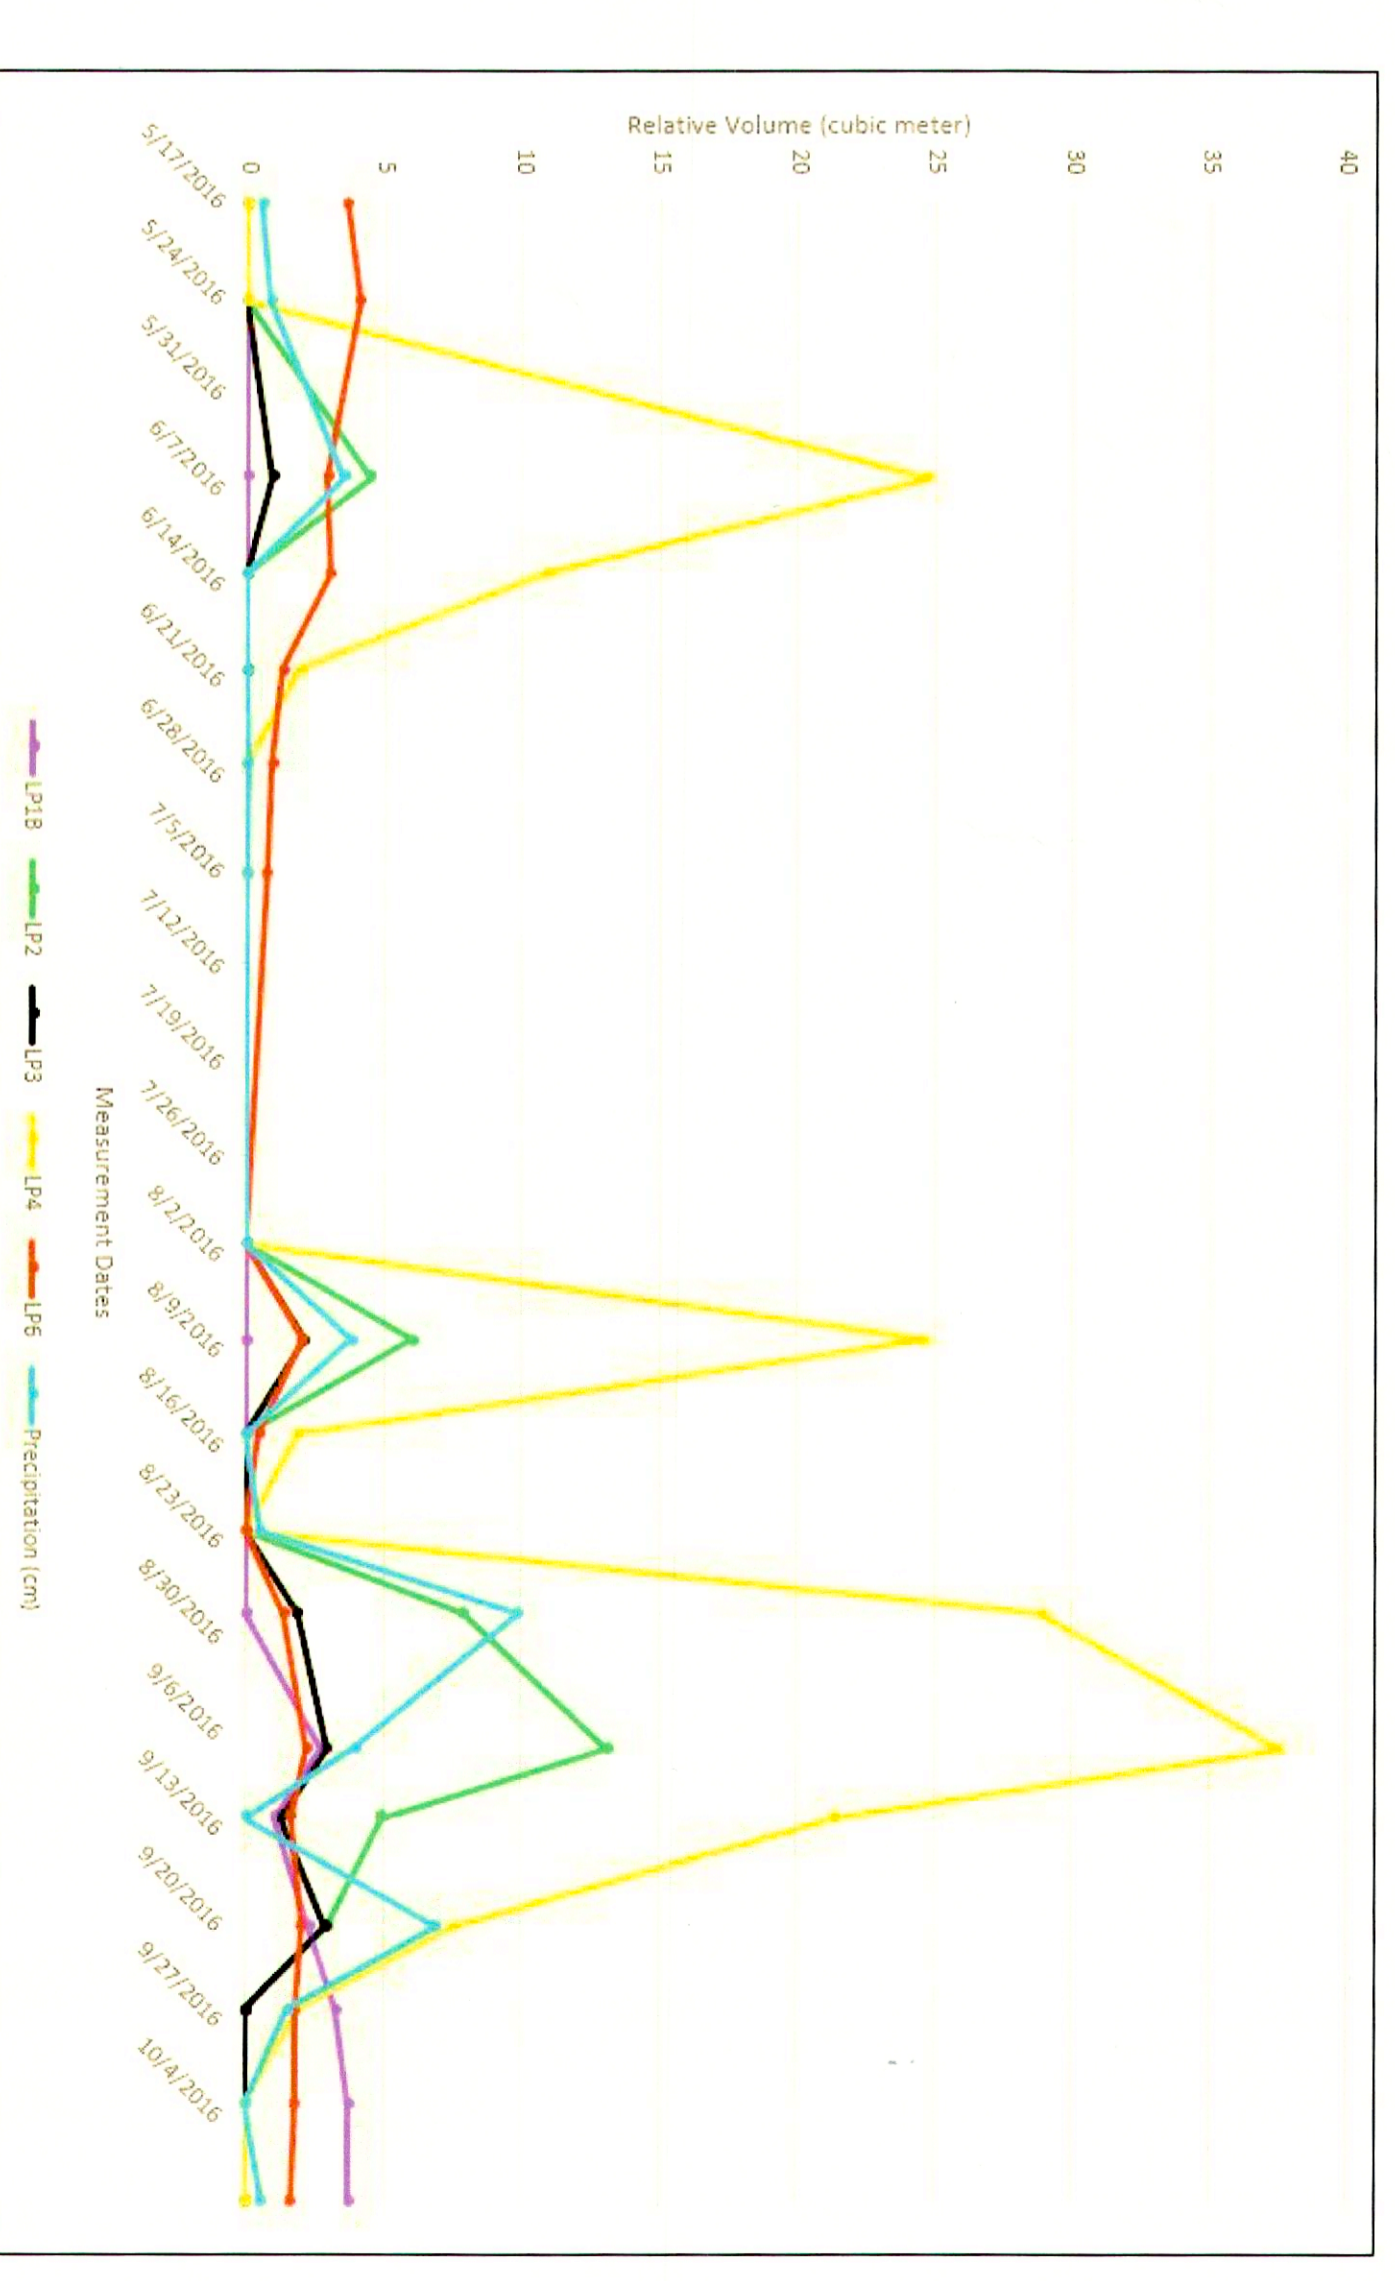
Figure 5. 2016 Relative volume (m<sup>3</sup>) measured at Loma Parada from, LP1B, LP2, LP3, LP4 and LP6 study pools, Rio Mora NWR, NM.

During the 2016 season, we saw longer dry periods than the previous year. This resulted in the loss of more water and every pool was dry at some point during the sampling season. LP6 relative volume was consistent for the duration of the 2016 season. In 2015, we didn't see a big correlation between relative volume and precipitation events. However, in 2016 there is a clear correlation between relative volume and precipitation events. Loma Parada arroyo is fed via precipitation events and sub-surface flow from stock ponds above the study pools. This can contribute to higher relative volume for longer periods of time. As a result of extended water availability in degraded arroyos through grade control structures, terrestrial habitat was created, providing refuge for aquatic and terrestrial wildlife. These structures appear to facilitate the recovery in these degraded systems.
