# **SAPELLO WATERSHED RESTORATION PROJECT**

## **FY02-J FINAL REPORT**

**Submitted to Surface Water Quality Bureau, New Mexico Environment  
Department, and the Environmental Protection Agency, Region VI  
February 2007**

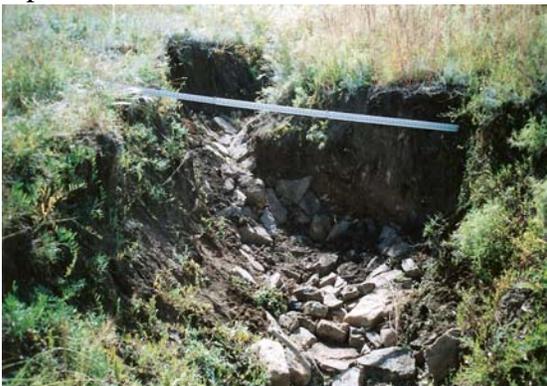
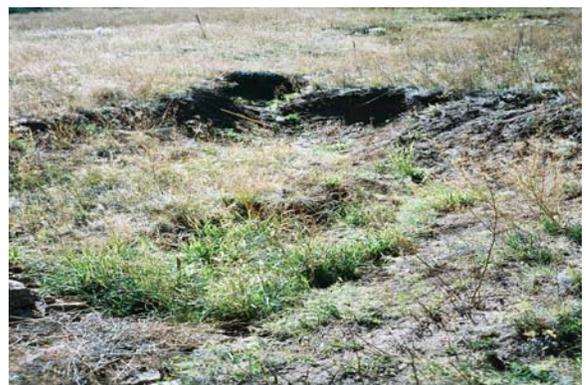
48 structures were built along **1200'** of an arroyo located on the Ernestine and Mary Ann Perea property in 2003 and 2004. This was another property that was affected by the Manuelitas fire. Some of the 2004 work was follow up maintenance, but the majority was adjusting or installing new structures applying different techniques learned while attending erosion control workshops taught by Bill Zeedyk. As noted below, after the good monsoon season of 2005, that the gully bottoms are healing and banks beginning to repose back.

Photos of structure installed and the after effect of the structure on the Perea property. These structures assist with erosion and runoff control.

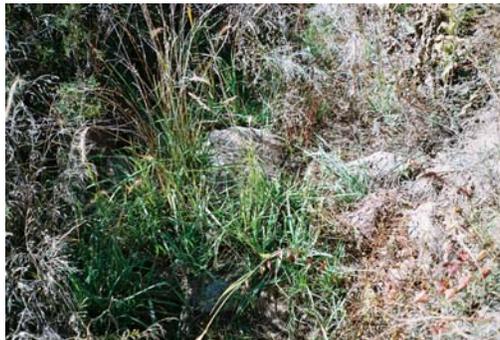
Photo of area seeded, within installed structure, after 1 year of growth

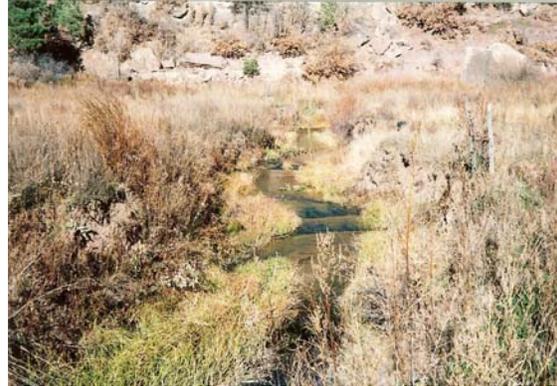
After induced meandering on Nelson's property

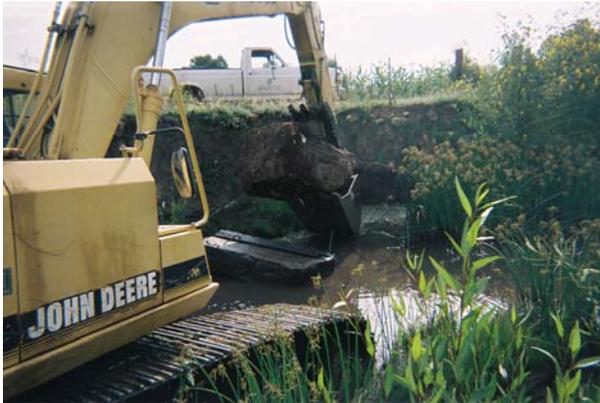
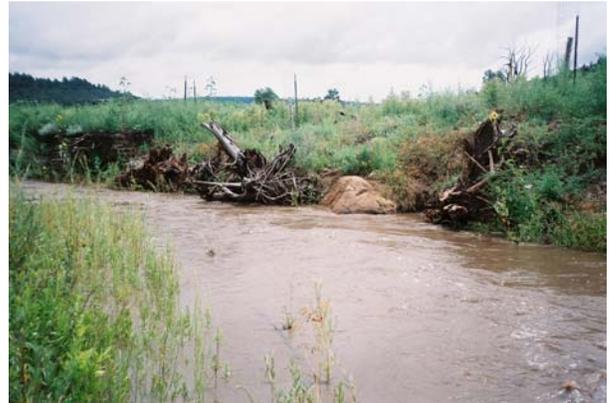
Root wads installed August of 2005, one year later

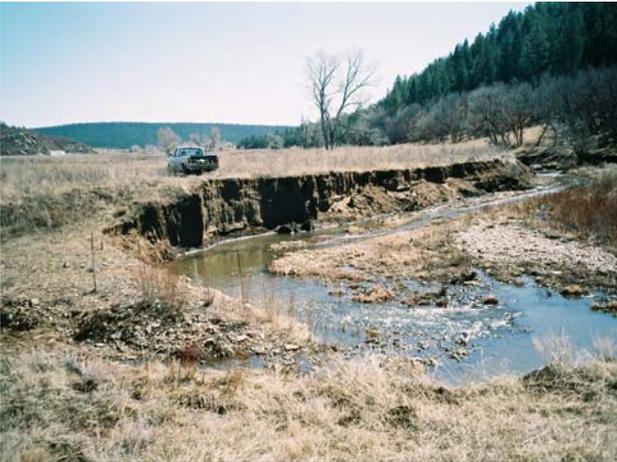
Before installation of vanes

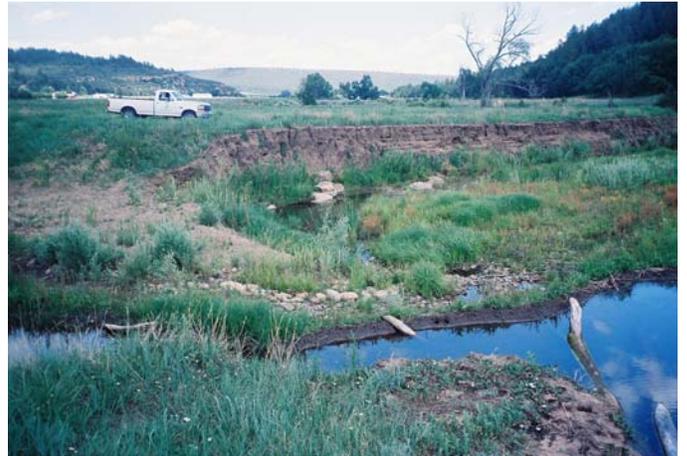
After installation of vanes for streambank stabilization

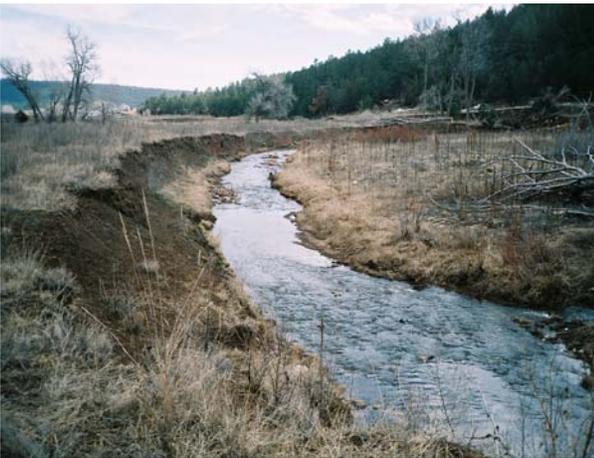
Before induced meandering

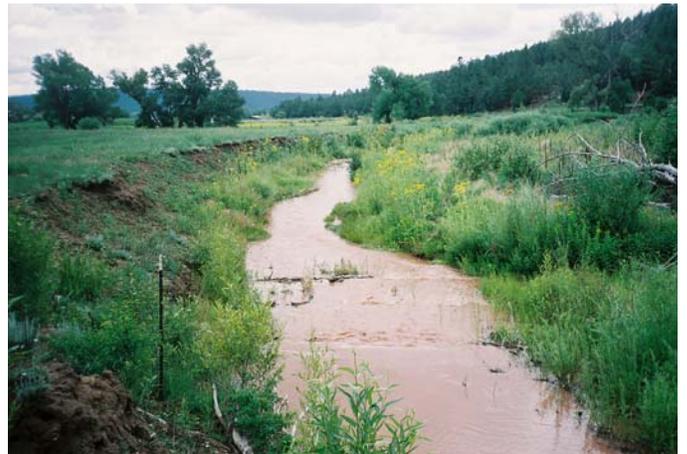
After induced meandering

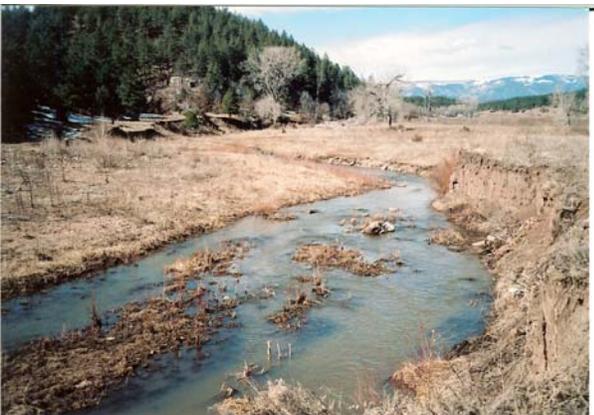
Before baffle installation

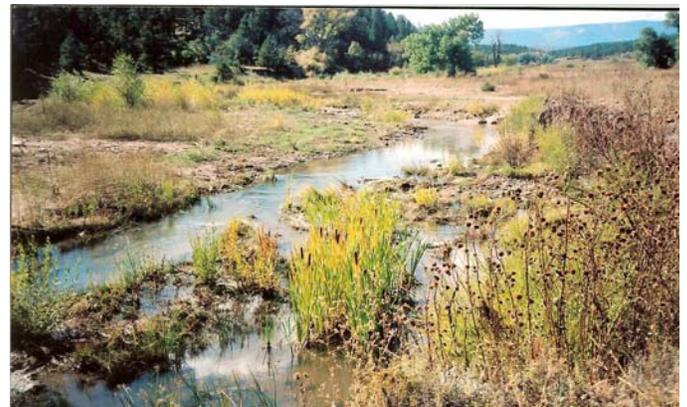
After baffle was installed

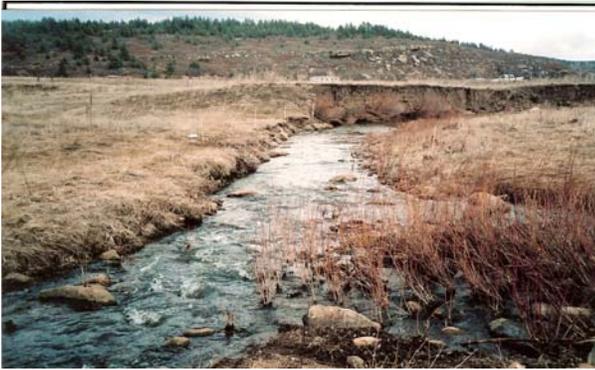
Before crossvanes were installed

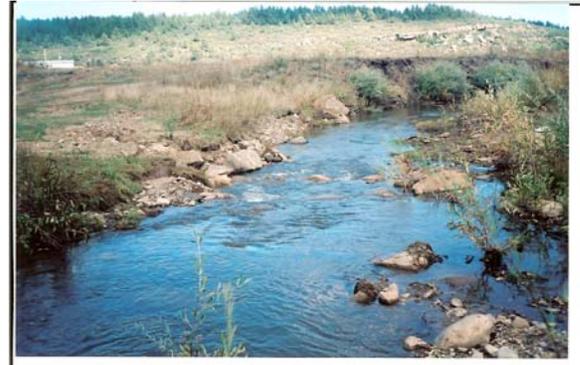
After installation of crossvanes

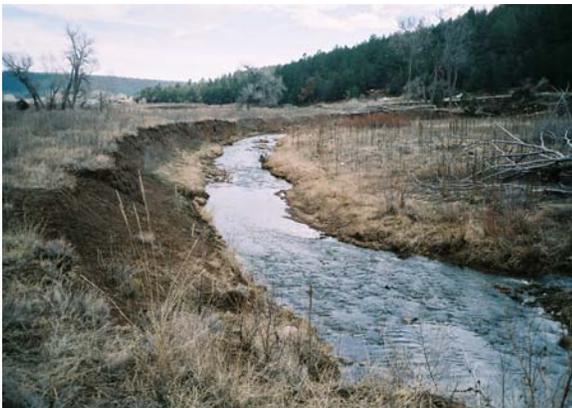
Before boulder vanes were installed

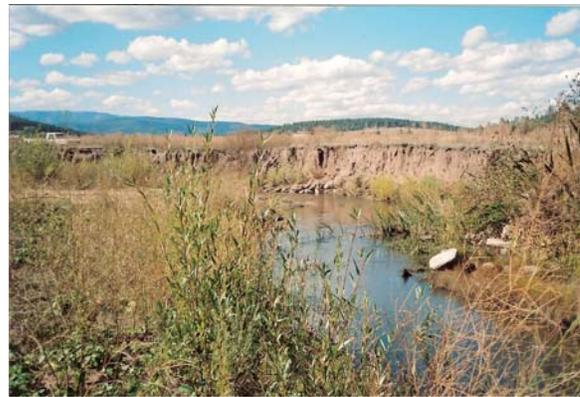
After boulder vanes were installed

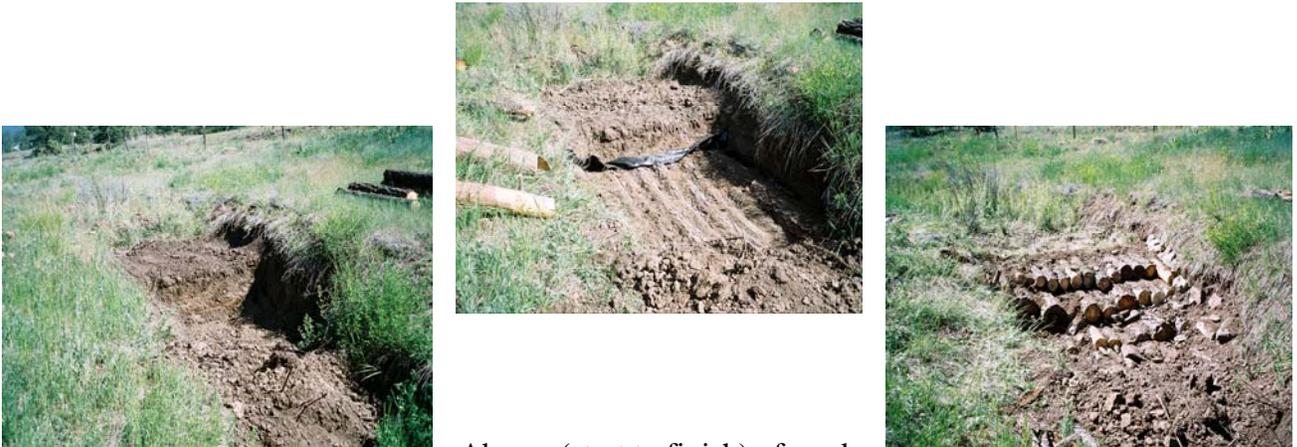
Five log head cut structures and 7 smaller rock structures were installed on this 600’ project arroyo site using local materials.

Above, (start to finish) of work involved in building one structure with approximately 40 logs.

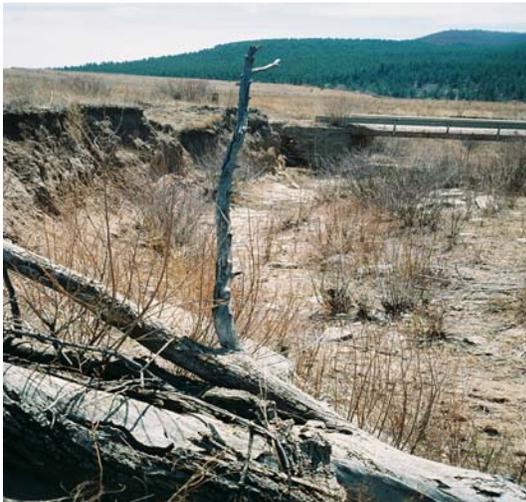
Before work on County Bridge

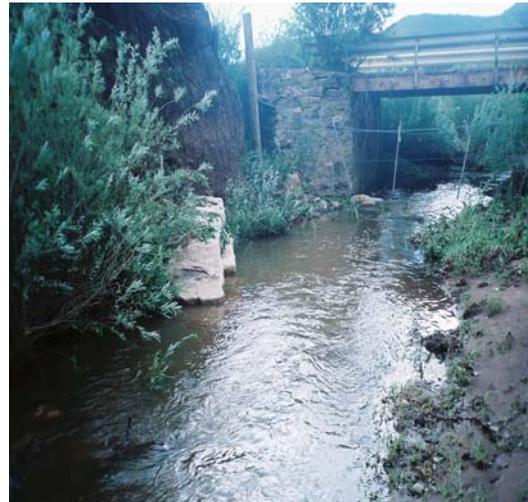
After installation of vanes to prevent further undercutting of bank

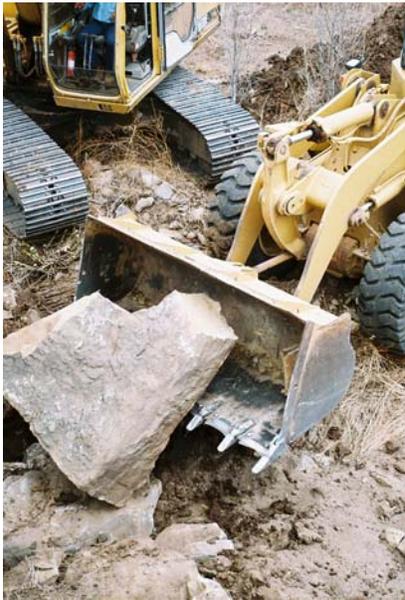
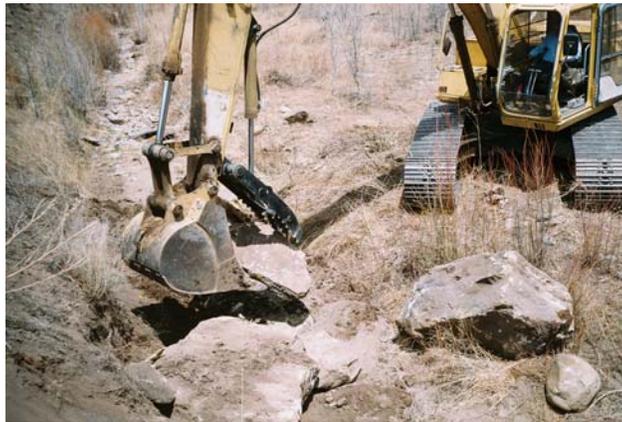
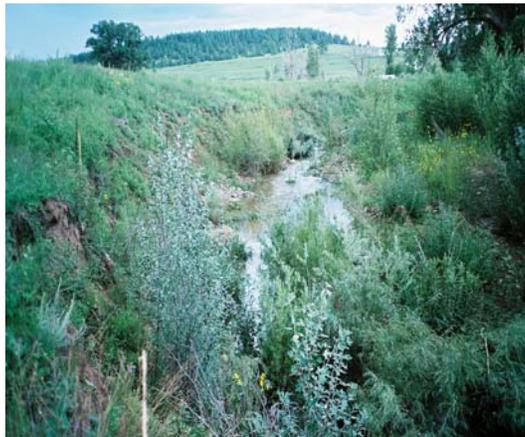
Below, footer boulders being placed on the Arroyo Horno streambed elevation, to avoid under-cutting of the vane structures.

Same area after above vane was installed

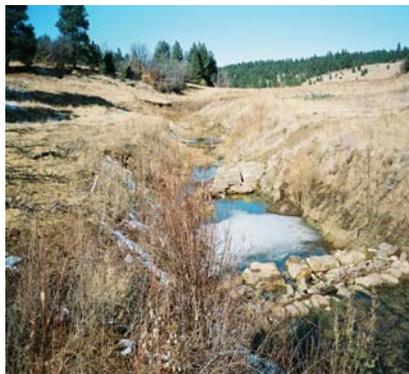
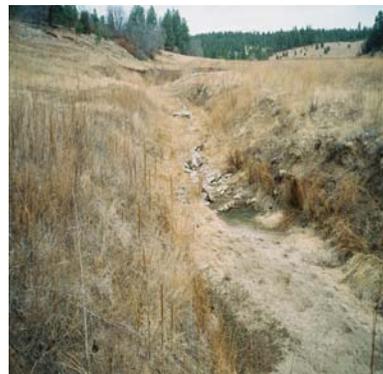
Below are two photos of the upper reach, before and after. At right is a rock/boulder weir, boulder baffle and at left, another weir and baffle above it.

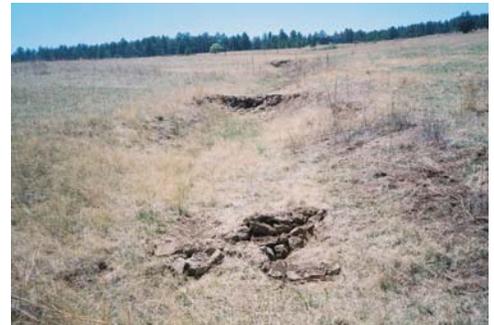
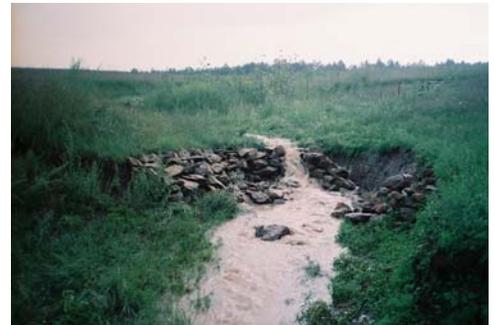
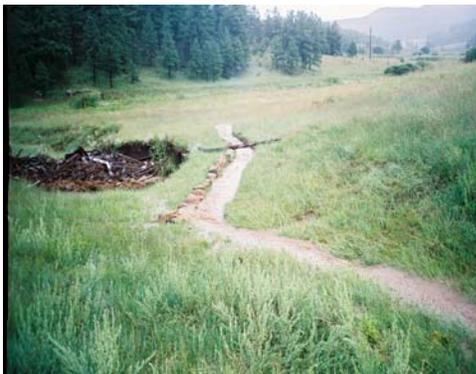
At right, the upper part of the arroyo after construction of head cut structures and a partially failed structure during a storm event. 11 more structures were built consisting of rock bowls, one rock dams, baffles, a silt dam and a “media luna” or half moon rock structure.

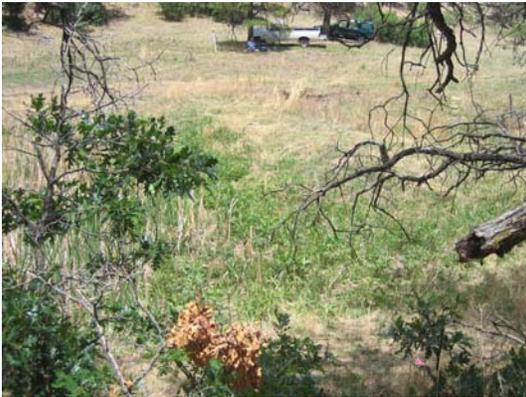
Tank prior to work

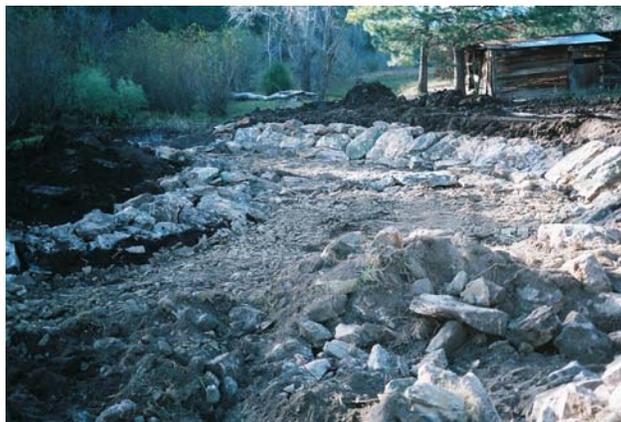
Tank upon completion of work

Boulders and rock for this spillway, the lower reconnection channel and the 9 structures involved, were harvested on site. This spillway required over 90yds<sup>3</sup> to complete. The above mentioned wetland area is in the photo's background.

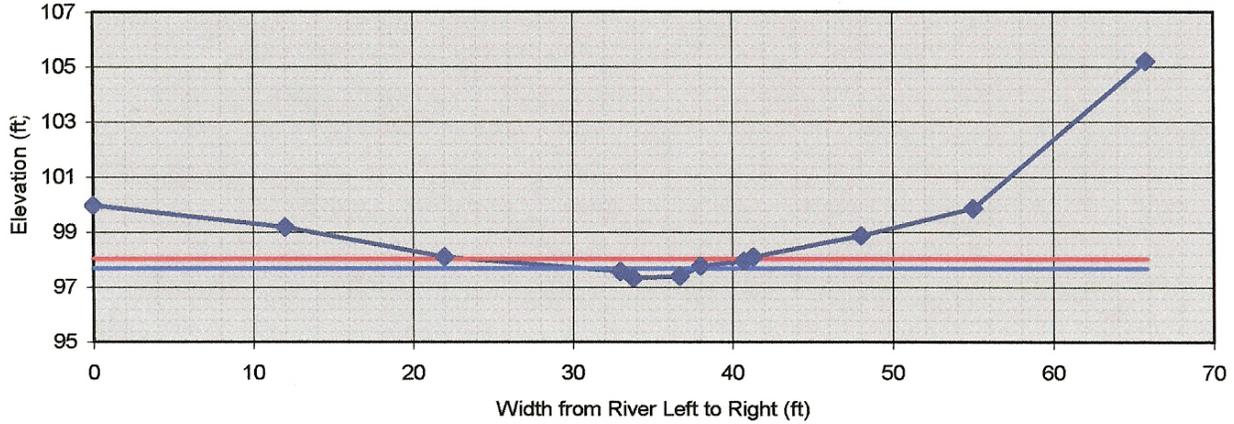
Corky Lopez Riffle Upper Horno

section: Corky Lopez			
Riffle			
stream: Upper Horno			
location: Sapello Watershed 02J, BM4.26 @ 325'long 40' stream right on rock			
description: 5/31/2006			
height of instrument (ft):			109.51
