# Monitoring of Forest Thinning Treatments and Wildfire Effects on Forest and Watershed Health in the Manzano Mountains, New Mexico

By David Lightfoot, Victoria Amato, and Cody Stropki

*SWCA Environmental Consultants*  
Albuquerque, NM

**Funded principally by the New Mexico State Water Trust Board  
to the  
Estancia Basin Watershed Health, Restoration,  
and Monitoring Steering Committee**

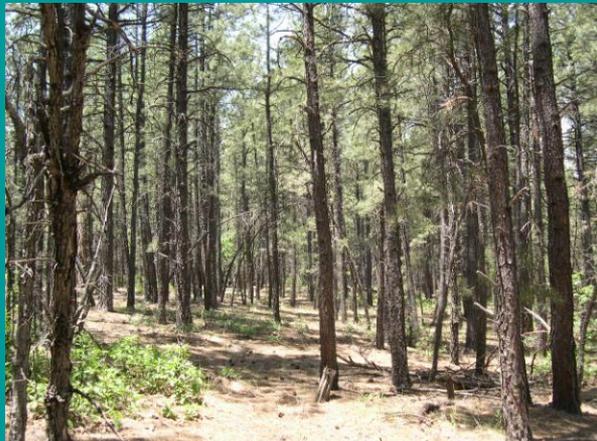
Pre-Trigo Fire 2007

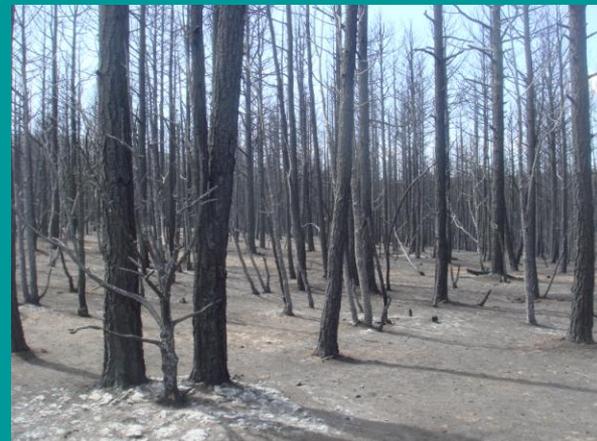
Post Trigo Fire 2008

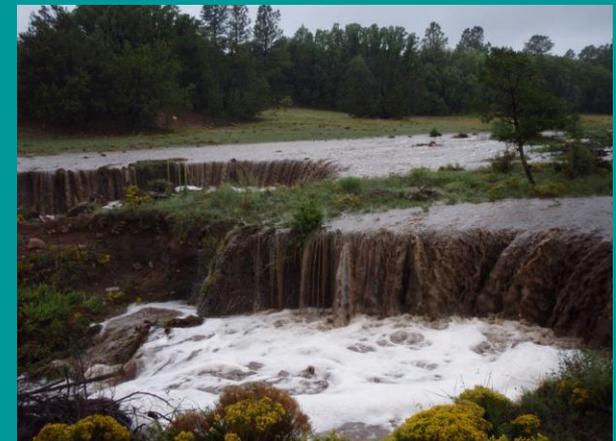
Runoff below Trigo 2009

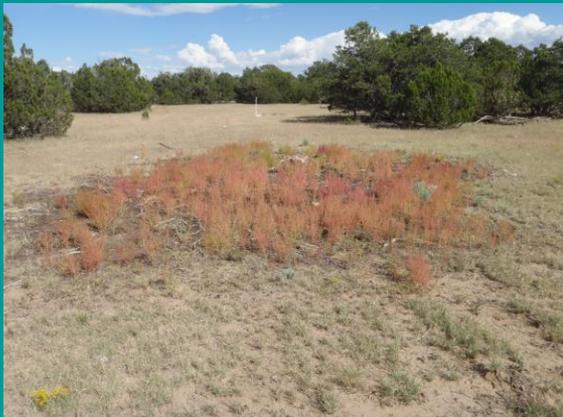
Juniper tree removed

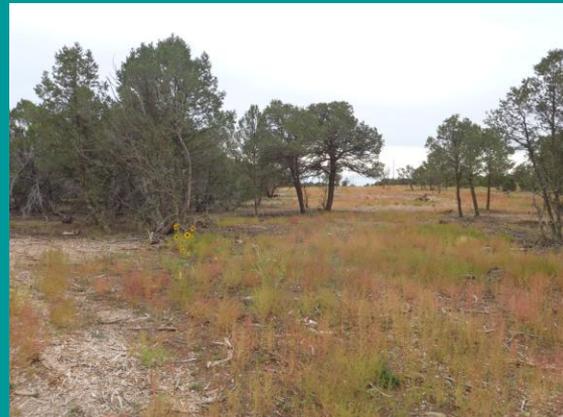
P/J thinning boundary

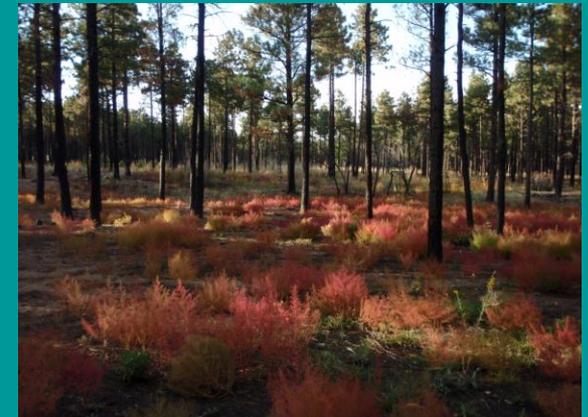
Ponderosa pine forest thinned

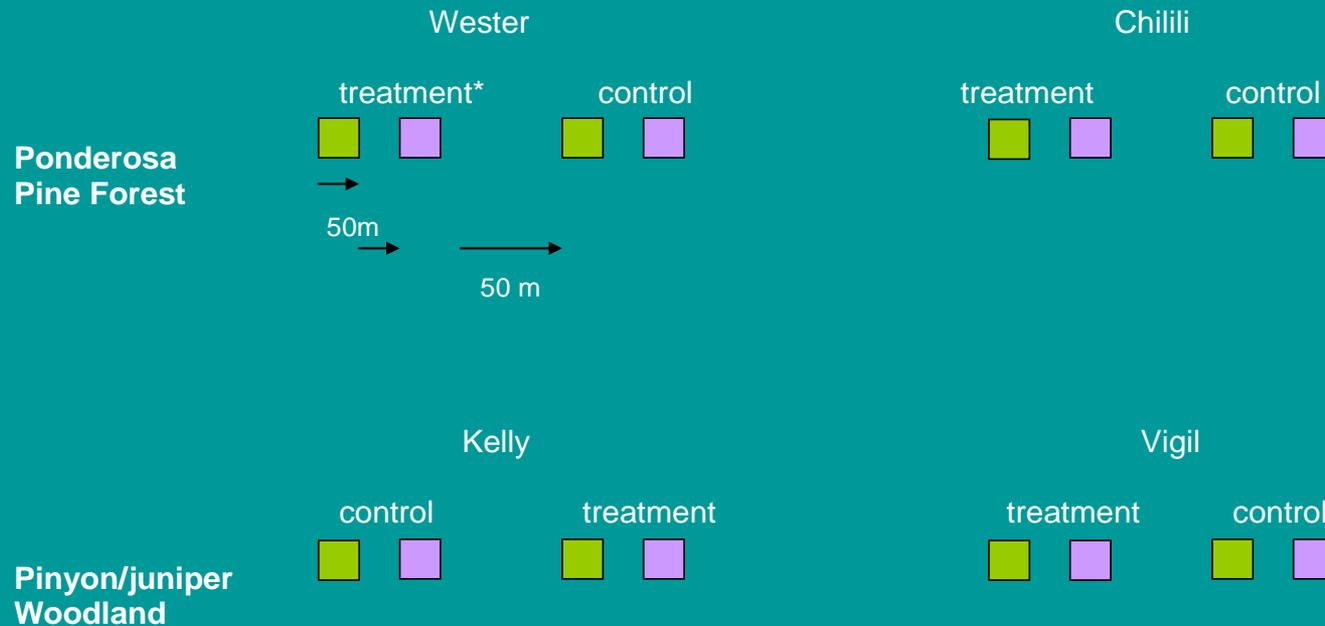
\* actual thinning treatments were randomly assigned to one of each subplot pair, treatments implemented winter/spring 2010

Vegetation / soils study subplot
-

Animal study subplot

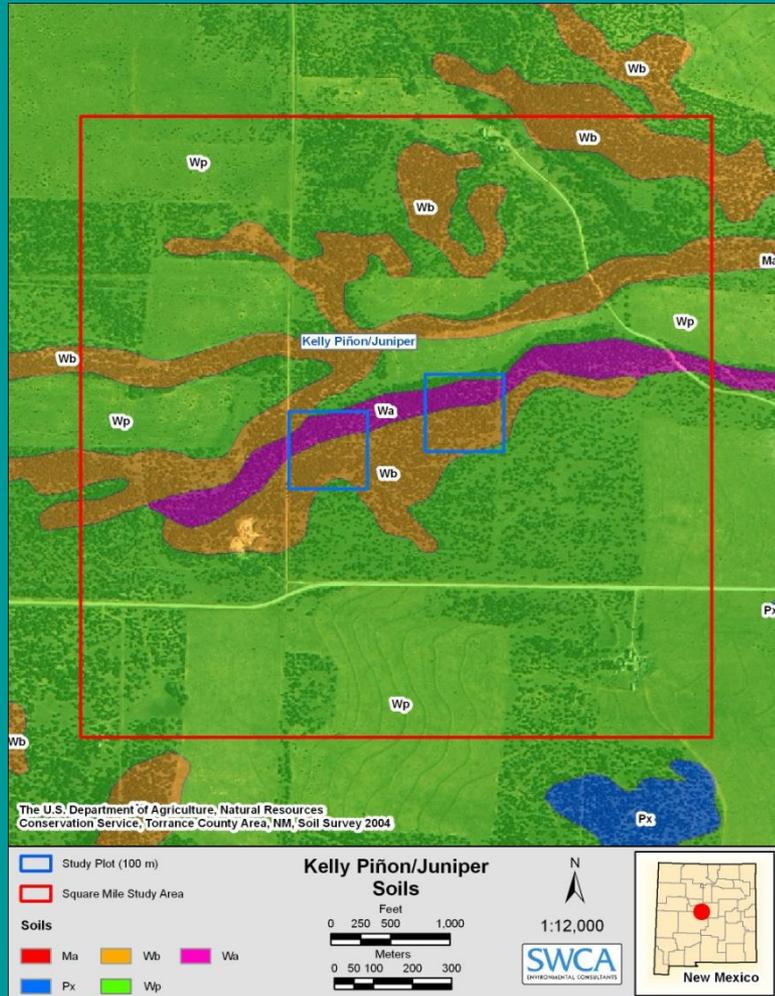
Paired plots, soils, topography

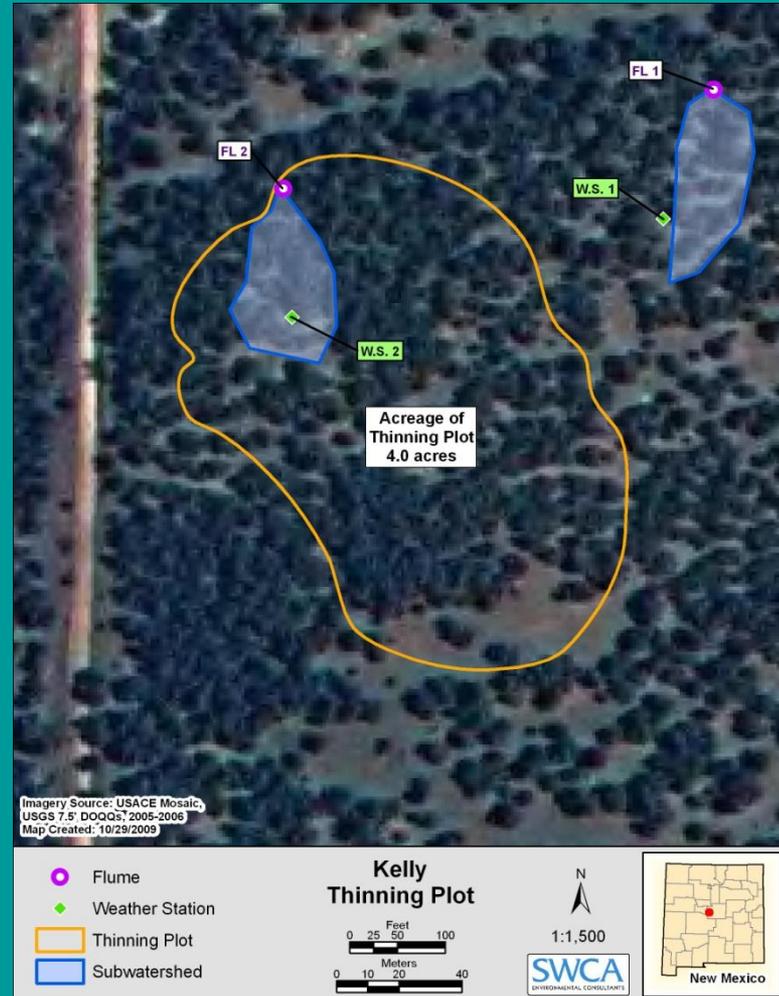
Paired subwatersheds, thinning area

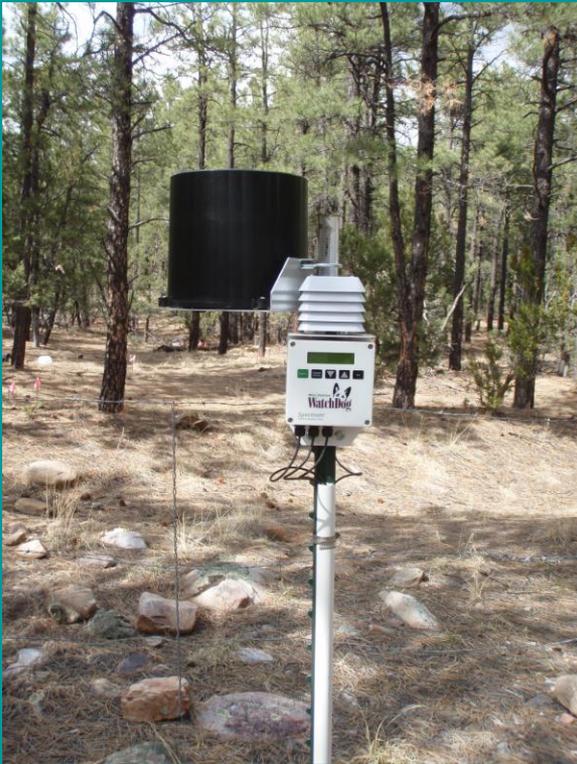
Automated mini meteorological stations at **each study plot**;  
**data recorded hourly on data loggers year-round.**

Weather data recorded:

- **precipitation**
- **soil moisture (-10 cm)**
- **ambient temperature**
- **soil temperature (-10 cm)**

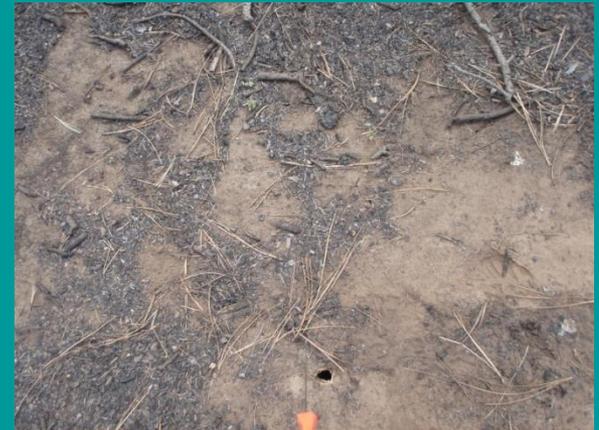
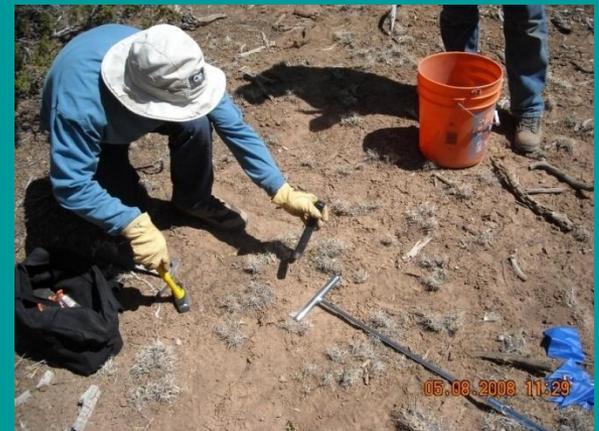
- surface stability test (*crust development, resilience; USDA-ARS*)

- soil erosion bridge (*drop-pin measures*)

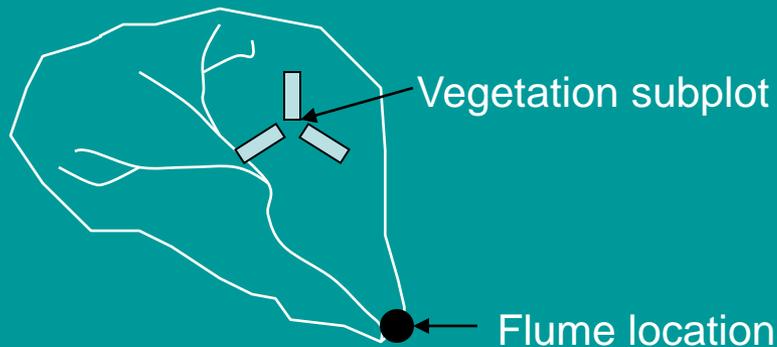
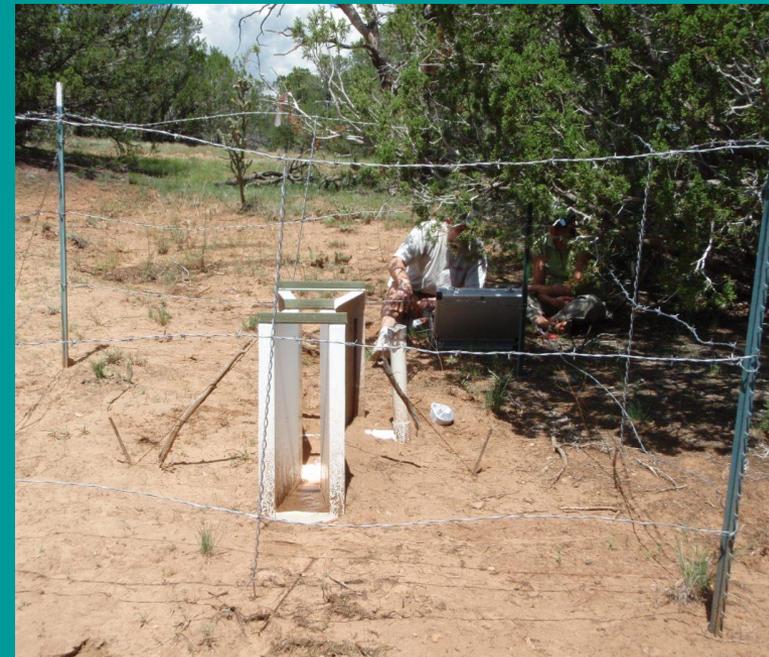
The surface outflow from the subwatershed associated with each subplot is monitored using pre-fab Parshall flumes:

Water levels in the flumes are automatically measured continuously using a pressure transducer/datalogger:

- measurements collected every 5 minutes

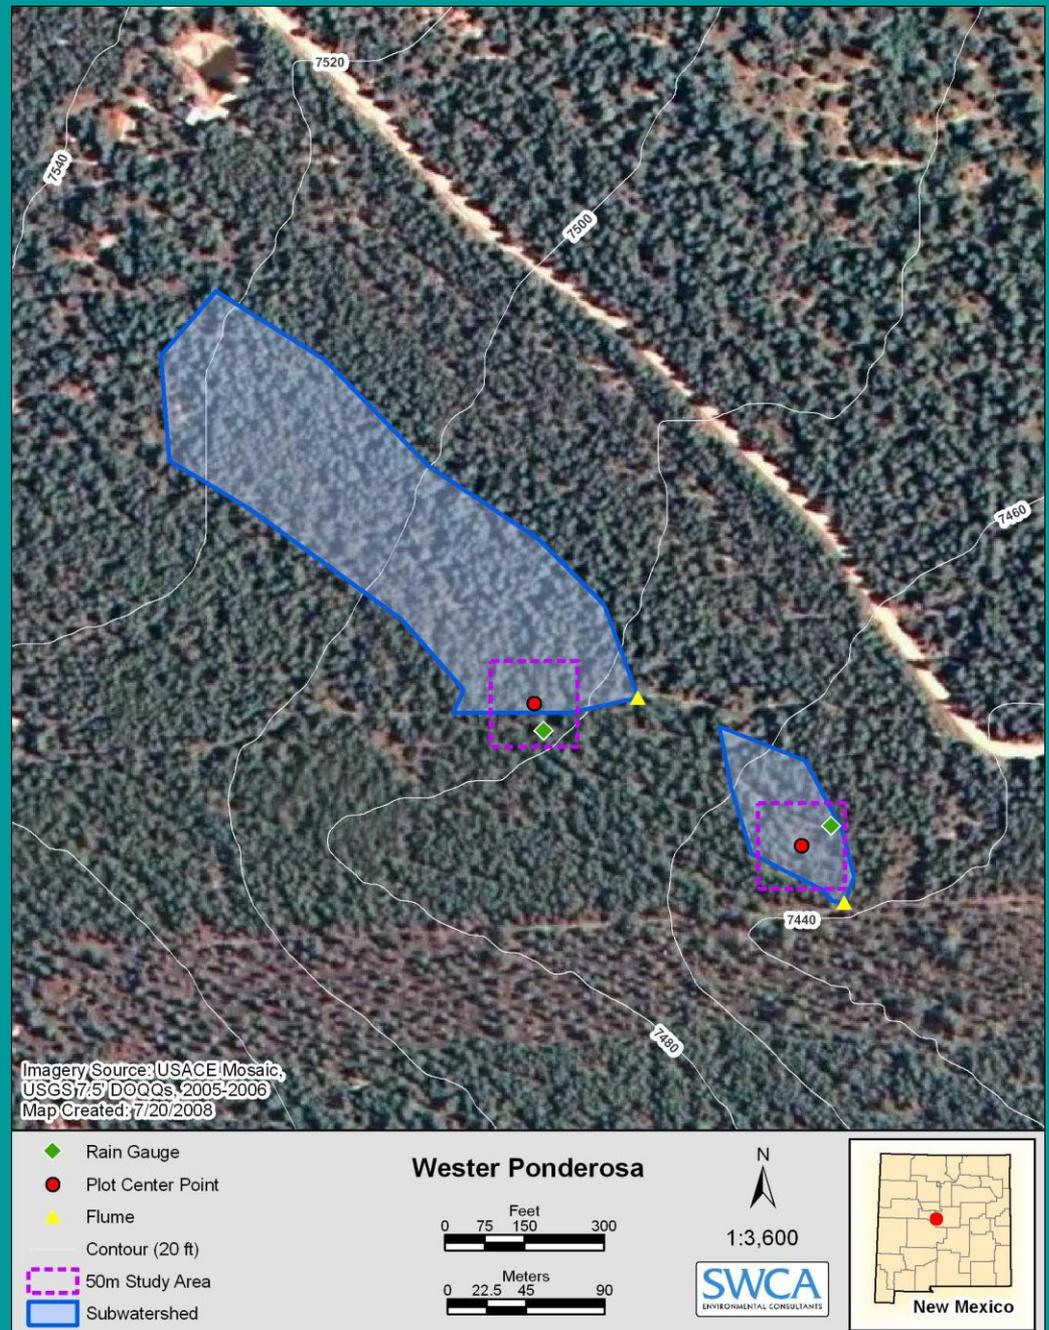
## Single storm flow event

Wester 2	9/17/2009
Flow Start*	4:57
Flow Stop**	5:27
Peak Stage	0.149 feet
Peak Flow	0.052 cfs
Flow Duration	30 min
Total Volume of Flow	55.8 ft <sup>3</sup>
Watershed Area	6.76 acres
Volume of Flow per Acre	8.25 ft <sup>3</sup> /acre
Total Rainfall	0.4 inches
Total Volumetric Rainfall	938 ft <sup>3</sup>
<b>Runoff Ratio</b>	<b>0.06</b>

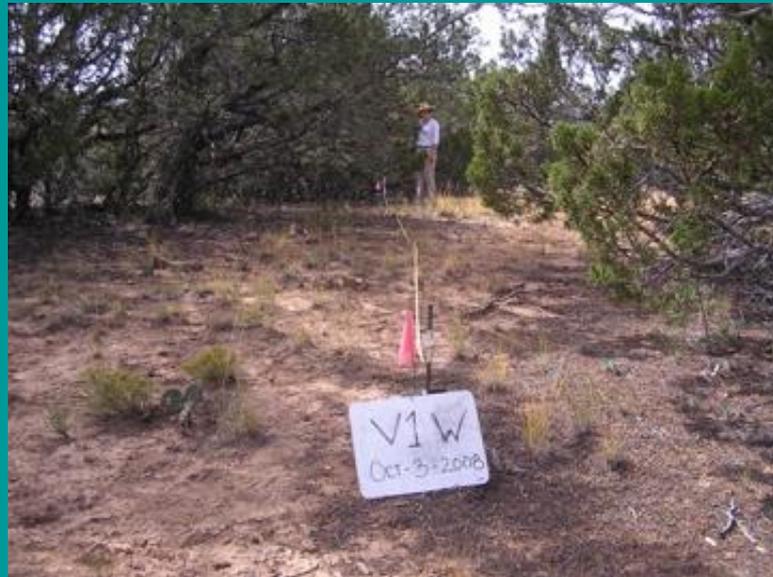
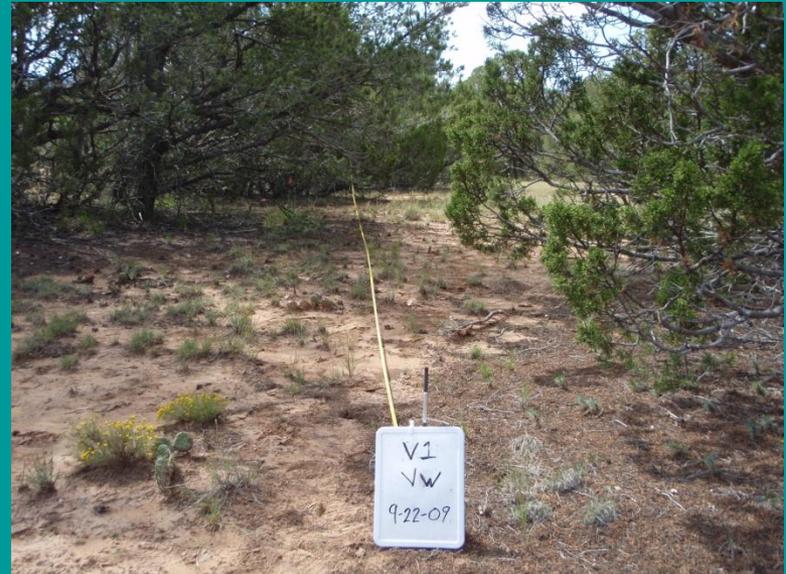
# Repeat Photo Points

Qualitative change over time

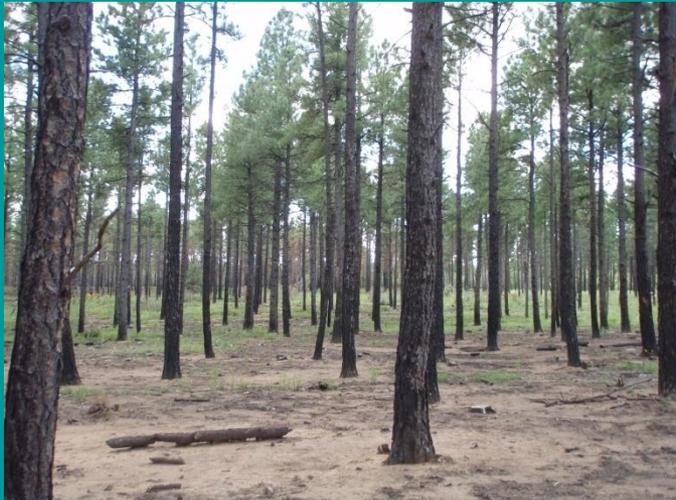
Low severity burn

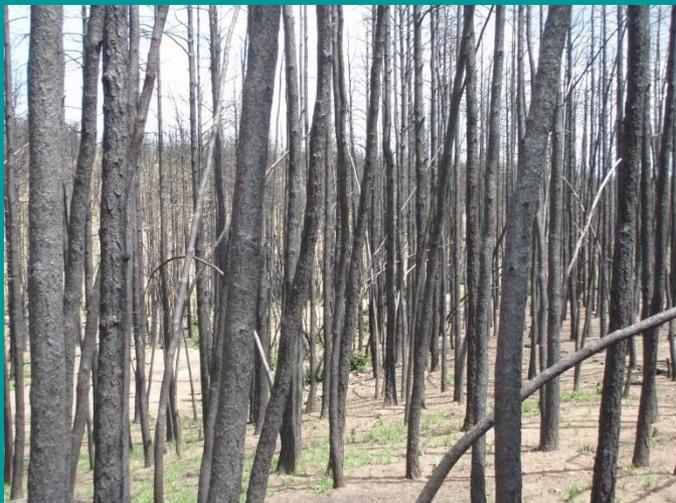
High severity burn

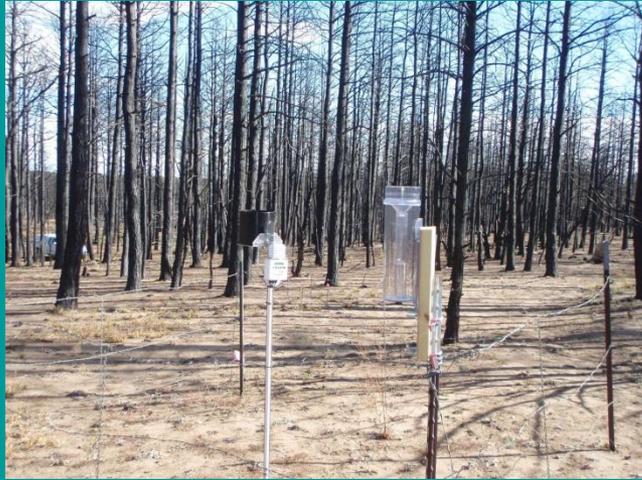
Mini-weather stations

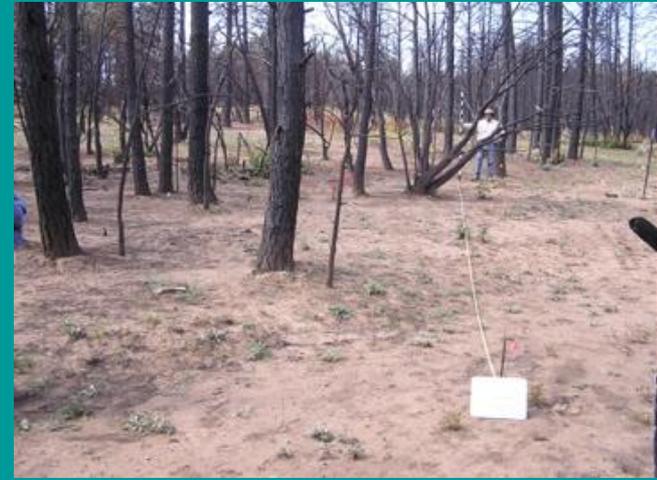
Vegetation transects & quadrats

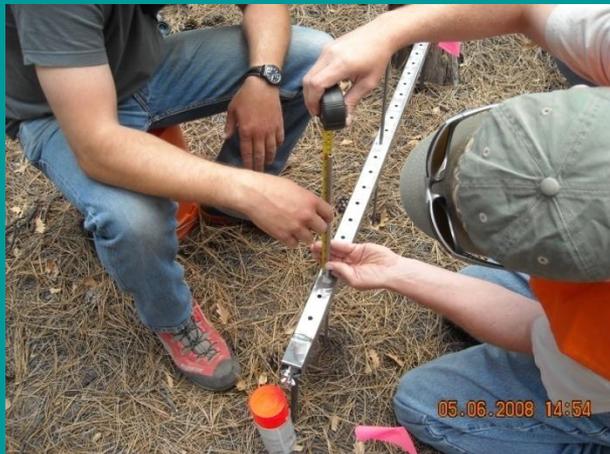
Soil erosion bridges

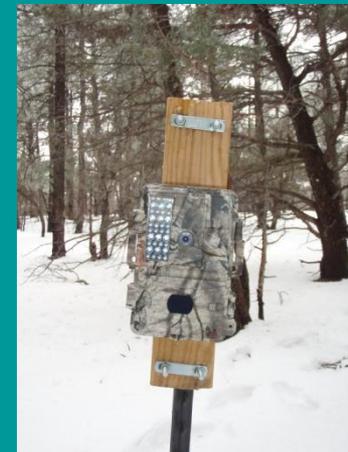
Automatic infrared wildlife cameras

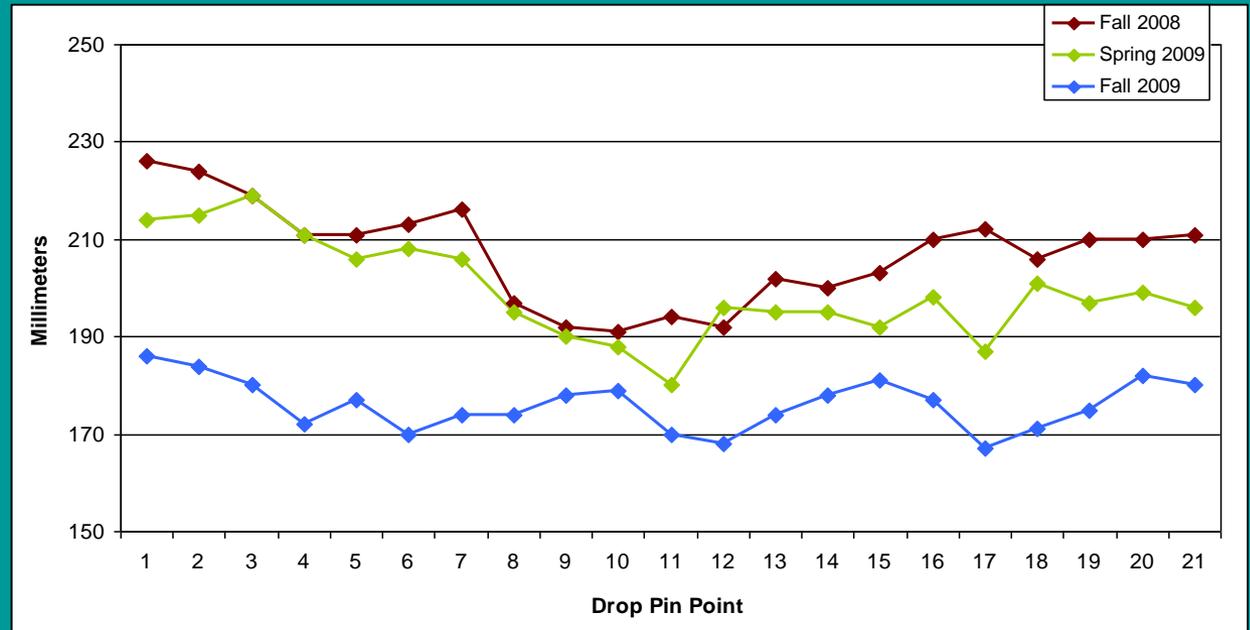
Example of one bridge repeat measurements

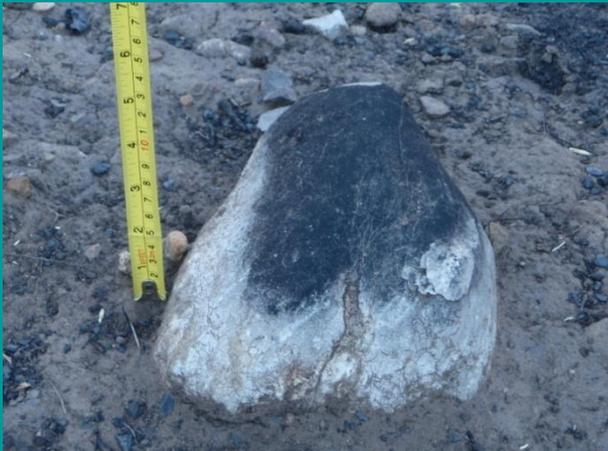
Initial duff & soil surface losses ~ 10 cm in high severity burn areas 2008

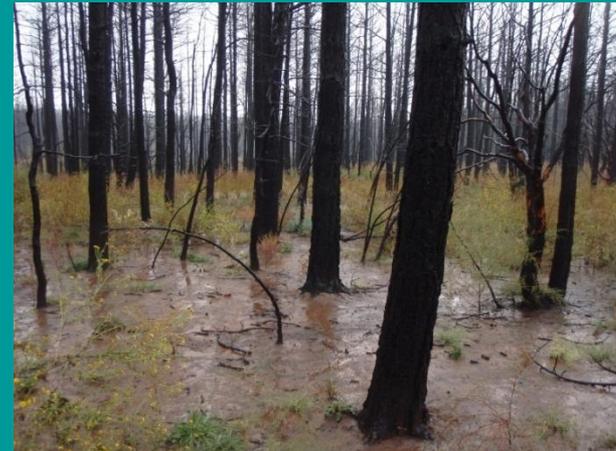
Herbaceous vegetation arresting soil loss in late summer 2009

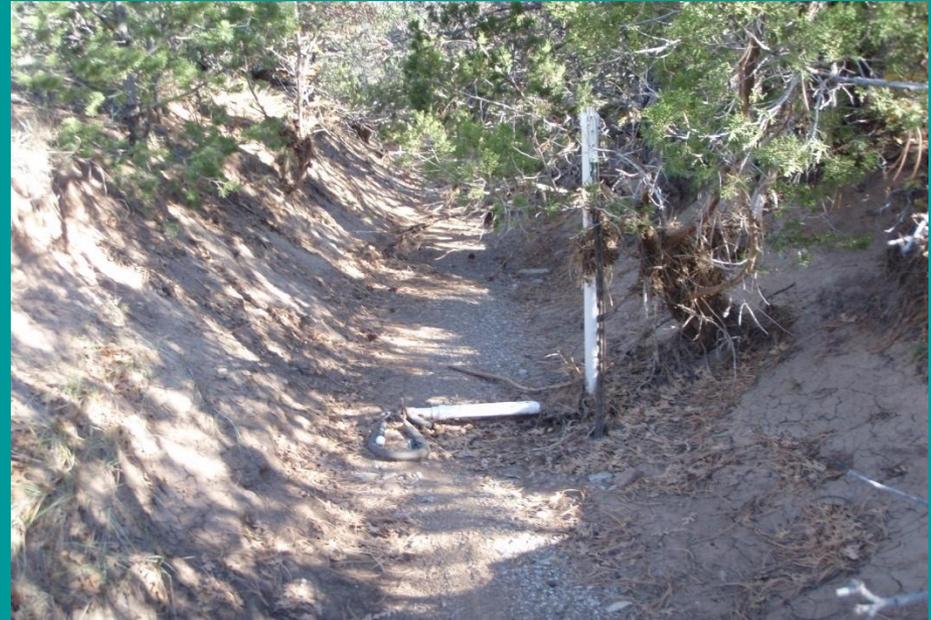
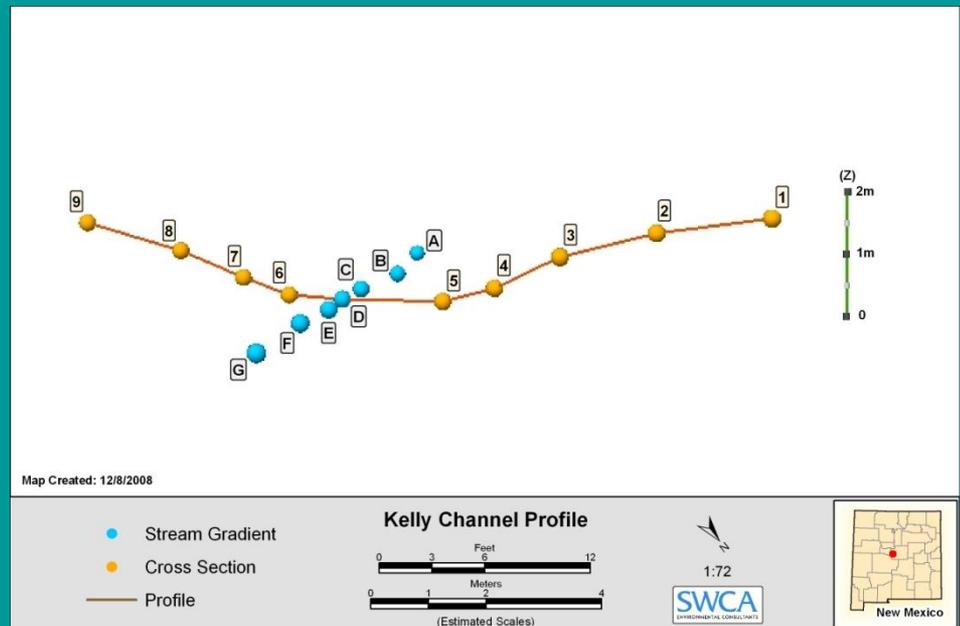
- Pressure sensor water level automatic data loggers

Stream profiles at piezometer locations to calculate flow volumes and rates based on stage level data over time.

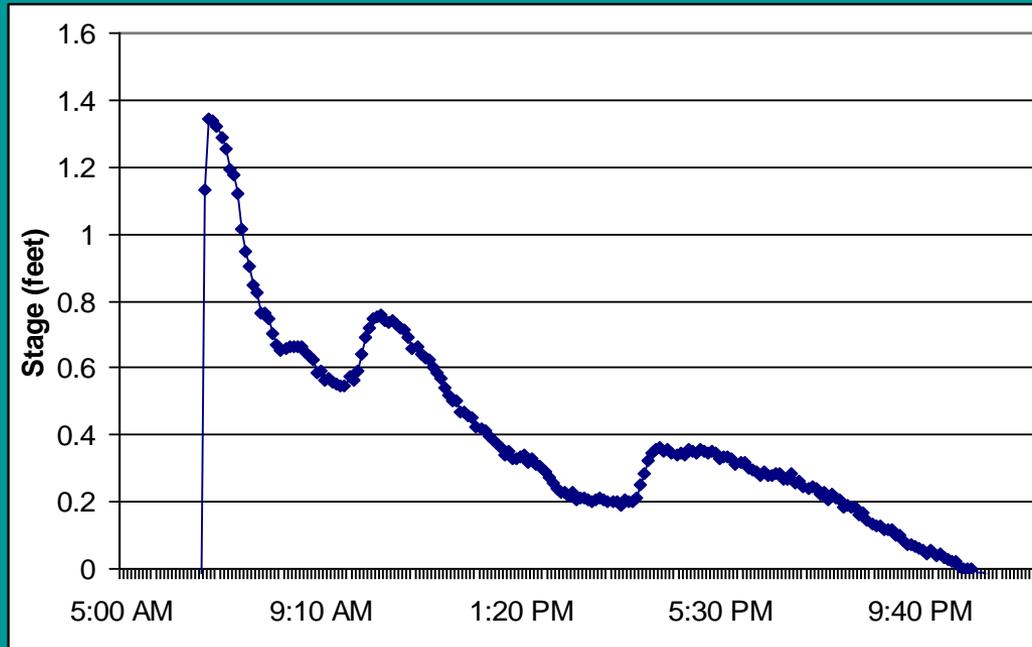
Example of stream stage over time following a storm

Example of runoff information determined by piezometer and stream profile data

Location	Date	Duration (hrs)	Peak Stage Height (ft)	Peak Flow (cfs)	Total Volume (acre-feet)
Vigil	10/5/08	24	1.44	30.03	40.39
Kelly	10/5/08	24	0.00	0.00	0.00

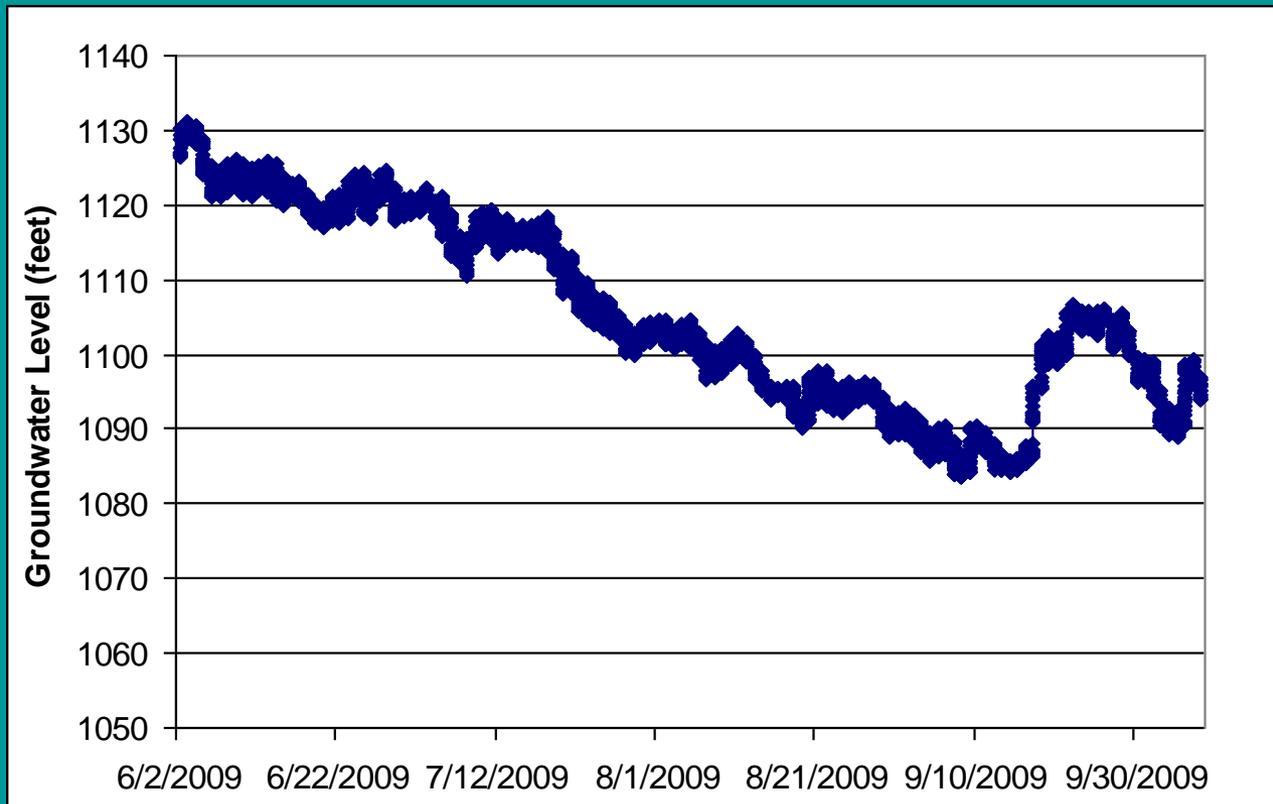
Example of ground water well data showing spike following a large storm event (Chilili)

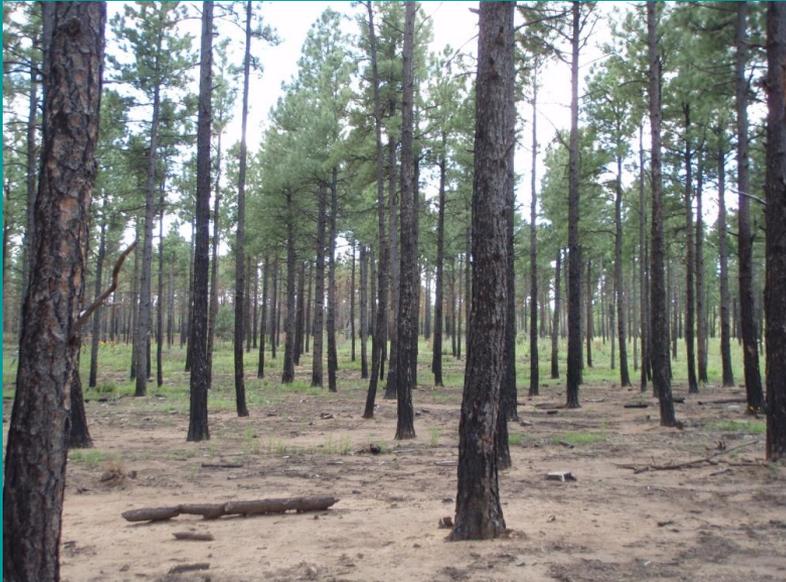
Thinned ponderosa stand post-Trigo

- Experimental forest thinning monitoring – treatments in fall 2010, post-treatment monitoring at least through 2013.
- Trigo Fire findings: fire severity, tree mortality, and soil loss less in low density and thinned ponderosa stands.

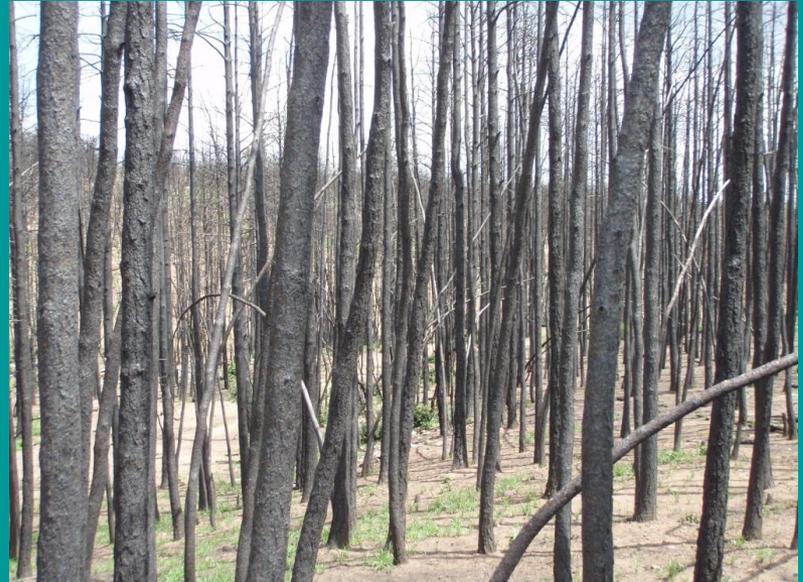
Adjacent non-thinned stand post-Trigo
