Stream Classification of the Mora River in The Wind River Ranch near Watros, New Mexico

Loraine Garcia and Jason Martinez,
Supervisors: Dr. Edward Martinez and Dr. Craig Conley
New Mexico Highlands University, Las Vegas, New Mexico

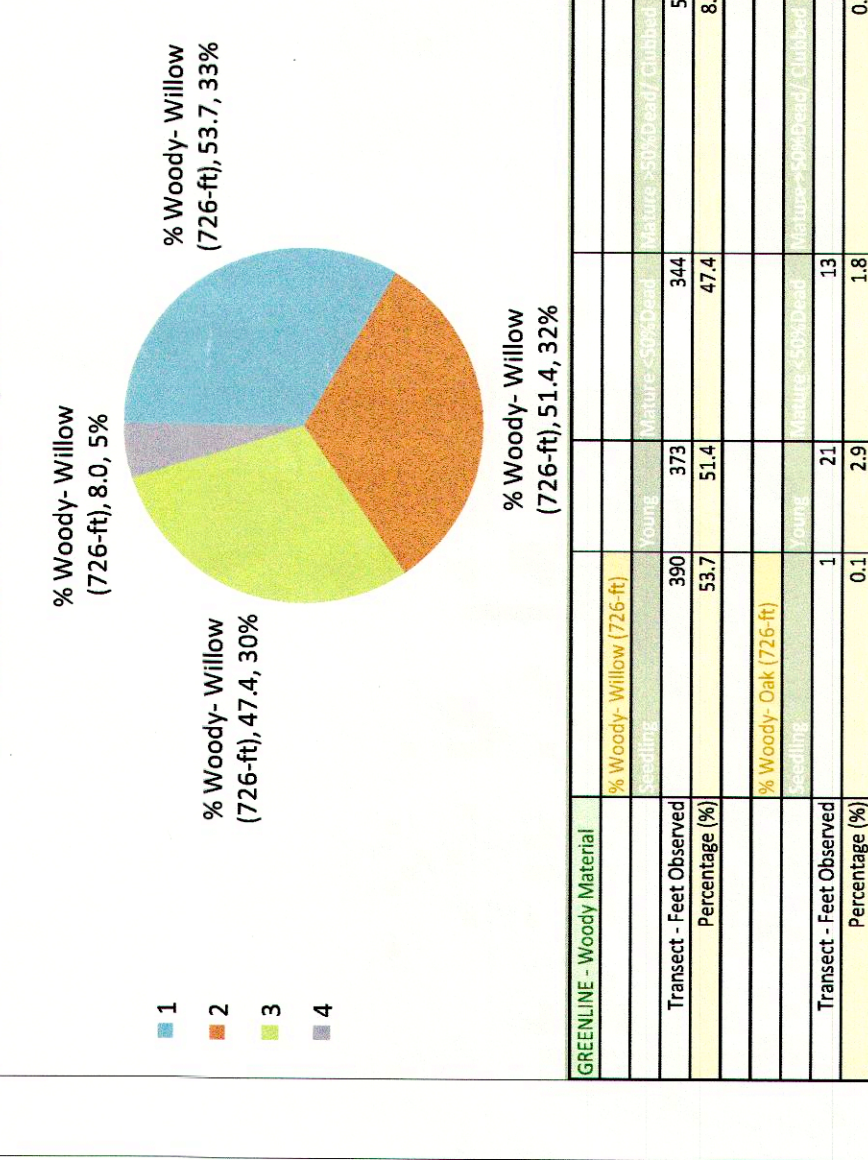
Greenline: Woody Material %

The greenline monitoring method is composed of three data collection procedures designed to generate a compatible data set. Greenline composition, riparian cross-section composition, and woody species density were the data objectives. Materials needed to collect data include data collection sheets, camera, six fence posts with the post hammer, GPS or compass, flagging, calculator, 6-ft rod (1). Placement of flagging on the greenline form the first cross-sectional transect and the starting point of the greenline transect. Using a GPS, the coordinates of each post of the cross-sectional transect were recorded. As a future reference, witness posts were located in upland vegetation to prevent them from being washed out and to allow for a potential increase in the width of the riparian zone. We then traversed the greenline upstream from the initial flagging, placing flagging at 100, 200, 300, and 363-ft. We then crossed the stream and traversed the greenline back down the opposite bank 363-ft. Flagging was placed to mark the end of the greenline transect. These markers helped the observers to keep track of the location within the transect and provide valuable reference points for the photographs.
